# DETERMINING THE ROOT CAUSES OF SUBSYNCHRONOUS INSTABILITY PROBLEMS IN TWO CENTRIFUGAL COMPRESSORS

## ABSTRACT

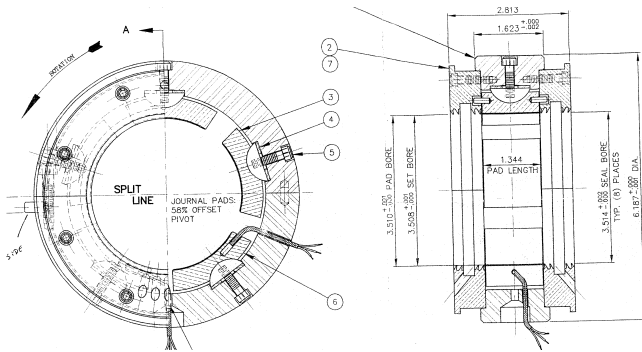
Figure 1. New LBP Bearing Installed in Compressor in 5/20/01.

propylene gas from 30 to 280 psig. The compressor operates between 10,000 and 12,500 rpm and is driven by a 3000 hp turbine through a speed-increasing gearbox. The original bearing design was a five-pad load-on-pad (LOP) bearing with center pivots and relatively tight clearance (0.004 to 0.005 inch on a 3 inch journal). In October of 2000, the compressor was overhauled as part of a normal unit turnaround. After the overhaul, the radial bearing temperatures were excessively high (~220°F) and would rapidly spike to over 300°F at times. This compressor had experienced high bearing temperatures in the past as well. To solve the problem, the bearing design was changed to a load-between-pad (LBP) design with offset/spherical pivots and higher radial clearance (Figure 1). The analysis of the new bearing design predicted that the bearing temperature would be lowered by at least 25°F. Likewise, the rotordynamic analysis of the compressor with the new bearing predicted that the synchronous vibration would be low with the new bearings (Figures 2 and 3). A lateral stability analysis was not performed by the contractor, mainly because the sole objective of the bearing design was to lower the bearing temperature, and because the vibration of the compressor had always been so low. Likewise, a stability analysis had been performed during the conversion to dry gas seals in 1994, which showed that the compressor rotor was very stable (Figure 4). Since the calculated aerodynamic cross coupling for the entire rotor was approximately 4300 lbf/in, the compressor was considered stable. These new bearings were installed in May of 2001. The radial bearing temperatures were at acceptable levels (< 175°F) after the bearing modification; however, the radial vibration increased from 0.3 mils to 3.5+ mils. Additionally, most of the vibration was at a subsynchronous frequency that had not been present before. This frequency coincided with the rotorbearing system's first natural frequency.

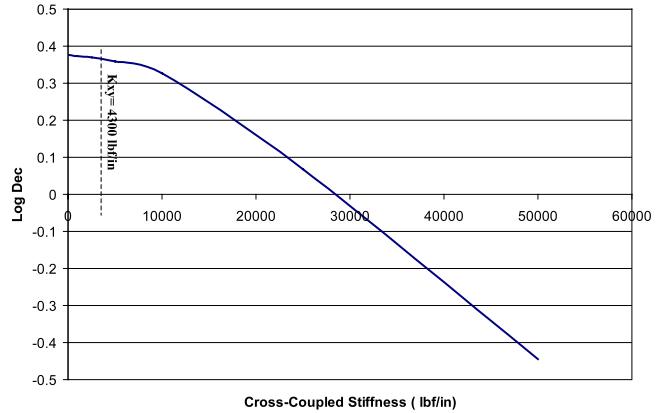
Figure 4. Effect of Aerodynamic Cross-Coupling on Stability from Analysis in 1994.

large degree of stability, Figure 14). Notice that the calculated  $I_d$  of 0.32 corresponds closely with the value shown in Figure 4 on the

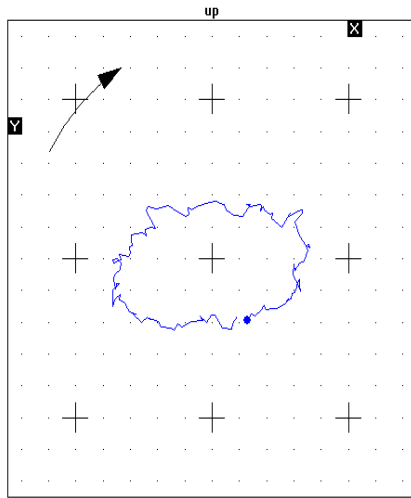
Figure 12. Shaft Orbit at 10,900 RPM (Before Speed Test).

condition of the compressor could be attributed to load (i.e., horsepower), on 7/12/01, the speed of the compressor was increased from 11,000 to 12,200 (Figure 11). The radial vibration jumped from an overall value of 1.6 to 3.3 mils, most of which was the subynchronous component. The drive end shaft orbits before and during the speed increase are shown in Figures 12 and 13. As can be seen, the internal loops are representative of a large subynchronous vibration at  $1/3$  of shaft speed. The speed was lowered back to 11,000 rpm, and the vibration dropped back down to its previous level. This further confirmed that the problem was indeed stability related.

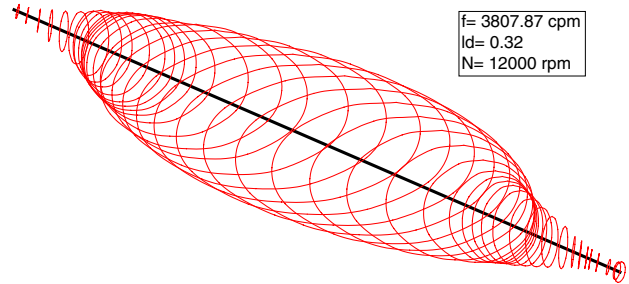
Figure 14. Calculated First Mode Shape Without Seal Effects.

far left of the curve. However, this did not correspond to the erratic subsynchronous vibration seen in the field. Since tilting pad bearings do not produce significant destabilizing forces, the rest of the compressor was examined. The most significant rotor support in the compressor, besides the bearings (because the compressor has dry gas seals), is the center labyrinth seal that separates the discharge of the two compression sections (Figure 15). This seal is a rotating labyrinth design with an abradable stationary. Even though this was a low pressure application, this seal was suspected as the source of instability, since rotating labyrinths typically produce more cross-coupled stiffness than stationary labyrinths. Likewise, this seal was in the center of the rotor, where it would have the most effect on the first mode (i.e., much more displacement at the center of the rotor). The dynamic coefficients of the center labyrinth seal were calculated using a two control volume bulk flow model (Figure 16). Adding the seal coefficients to the rotor model with the new bearings causes the calculated log decrement of the first mode to drop considerably (Figure 17). However, these calculated coefficients seem to be unusually large because, if the seal coefficients are added to the model with the old style bearing, it also predicts an unstable system (Figure 18). Since this compressor has a long history of operating with low vibration, this indicated that either the model for the center labyrinth seal was incorrect or the destabilizing effects in the compressor had changed since the new bearings were installed.

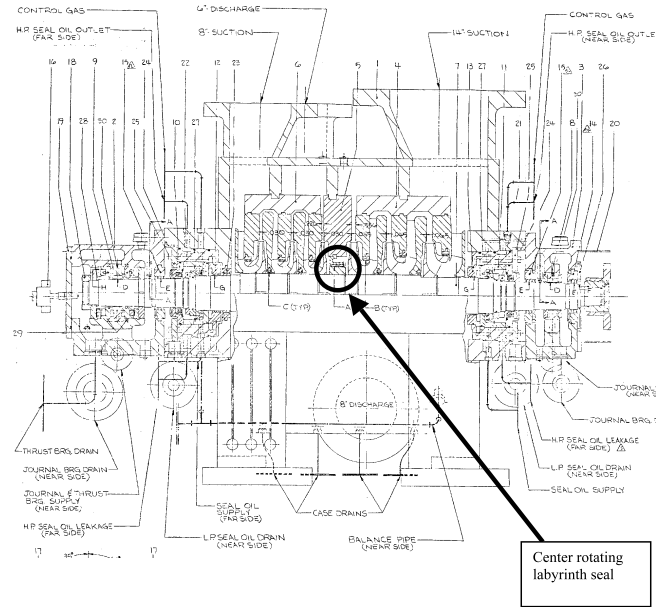
Figure 15. Cross-Section of Compressor, Showing Center Seal.

The center labyrinth seal might have been damaged since the bearing modification, which would have caused it to produce more destabilizing forces on the rotor. The most likely cause of this would be a rub during startup of the compressor.

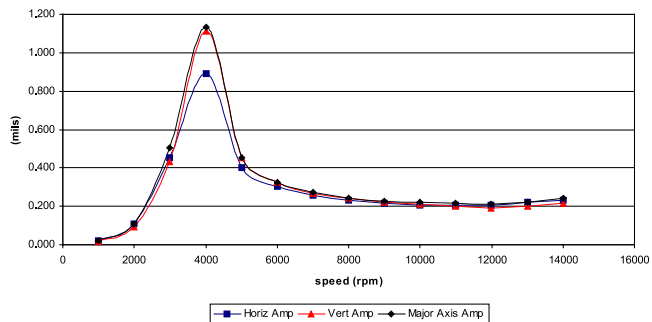
Figure 19. Forced Synchronous Response at Center Seal with Modified Bearing.

The most likely damage to the center labyrinth seal would occur during startup of the compressor on 5/10/01. Since it is a rotating labyrinth seal with an abradable stationary, the rub would not be as detrimental as a stationary aluminum labyrinth against a steel sleeve. To determine if the center seal did rub, the measured synchronous response, first mode shape, and predicted synchronous response must be used. As can be seen in Figure 9, the synchronous amplitude measured on startup at 11,000 rpm is approximately 0.6 mils peak-to-peak. This is very comparable to the amplitude predicted in the calculated synchronous response (Figure 3). This verifies that the assumed unbalance is close to the actual. Likewise, the predicted synchronous response at the center seal is shown in Figure 19. As can be seen, the maximum synchronous amplitude is approximately 1.1 mils peak-to-peak. Since the diametrical clearance of the center seal is 0.006 inch, it seems unlikely that it rubbed on startup of the new bearings. Another interesting note is

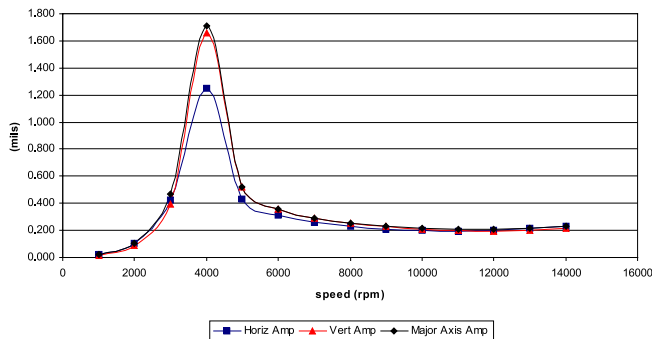
Figure 20. Forced Synchronous Response at Center Seal with Original Bearings.

that the synchronous response at the center seal with the original bearing is actually higher (Figure 20). While at first this seems incorrect, it is important to remember that the amplification factor of a rotor system is a strong function of the bearing to shaft stiffness ratio. As the bearing stiffness goes up for the same rotor, the amplification factor goes up as well. Since the original bearings had a much higher stiffness, this increased the amplification factor (even though the clearance was lower). However, it is unlikely that the center seal rubbed with the old bearings as well because the maximum amplitude is 1.6 mils peak-to-peak, plus there were no vibration problems prior to the bearing modification.

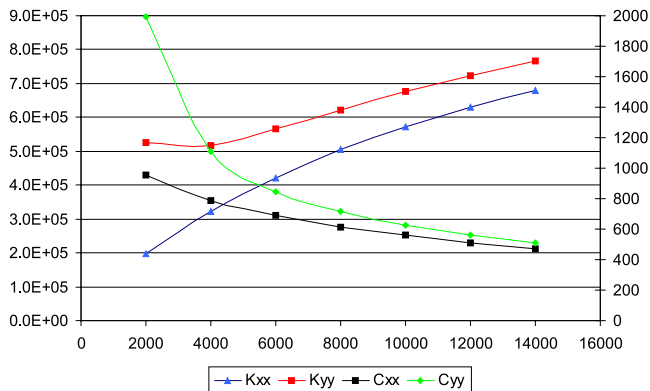
Figure 27. LOP Bearing Design with 58 Percent Offset Pivot.

A 58 percent offset pivot was considered for the LOP design to lower the operating temperature; however, the offset pivot causes the principal stiffness to increase dramatically, with very little increase in damping (Figure 27). The net result is a decrease in stability in comparison to the center pivot design (Figure 28). The ampcolloy pad material helps to compensate for this change because its thermal conductivity is approximately  $4\times$  that of bronze and  $4.5\times$  that of steel. The calculated maximum babbitt temperature with copper and bronze pads is shown in Figure 29.

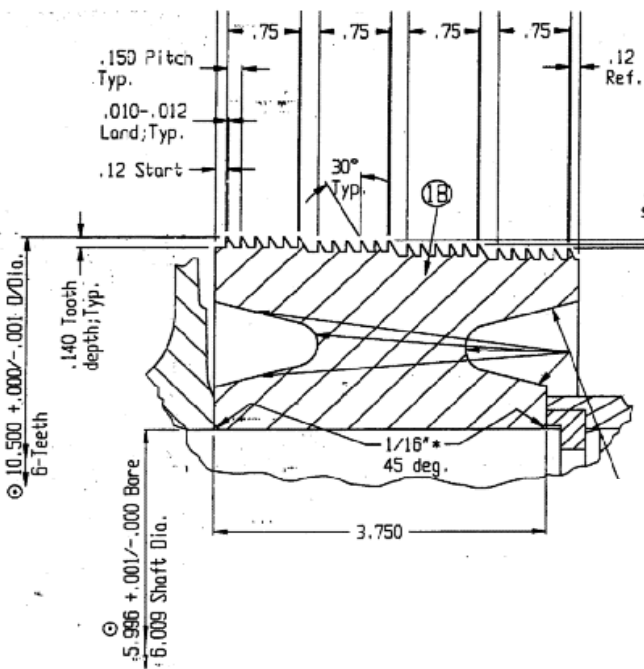
Figure 40. Cross-Section of Balance Piston Seal.

- The original stability analysis used 1500 and 2500 lbf/in as the cross-coupled stiffness produced by the impellers and balance piston seal, respectively. While the impeller coefficients were inline with industry practice (i.e., the Wachel equation), the values used for the balance piston seal appeared unusually low, considering the design of the balance piston seal. The seal is a teeth-on-rotor (TOR) design, with relatively high differential pressure and surface velocity, and moderate molecular weight (Table 1 and Figure 40). All these factors tend to indicate a labyrinth seal that can be very destabilizing.

1997. A correlation between the balance line differential pressure and the radial vibration excursions on the compressor could be seen when plotted back to 1997 (Figure 41). Since the subsynchronous vibration seemed to be tied to increased flow through the balance line, it was suspected that the seal had suffered some type of failure that would allow increased flow. The director of a major university's research laboratory was contracted to provide the seal coefficients shown in Table 2, as well as Figures 42 and 43 for different clearance and inlet velocity ratios. As mentioned in the prior case study, the  $K_{xy}$  values were reduced so that the whirl frequency coefficients were equal to the inlet velocity ratios. The estimated leakage based on balance line differential pressure was close to the calculated leakage for the seal with 0.020 inch clearance.

unstable. It was deduced that the balance piston seal had suffered a severe failure that was causing it to produce more cross-coupled stiffness than the code predicted. The decision was made to split the case during the upcoming outage and inspect the balance piston seal, instead of just changing the bearings, because the analysis indicated a significant failure of an internal component to drive the machine unstable. Additionally, this plant had experience with a

previous design stationary abradable seal failing catastrophically when process pressure closed the seal onto the shaft. To address the instability, an alternate stationary balance piston seal was designed using an aluminum honeycomb to run against the rotating teeth to provide a more robust seal and additional resistance to swirl.

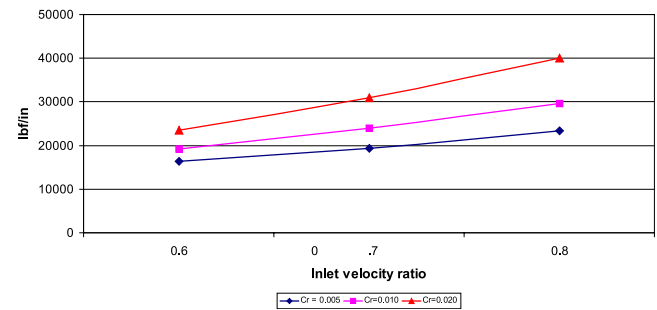
Figure 42. Cross-Coupled Stiffness Produced by Balance Piston Seal for Different Clearances and Inlet Velocity Ratio.

A stability map for different values of cross-coupling at the balance piston (with the original five-pad LOP bearings) is shown in Figure 44. Since the calculated value of the cross-coupled stiffness produced by the balance piston seal was only 30,930, this indicates that the rotor is quite stable with the original LOP bearings. According to the calculations, the balance piston seal does not produce enough cross-coupled stiffness to drive the compressor
