ELIMINATION OF FLOW-INDUCED INSTABILITY FROM STEAM TURBINE CONTROL VALVES

ABSTRACT

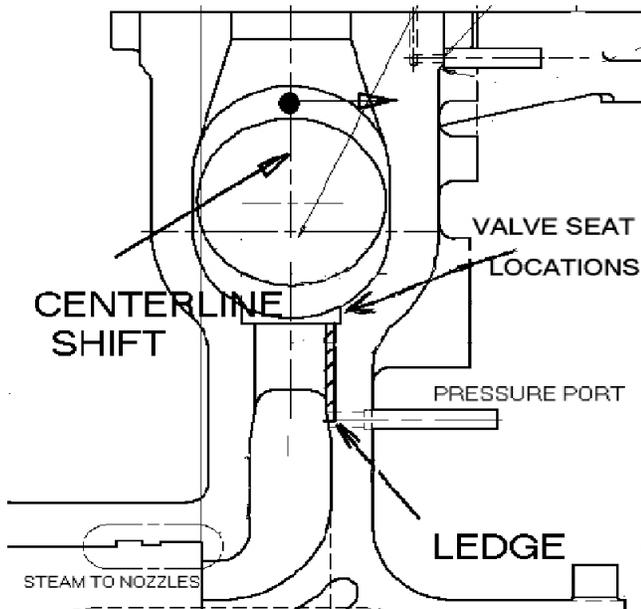
Initial data obtained in the field was with accelerometers that were helpful, but concurrent pressure pulsation data from ports downstream of the valves, shown in Figure 6, were deemed at first to be useless. Pressure pulsations at high amplitudes in the frequency range of 250 to 500 Hz were eventually shown to be due to "organ pipe" resonance due to probes not being flush-mounted. "Organ pipe" is a term used for longitudinal acoustic modes of tubes using calculations shown in APPENDIX A. However, laboratory testing discussed in APPENDIX A clarified what data were useful from the pressure probe measurements, and more field tests during valve vibration after the second valve failure correlated with analysis and valve rig tests to prove the cause of vibration. Data were obtained for Mod 2 valve No. 2 for valve rack lift near 58 percent opening, showing the occurrence of severe vibration in the 30 to 40 Hz frequency range. For these tests, transient data were obtained with a tape recorder for laboratory analysis. Indeed, listening with a speaker connected to the tape recorder output of the dynamic pressure probe sounded similar to a vehicle traveling over rumble strips, as the observed sound from the valves had been described earlier.

Figure 6. Side View of Steam Chest Downstream of Valves Showing Machined-In Ledge at Pressure Ports Leading to Pressure Transducers.

In order to clear insulation blankets, the pressure ports shown in Figure 6 had long lengths of piping with access valves to install static pressure gauges or transducers to measure nozzle ring pressures as valves are opened. However, some pressure transducers also can obtain dynamic pressures. For the turbine, strain-gauge transducers were used that also provide static pressures. Because the transducers are not flush-mounted, there will be an acoustic resonance having a quarter-wave length ($1/4$ of the length from the opening to the end of the piping where the transducer is located). In other words, this open-closed pipe will have a very small pulsation from the excitation of turbulent flow just at the port opening, a node, with maximum pressure pulsation at the closed end where the transducer is located. The equation from den Hartog (1954) for the frequency, F_1 , in Hz for the first open-closed mode is given by: $F_1 = V_A / (4 \cdot L)$ where V_A is gas acoustic velocity in ft/sec, and L is overall pipe length in feet. The diameter of the cavity has a small effect for long tubes, and the presence of the valve trim will also modify the frequency. The effective length for short tubes is $(L + 8D/3)$, where L is the length and D is the diameter.

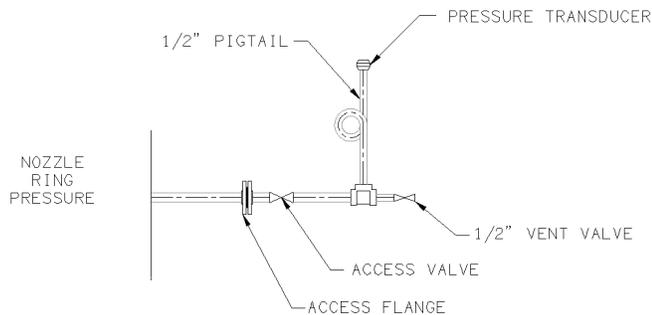
A mockup of a port, valve, "pig-tail," and transducer was tested by blowing shop air past the 1 inch pipe port opening, as shown in Figure A-1. The pipe length to the access valve is about 17 inches, with another 38 inches to the transducer. Frequencies found for various test conditions are given in Table A-1. The equivalent frequencies for turbine inlet steam conditions are also given in the table. During testing, the resonance inside the port assembly could be heard inside the laboratory, as one would hear the resonance from organ pipes or blowing across the top of a bottle. The node for the mode is actually just inside the port. Tests were done to quantify the power of the open-closed "organ pipe" using a microphone measurement to obtain the sound power emanating from the port. For the air test, the ratio of pressure at the transducer at the end of the port to that 2.5 inches away, outside the port entrance, was near 200 to 1. Using this ratio for equivalent pressures to those for the turbine at conditions during severe vibration, calculations resulted in a sound power that would translate to about 5 psi peak pressure at the valve. In order to significantly reduce the high pul-

Figure A-1. Schematic of 1 Inch Pressure Port Including Vent Valve Used at Site.

sations, plugs were designed to mate at the access flanges; the sound power with a small 1/8 inch diameter bore, 3.5 inches long at the port entrance, would be reduced by a factor of 40. Another test was done holding a microphone calibrator against the port opening with a 114 dB sound pressure level. Measurement at the closed access valve also gave 114 dB for a frequency well below the first mode of the closed-closed tube, showing that field data at 30 to 40 Hz would give accurate amplitudes.
