TURBINE REMANUFACTURE—ONE OPTION FOR RELIABILITY AND EFFICIENCY IMPROVEMENT

A case study of a remanufacture of a steam turbine is presented. The turbine has been in service for 20 years. Thermal and physical stresses have taken their toll on the turbine casing and supporting hardware.

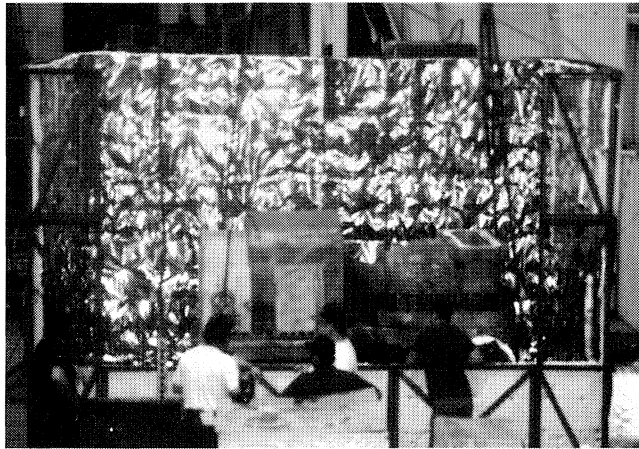
Figure 9. Turbine Case in Furnace After Stress Relief.

was determined that the horizontal joint had been corrected to an acceptable state where approximately 25 percent of the OEM specified bolting torque would be required to obtain a metal-to-metal seal. Overall, the HP and LP gaps after heat treatment were reduced 0.005 in and 0.010 in, respectively. This was determined to be acceptable. Machining of the entire horizontal joint was not required. While unbolted, the horizontal joint gap was reduced by 0.005 in and 0.010 in, for the HP and LP, respectively, when compared to the prestress relieved condition. While bolted, no gap existed except in two small areas on the HP case near the vertical joint. The out-of-roundness of the casing was improved by 0.005 in and 0.002 in radially on the HP and LP, respectively. The LP experienced minor change, because initially it was only 0.009 in out-of-round, compared with the HP's 0.017 in radial distortion, on average. Also, the residual stresses were relaxed out of the casing, which should provide years of distortion-free operation, assuming normal operating procedures are followed.

Following cool down of the case to ambient (Figure 9), the horizontal joint was unbolted and checked with feeler gauges. It

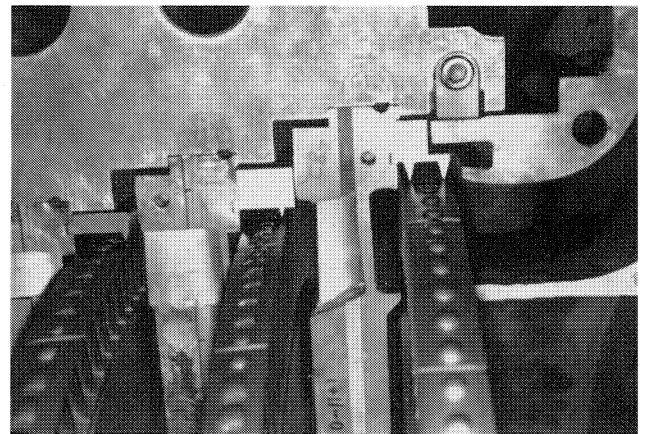
Figure 26. New Seal Rings.

Originally, the seventh stage diaphragm had a bolted-on ring with radial seals (Figure 25). This ring was replaced with a new ring of the same design, but tighter clearance (Figure 26). The third through sixth stages were modified to accept bolted-on radial seal rings. The application of radial seal rings reduced blade tip sealing clearance to less than half that of original design in every stage. In several stages, the resulting clearances were less than 25 percent of design.
