IS THE DRY COUPLING REALLY CAUSING YOUR VIBRATION PROBLEM?

Guill A. Cornejo

Joseph P. Corcoran

ABSTRACT

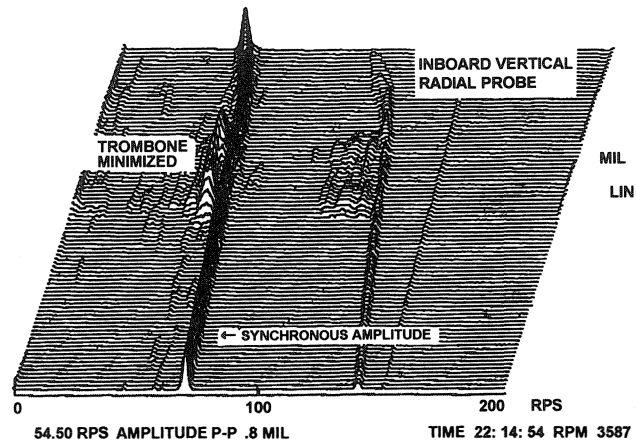
Figure 5. Unit 2 Normal Stop, Unit @ Alarm (But No Shutdown) @ 60 Percent Speed; Gear Coupling.

There was vast operating experience with lubricated (wet) or splined/geared couplings for this type of compressor train. A wet coupling was installed as soon as it was available. The result of a normal controlled stop is presented in Figure 5. There was a repetition of the "trombone" phenomena, however, but the vibration amplitudes at the forward bearing only activated the alarm setting, not a shutdown. After repeating the stops several times, there was a spell of relief when the shutdowns did not materialize. However, the line pressure conditions were not at the maximum. As soon as the line returned to maximum pressure, the vibration did not always stay at the alarm level, and it reached the shutdown setting at least once.

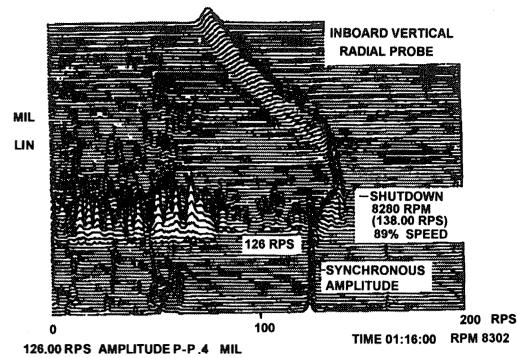
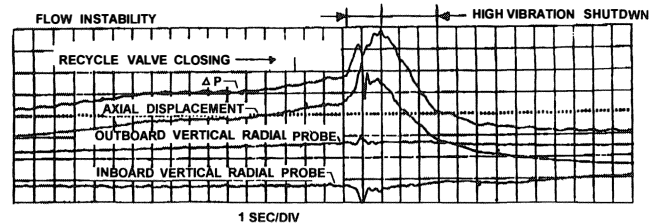
Figure 6. Shutdown Caused by Flow Instability.

It was already known that process delta pressure (ΔP) discontinuities across the compressor, during uploading or downloading, resulted in a coupled response of the compressor shaft axial position (Figure 6). The close relationship of the ΔP variations across the compressor and the axial response of the shaft is shown in Figure 6. Except for a small phase shift one can use the axial shaft position as an indication of the process ΔP .

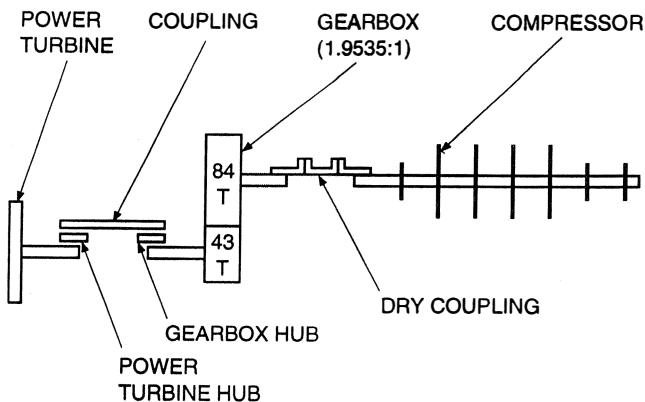
Figure 10. Case #2 Train.

The power train discussed in this case is depicted in Figure 10. There were features of this power train that made it different from a standard production package. These features were: a disc pack coupling (dry coupling) between the gearbox and the compressor, the compressor alignment parameters, which included a vertical offset and a skew offset, and the compressor itself. This compressor was a standard design but never proven in the configuration discussed here. The gas producer turbine, the power turbine and the gearbox were standard package components rated at 1000 hp at 24,000 rpm.

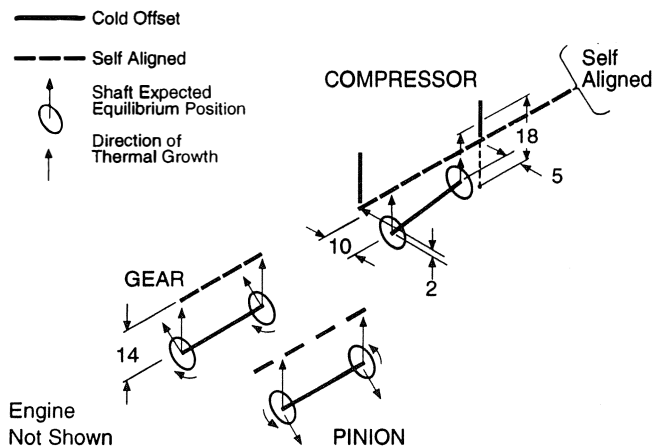
Figure 12. Relative Position of Shafts Showing Complex Alignment Between the Gearbox and the Compressor.

compressor shaft did not, due to a lack of load. This meant that anytime during the string testing, the dry coupling axial preload of about 0.070 in was never fully relieved, resulting in an axial spring load of the coupling disc pack yielding susceptibility to the coupling's axial natural frequency (ANF).

Therefore, the bidirectional cold offsets and the axial preload were thought to combine into a setting that caused a mismatch of the gear mesh that led to the multiple spiking.

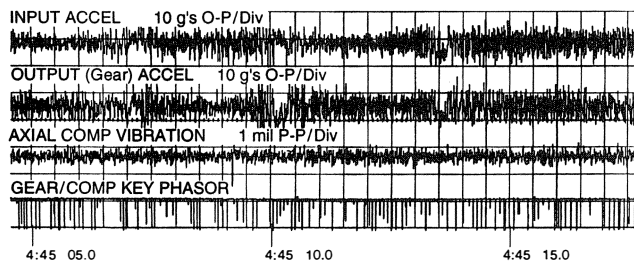
Figure 14. Trace of the Axial Displacement of the Shaft.

The first test was the dry coupling preload axial natural frequency (ANF). The trace is shown in Figure 14 of the axial displacement of the shaft measured by the standard axial compressor probe. The mass elastic model consisted of a spring loaded in the axial direction with masses attached at each end. At the inboard end, the masses were the gear viscously coupled to the pinion at the mesh; at the outboard end the mass was the compressor shaft.

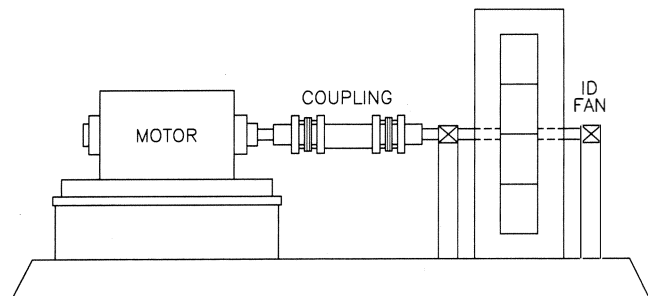
Figure 23. Case 4 Train Schematic.

The original drive train consisted of an induction motor with a variable speed drive (VSD) connected to an induced draft (ID) fan with a 6-link (3-drive bolt) standard type disc coupling, as shown in Figures 23 and 24. The drive was rated 600 hp at 600 rpm, with a general operating range of 400-600 rpm and a maximum fan demand of 6000 ft-lb. The motor rotor was supported by sleeve bearings and the axial float was restricted by the thrust bearings of the fan and the inherently limited end float disc coupling.

During the first startup, loud "clicking and popping" noises were heard in the vicinity of the coupling. Plant personnel found

that the disc packs in the coupling had developed gaps between discs and looked “buckled.”

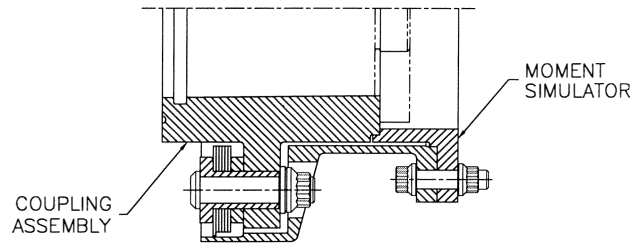
Figure 26. Moment Simulator.

moment simulator used to simulate the effects of rest of the connection on the shaft end (Figure 26).

The solution for this case was to supply a double piloted moment simulator plate that was manufactured to tight tolerances and made for zero clearances at the pilots. This plate also was designed such that when bolted to the half coupling, the proper moment was obtained with respect to the gearbox bearing, as in Figure 26.

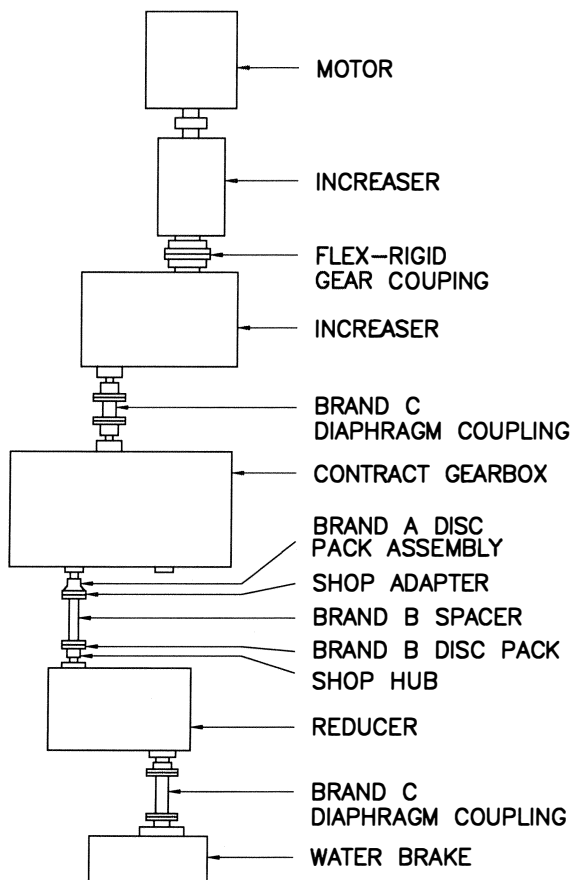
Figure 27. Case 5a Schematic of Test Set-up.

The excessive vibration was reported to be synchronous with speed at levels up to 1.0 mil radial on the contract gearbox shaft and the water brake reducer shaft. The levels also appeared to “shift suddenly” indicating the possibility of a clearance problem. An identical half coupling with simulator from a “sister” project was also tried and the results were similar.

Concurrently, initial measurements were made on the shop coupling pieces, and it was found that there were excessive clearances between the mating parts. The actual “shop” coupling between the contract gearbox and the brake arrangement consisted of the contract half coupling manufactured by brand A, connected to a shop manufactured adapter, connected to a brand B spacer, then a brand B disc pack bolted to a shop manufactured hub on the reducer shaft.

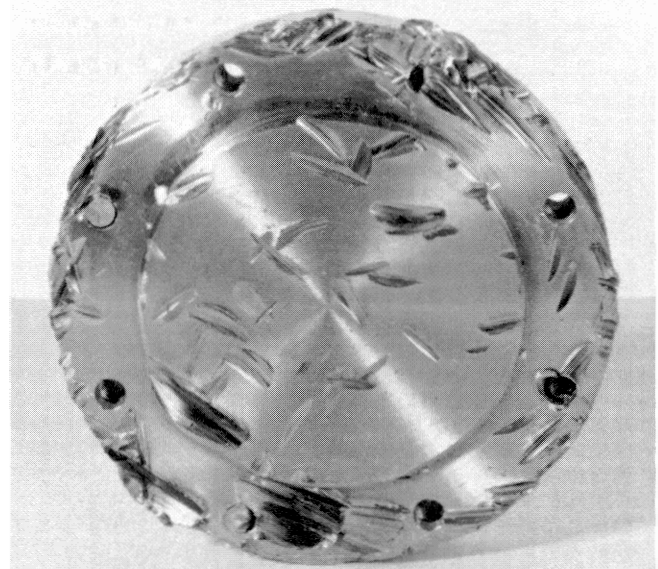
Figure 31. Customer Manufactured Simulator Plate.

The source of the unbalance was traced to the improper design and manufacture of the customer manufactured solo plate. This plate, which was supposed to act as a moment simulator, was in fact nothing more than a weight simulator, simulating the weight of the unconnected parts of the coupling. (See Figures 31 and 32 for damaged plate and the actual arrangement.) The half coupling was rigidified with cap and set screws.

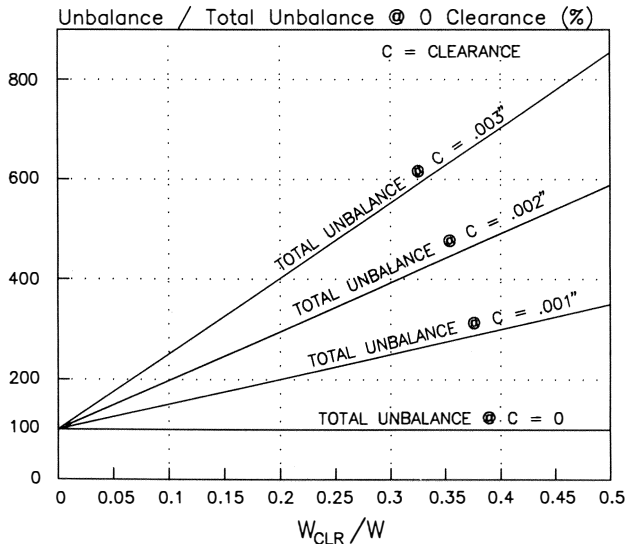
Figure 35. Effect of Clearance on Total Unbalance.

As can be seen, the unbalance due to clearances can be significant. If a coupling spacer weighed 20 percent of a total coupling weight, and the total clearance at the spacer coupling interface was 0.001 in, then, from the chart, the worst case normalized unbalance ratio could be 200 percent. In this case, the actual balance machine residual unbalance would be 17.5 percent of the total unbalance. In terms of actual unbalance numbers, if this coupling were balanced on the machine to 50 μ -in balance tolerance, the total unbalance would be 286 μ -in, with 93 μ -in due to eccentricity and 143 μ -in due to the clearance. Note that these numbers don't include any effects of rotor shaft runout.
