AN EXPERIENCE WITH NONSTANDARD COUPLING APPLICATION

Du Pont Polymers

Beaumont, Texas

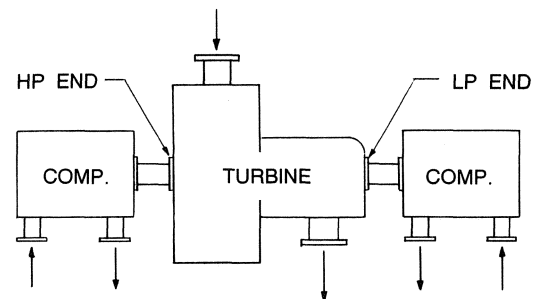
Figure 1. Entire Compressor Train.

In the early 1980s, a process unit at Du Pont's Beaumont, Texas, site installed several new turbomachinery trains as part of a process modernization. One of these new trains experienced several unusual drive coupling problems. The train consisted of a 40,000 hp, 9,000 rpm steam turbine driving two compressors, one on each end of the turbine (Figure 1). The train was installed on an existing foundation, which imposed severe space limitations on the drive couplings. The turbine had integral hubs on each end, and the thrust end hub was the outboard side of the thrust disk.

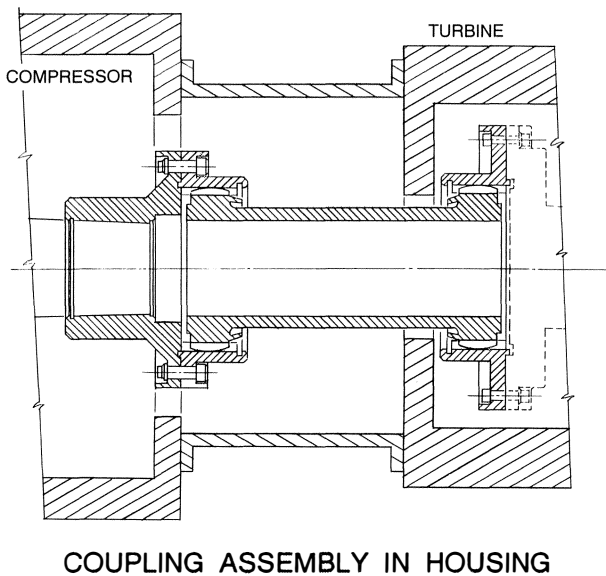
Figure 3. Turbine Hubs within Bearing Housing.

the integral turbine hubs, marine style gear couplings were used. Marine couplings have the teeth on the spacer rather than on the coupling hub. To be consistent, the compressor ends of the couplings were also marine style. The thrust end of the turbine had an integral flange that was larger than normal to accommodate both the thrust disk and the bolt circle for the coupling (Figure 2). The bolt circle for the flange was 13 1/2 in, compared to a normal 9 11/16 in, thus requiring a special sleeve design. Because of space limitation, the integral turbine hubs were located within the turbine bearing housings, as shown in Figure 3. The top half of the turbine bearing housing had to be removed to assemble the coupling, as can be seen in Figure 4.

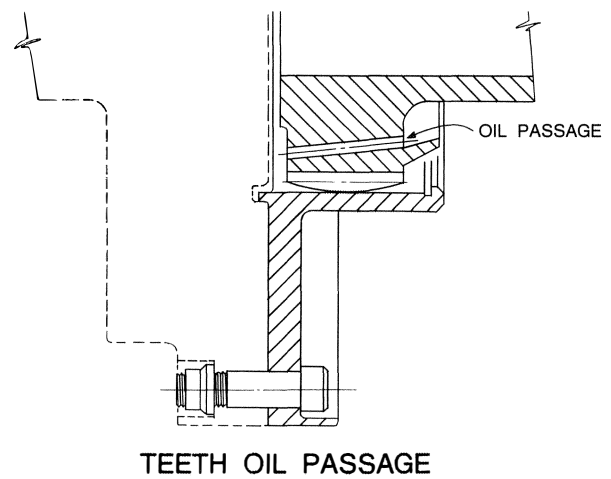
Figure 5. Coupling Antisludge Design Feature

Coupling lubrication was by oil sprayed into antisludge design gear meshes (Figure 5). The turbine manufacturer provided the spray nozzle for the turbine end, and the compressor manufacturer provided the spray nozzle for the compressor end.

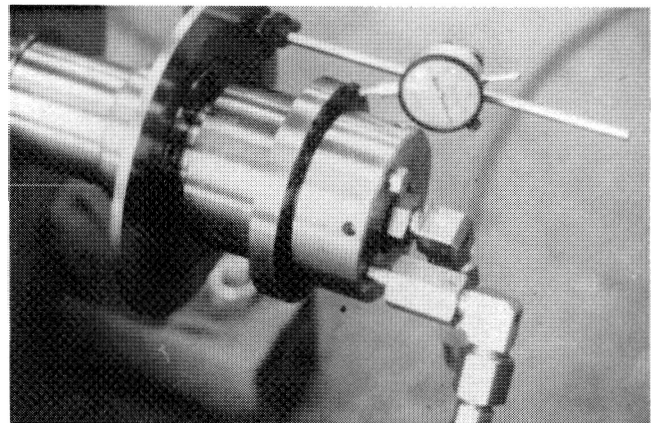
Figure 9. Hydraulic Rig for Coupling Installation.

The most persistent, long term problem with the coupling hubs of both compressors has been galling during installation and removal. To do a normal hub installation and removal, the hub is expanded by injecting pressurized oil between the hub bore and compressor shaft. The hub is positioned on the shaft and pushed by hand onto the shaft taper until the O-rings form a seal. A portable hand-operated hydraulic pump is connected to a predrilled oil passageway in the shaft (Figure 9). The hub is then hydraulically expanded and pushed further onto the shaft taper until it reaches a predetermined hub location. The final location depends on shaft taper and required hub-to-shaft interference for torque transmission by friction. For example, with a 3/4 in on diameter per ft taper, a 0.002 in per in of diameter shrink requirement, and a 3.0 in diameter shaft, the hub needs to travel axially 0.096 in ($3.0 \times 0.002 \times 12.0/.75$) beyond the metal-to-metal contact [1].

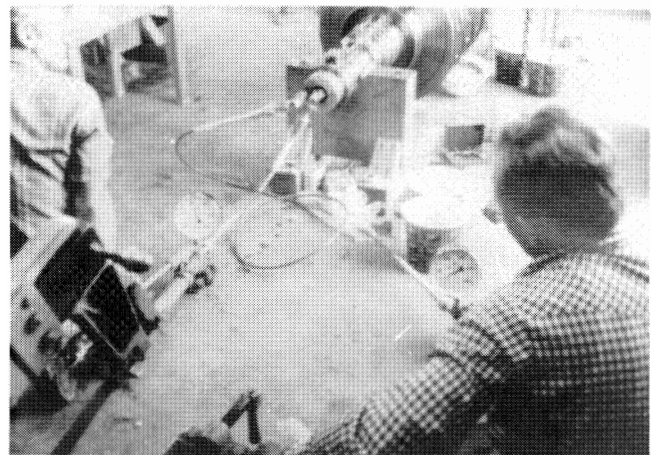
A finite element analysis was done to model bore expansion during hub installation with hopes of finding a possible modification to stop the galling (Figure 10). No modification was found that satisfied all concerns.

- During hydraulic installation, the hub was now pushed onto the shaft in steps separated by one minute pauses to allow for bore expansion and complete oil dispersion. A higher maximum pressure for hub bore expansion during installation was also put in use. The coupling vendor increased this by 20 percent to approximately 25,000 psig.
- The maximum pressure for hub removal was raised by 30 percent to 28,000 psig.
- The shaft end was chamfered in the area where galling occurred as per vendor recommendation (Figure 11).
