EMERGENCY TURBINE REPAIR PROCEDURES

ABSTRACT

Emergency repairs of a cracked steam turbine disc can be accomplished effectively by using sound basic engineering principles. One such method used to expedite a repair is reported.

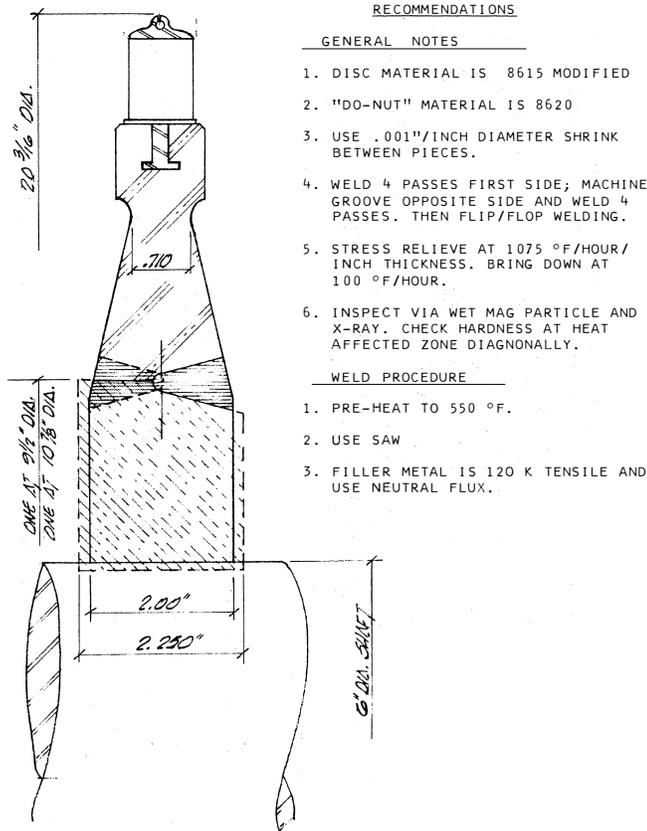
Discs were final-machined and hardness was checked again. This hardness test was used to determine the shrink fit stress. A few points were lost after machining, and insurer, customer, and

repair shop agreed to 0.0022 in to 0.0025 in/in of diameter shrink was sufficient to achieve the desired fix.
