MAJOR REVAMP AND RETROFIT OF IDENTICAL PROCESS COMPRESSOR TRAINS

Standard Oil Chemical Company

Port Lavaca, Texas

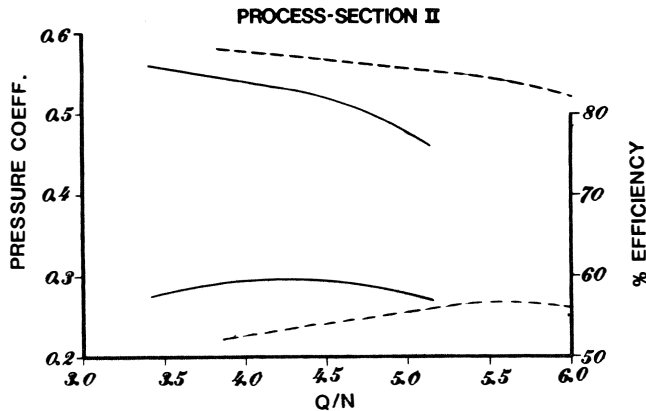
Figure 13. Process Compressor Expected Performance Curves.

The process gas compressor performance was also in question due to the actual data's relation to the expected performance on the pressure coefficient and efficiency curves (Figures 12 and 13). The most obvious problem was that inlet temperature was much higher than expected, boosting the actual cubic feet per minute ACFM significantly along with the corresponding horsepower required. Chemical cleaning of the suction coolers at the first opportunity solved that problem. The performance engineer also stated that the open impeller appeared to have a ten percent larger capacity than expected. This tended to lift actual data above the pressure coefficient curve. In addition, the higher calculated efficiency was due to liquid entrainment. Liquid entrainment has a positive effect in that evaporation of

liquid particles in the stream acts like an intercooler increasing calculated efficiency. However, film evaporation of liquid on the thermowell can distort discharge temperature readings to well below thermodynamically expected values. The performance engineer stated that although there was a net increase in performance, as supported by the net horsepower balance, the real efficiency and pressure increases were much lower than the calculations indicated. He also stated that he had no way of quantifying actual compressor performance for our two phase flow. The final conclusion was that the compressor was performing better than expected. Exactly how much better is not known. A strain gauge torque meter would give the best definition of actual horsepower, but was viewed as an unjustifiable cost.
