RADIAL AND THRUST BEARING PRACTICES WITH CASE HISTORIES

Charles Jackson

Monsanto Company

Case histories for 13 selected bearing design conversions for specific end results are presented. They were selected out of a group of bearing designs over a 25 year span to give a varied array of non-repetitive case histories. In addition, some ideas for proper measurements are also included.

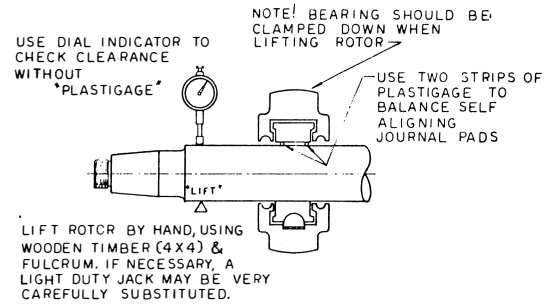
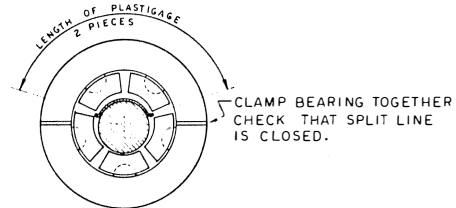
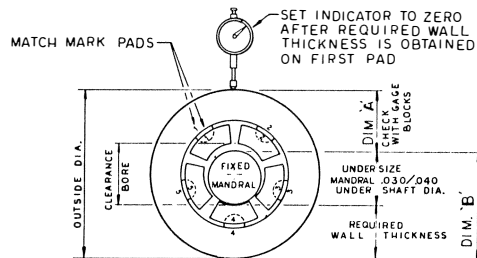
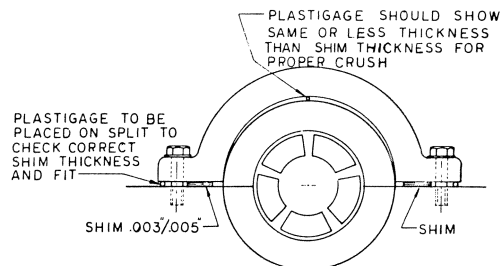
TWO METHODS OF CHECKING BEARING CLEARANCE...
NORMAL CLEARANCE = .0015" PER IN. OF DIA.

METHOD FOR CHECKING CLEARANCE AND CONCENTRICITY

METHOD FOR CHECKING BEARING TO HOUSING FIT (OR CRUSH)

Figure 1. Checking Methods for Self-Aligning Tilting Pad Journal Bearings.

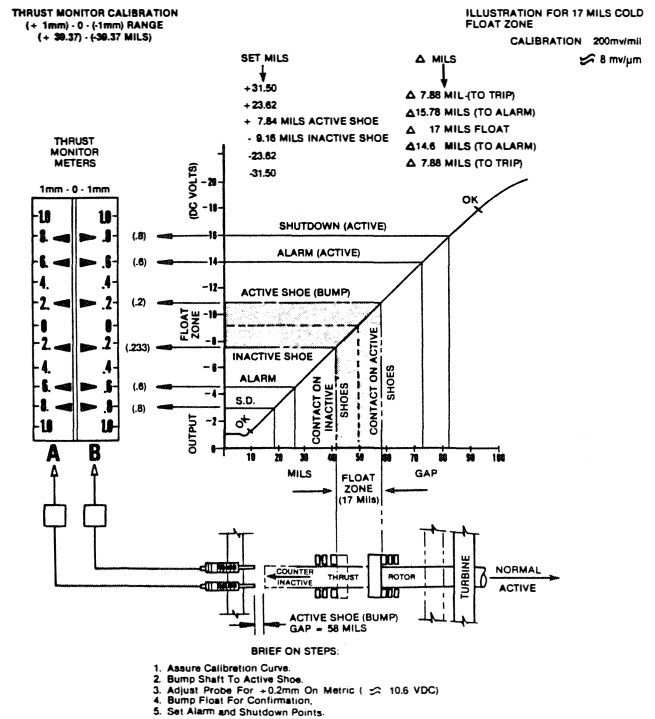
Figure 2. Typical Calibration Curve for Axial Position-Steam Turbine-Metric Based (from API 670 Standard, 2nd Revision, 1985, Vibration, Axial Position and Bearing Temperature Monitoring System).

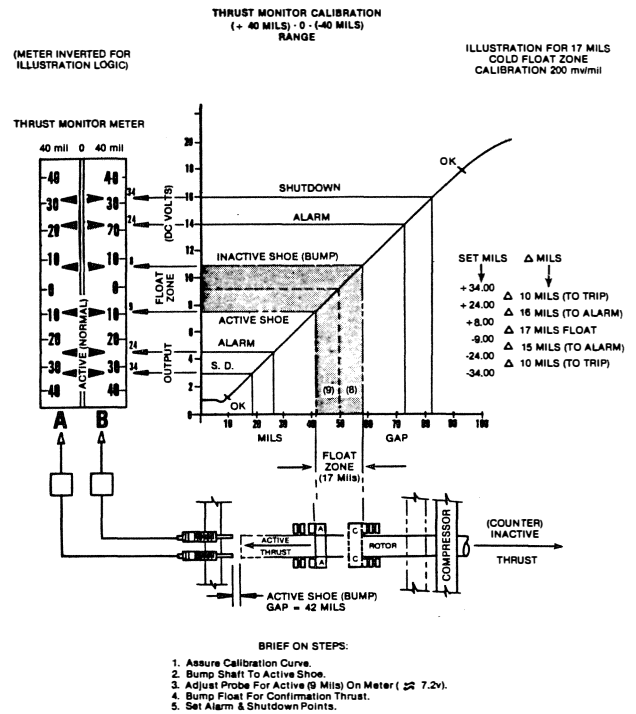
Figure 3. Typical Calibration Curve for Axial Position-Compressor-English Based (Ref: same as Figure 2).

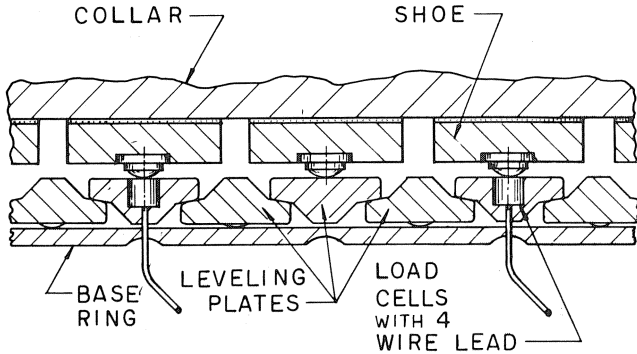
The initial thrust load equaled 450 psi babbitt pressure, with new condition labyrinths, rotor clearances and axial spill strip tolerances. The effective thrust bearing babbitt area was 23 in². Babbitt metal temperature was approximately 240°F. The six-pad thrust bearing required self-levelling by a spherical seat, which basically can only self-level at warm-up speed/load conditions (Figure 4).

Figure 4. Thrust Bearing Tilting Pads on Self-Leveling Links with Load Cells Receiving Force from Pads.

The bearing chamber was machined in place utilizing a field erected boring bar with an air operated star feeder. A tilting pad, 8 in diameter, six-pad thrust bearing, with articulating level links, was installed with load cells on 50 percent of the pads and thermocouples on 50 percent of the pads in the 75 percent radius, 75 percent pad length position. While an area increase from 23 in² to 32 in² was affected, the ability to self-level and the tangential oil exit were felt to be the primary correction. Temperatures were lowered to 190°F. Load cell and temperature measurements confirmed one another and the temperatures were noted to be adequately sensitive (not over sensitive) to load changes. Four years of data were recorded on a direct current (DC) strip recorder. No further failure occurred on either machine for the six remaining years of this 18 year life process (Figure 5).

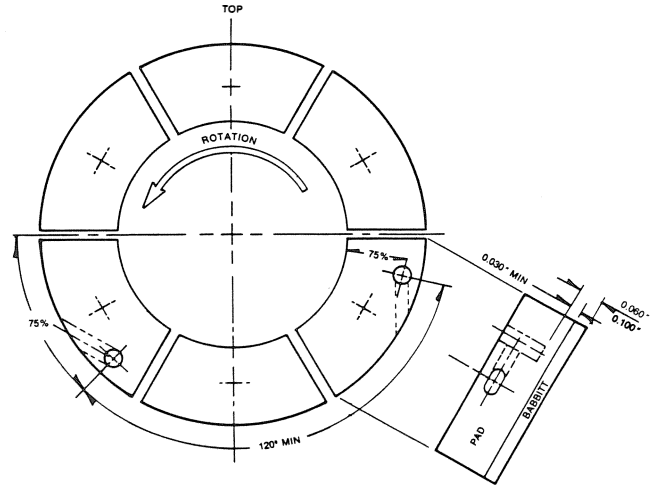
Figure 5. Typical Thrust Bearing Temperature Sensor Installation.

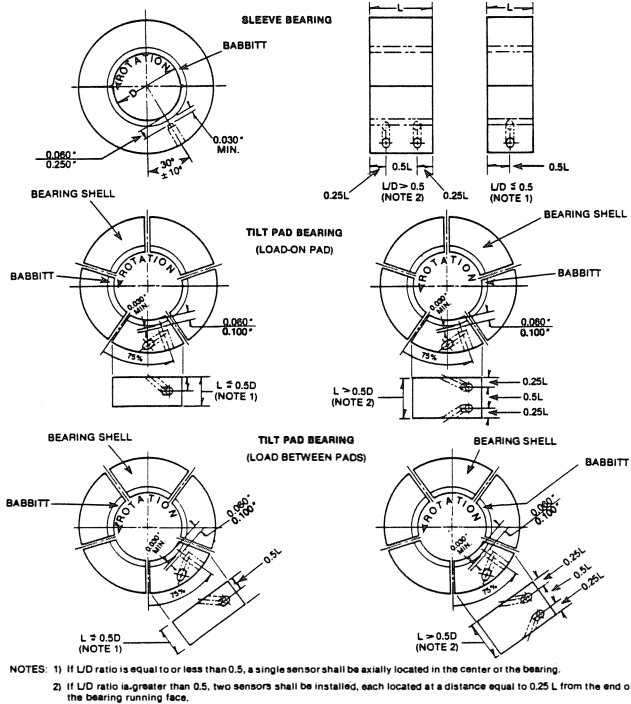
Figure 8. Typical Radial Bearing Temperature Sensor Installation (API 670, Rev. 2). Note 0.030 in minimum between babbitt interface and sensor. Also note placements of temperature sensors.

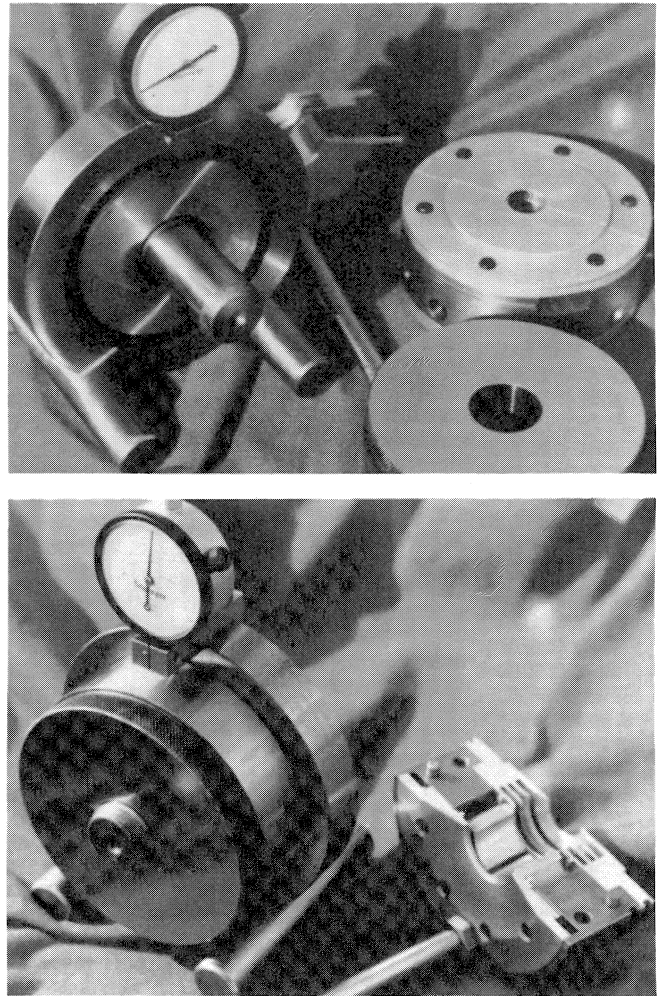
Figure 16. Small Mandrel Checker.

Since pads are generally made the same thickness (must be checked with a pin or knife micrometer), it is necessary to note brinelling indentions in the retainer bore. Indentions as much as five mils deep have been noted and corrected. The correction could entail machining out the indentions, chrome plating and remachining the proper bore, thereby reestablishing the proper pivot circle and clearance. Some designs like the one shown (in Figure 18) allow the spherical balls which receive the pad spherical seats to be readjusted. These can also be electronically gauged as shown in Figures 16 and 17.

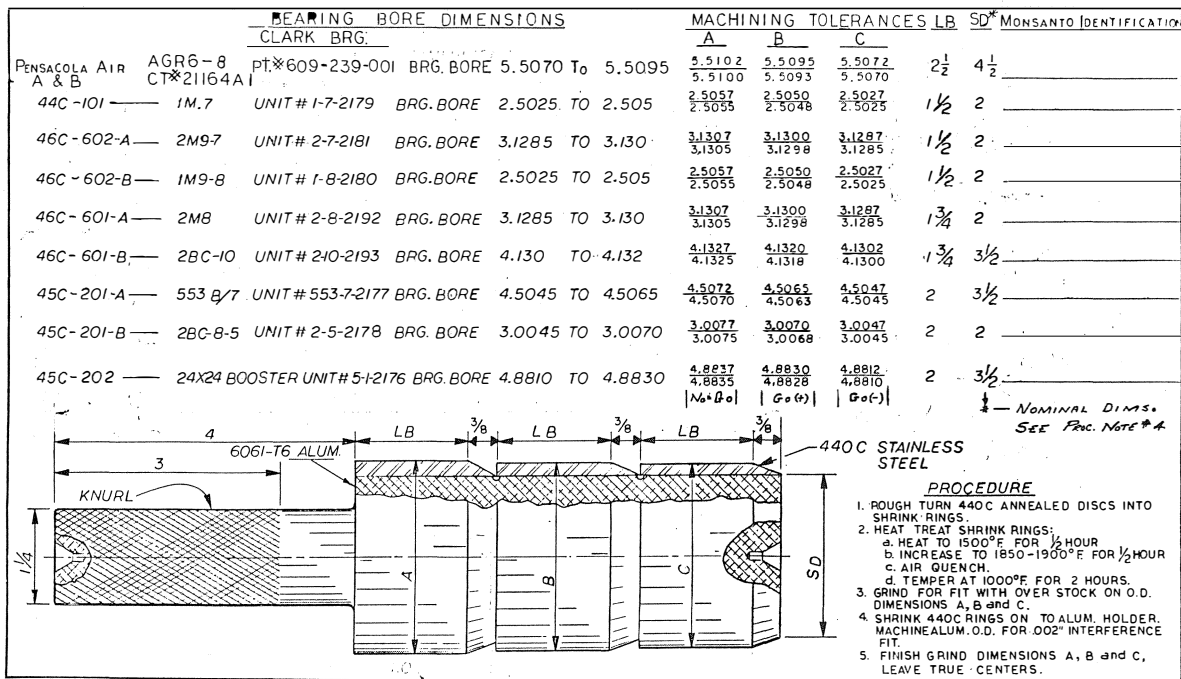
Figure 15. Three-step Go—No Plug Gage for Tilting Pad Radial Bearings.

Note: A three-step gauge is shown (Figure 15) for tilting pad bearing checks in the retainer. Also, a mandrel checker is shown (Figures 16 and 17) which allows individual checking of the pads.

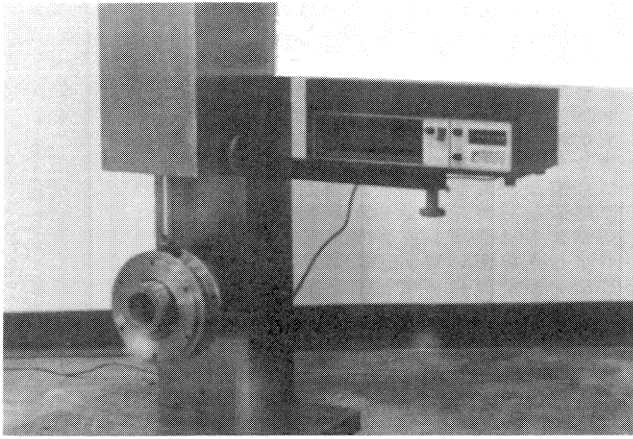
Figure 17. Electronic Gage Being Used on Tilting Pad Radial Bearing with Adjustable Spherical Ball and Seat Pads.

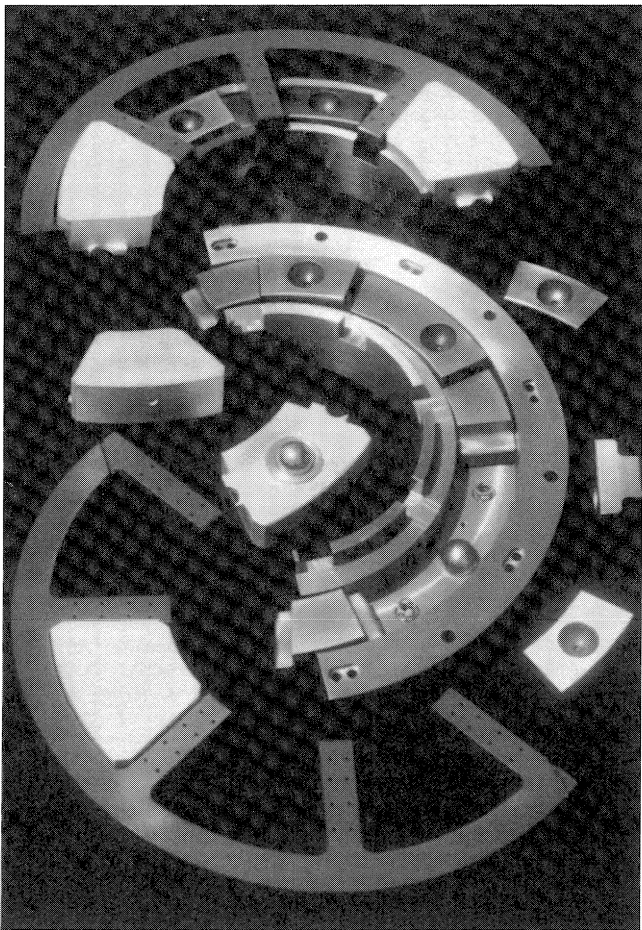
Figure 24. Details of the Redesigned Thrust Bearing.

- Copper backed pads over steel backed pads.
- Seven pads over six pads (shorter pads).
- Offset ratio changed from 0.5 to 0.55. (Pivot is 55 percent from leading edge to assist oil into the pads. Failed pads had front (leading) edge damage).
- Flooded directed lubrication supply.
- Spherical seated level plates and pads (Figure 24).
