STRUCTURAL INTEGRITY OF LARGE STEAM TURBINE ROTORS

ABSTRACT

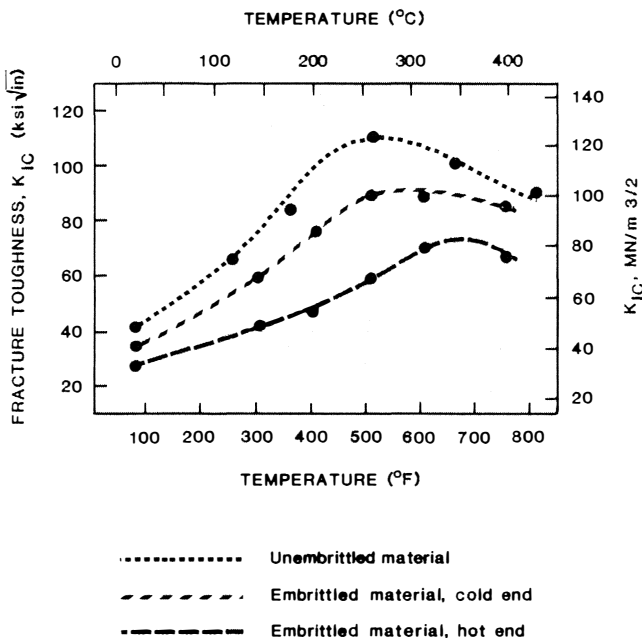
factor (K), which is proportional to the local tangential stress and the square root of the crack depth, equals the fracture toughness of the material. The fracture toughness, as shown in Figure 1, varies significantly with temperature; therefore, it is necessary to know both the local stress and temperature histories in order to calculate the largest crack which will *not* grow.

Figure 1. Effect of Temper Embrittlement on Fracture Toughness of 1CrMoV Rotor Steel.

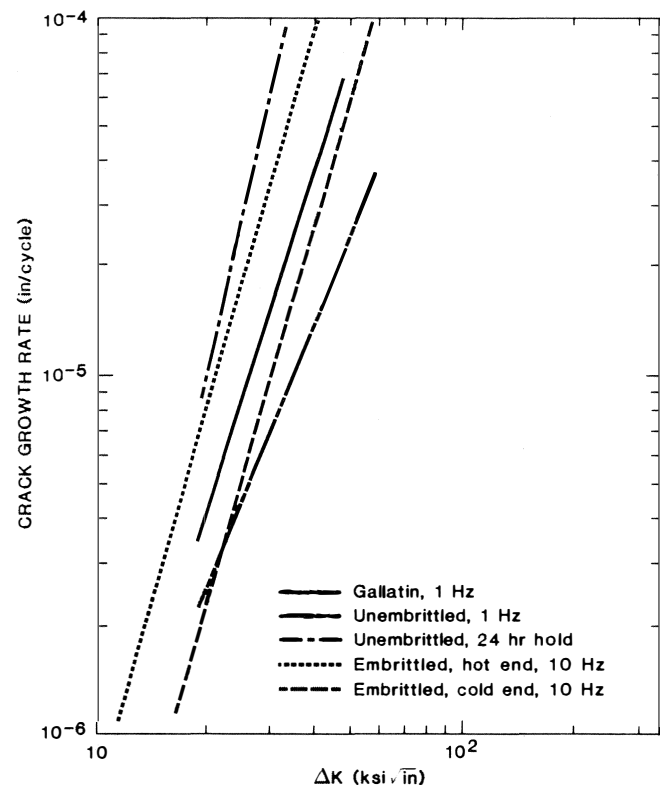
growth rate data, such as those shown in Figure 2. As is the case with fracture toughness, crack growth rate varies with temperature and degree of embrittlement; in addition, growth rates at elevated temperature are frequency dependent. A single parameter can be employed to represent effects of both temperature and frequency on fatigue crack growth rate. However, there are a few situations in which crack growth may occur under steady-state stress at high temperature; i.e., under creep rupture conditions. Creep crack growth rate data are conventionally correlated on the basis of a "path-independent crack-tip integral" of strain energy dissipation rate (C^*) [5]. Figure 3 shows the compilation of some available data.

Figure 2. Crack Growth Rate Data.

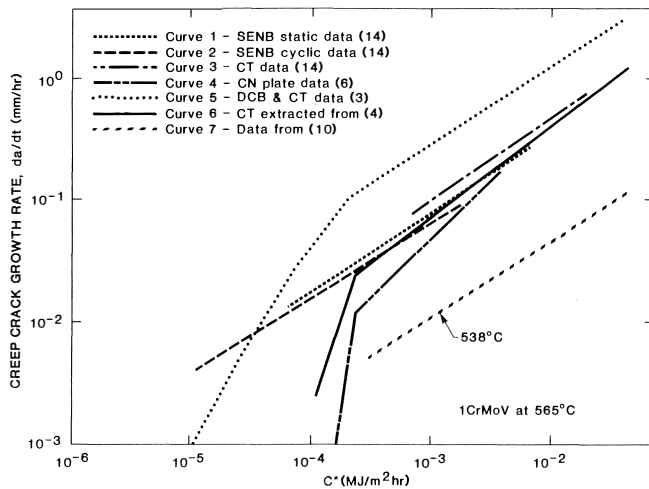
Figure 3. Summary of Correlations Based on the Parameter C^* .

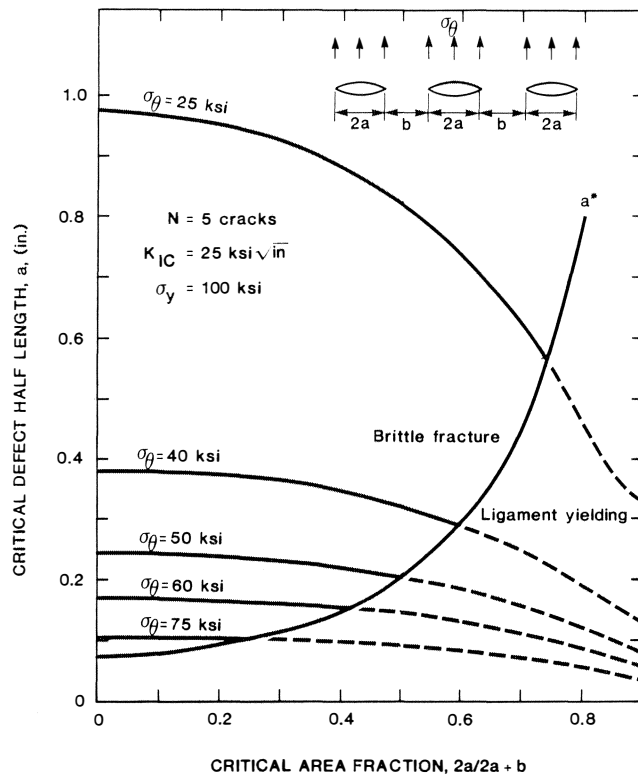
increases significantly with distance from the bore. However, in the case of multiple flaws that are closely spaced, critical linkup between clustered flaws must be considered. In general, the ligaments between small flaws will yield before the critical stress intensity level is reached. Figure 4 illustrates this limitation for an idealized situation with equally spaced cracks of the same size, aligned in a row perpendicular to the tangential stress.

Unfortunately, inclusions and pores are not neatly aligned as in Figure 4, but are randomly dispersed throughout the volume of the rotor. Since cracks propagate under the tangential stress, we are primarily concerned about flaws that can link up in the radial and axial directions. A conservative procedure to allow rapid sorting of ultrasonic indications has been developed. The technique involves geometric grouping of flaws and approximation of elliptical cracks with conservative constraints. Reference 4 describes this technique in detail.

Figure 4. Limits of Fracture Mechanics in Predicting Cracking Within Clusters.

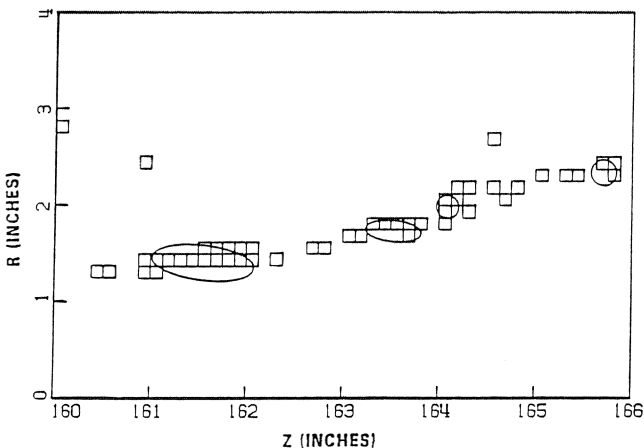
Figure 8. Holding Indication in Rotor—TREES Cell Data and FRAC Linkup Prediction (SAFER Results). Source: Southwest Research Institute.

ure 8 indicates the satisfactory agreement between inspection results and destructive evaluation of an intergranular crack in a test block. The inspection was performed by an EPRI-developed, immersion, focused shear beam ultrasonic system known by the acronym TREES.

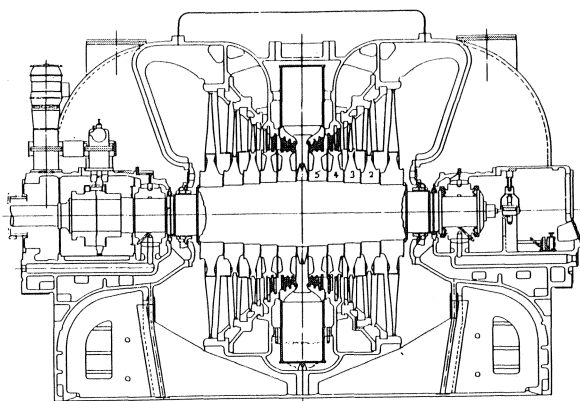
On August 21, 1977, 1 hour and 13 minutes after the unit was started following a maintenance shutdown, a last stage low-pressure turbine disk ruptured on a unit owned by a northeastern electric utility. The turbine was rotating at its 1800 rpm operating speed when the rupture occurred. The unit was a cross-compound, eight stage, double-flow turbine rated at 130 MW and had operated for 23 years prior to failure. A typical cross section of the turbine is shown in Figure 10.

Figure 10. Typical Cross Section Through LP Turbine of Close-Coupled, Cross-Compound, Reheat Unit.

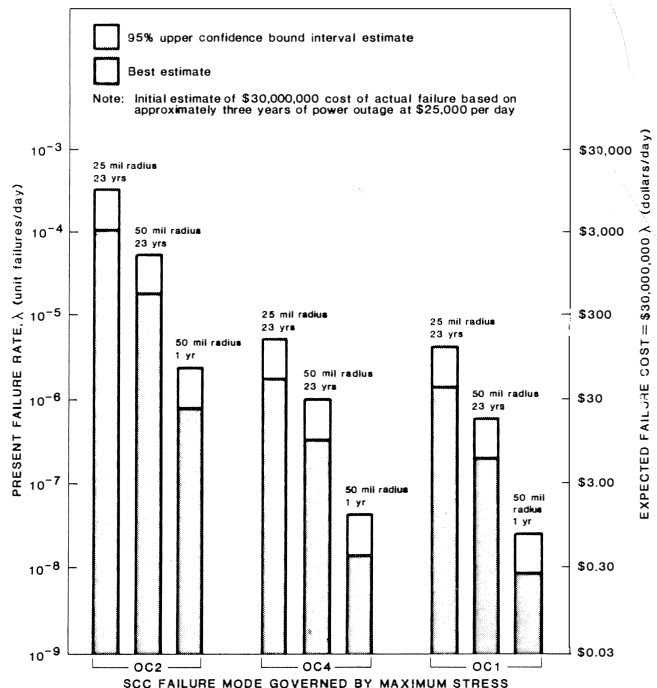
The estimated SCC failure rates for the three remaining turbine units are presented in Table 2, along with the average failure rate for the entire turbine generator industry [1]. Because of the lower steady stresses and the greater material resistance to sulfide SCC, Units No. 1 and No. 4 had a significantly lower failure probability than No. 2 and No. 3, and they had an estimated failure rate only slightly above the industry average. By increasing the fillet radius to 0.050 inch, the concentrated stress would have been further reduced, and, correspondingly, the estimated failure rate would have been reduced to well below the industry average. Figure 20 summarizes the failure rates and expected failure costs associated with the various units.

Figure 20. Estimates of Daily Failure Rates and Expected Costs for Exhaust Disk Rim Cracking Failure Mode in a Northeastern Utility's Units No. 1, No. 2, and No. 4.

Turbine operators now have access to a focused field eddy current inspection technology, which could have detected at a very early stage the crack which led to the failure of Unit No. 3.

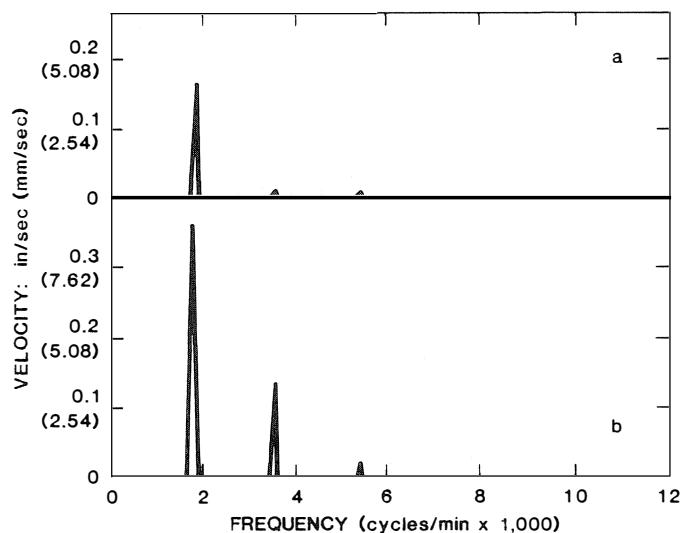
Figure 23a is the normal steady state vibration signature obtained with a shaft rider probe at the No. 1 turbine bearing. A strong, synchronous 1800 rpm signal and very slight two- and three-per-revolution signals are present. Figure 23b, on the other hand, shows the signature at peak vibration levels subsequent to a thermal down ramp of 140°F (77°C). Note the increase in the one-, two-, and three-per-revolution amplitudes.

Figure 23. Shaft Rider Vibration Signature of Amplitude vs. Frequency, a) During Normal, Fill-Load Operation, b) During Peak Vibration Subsequent to a Thermal Down Ramp.

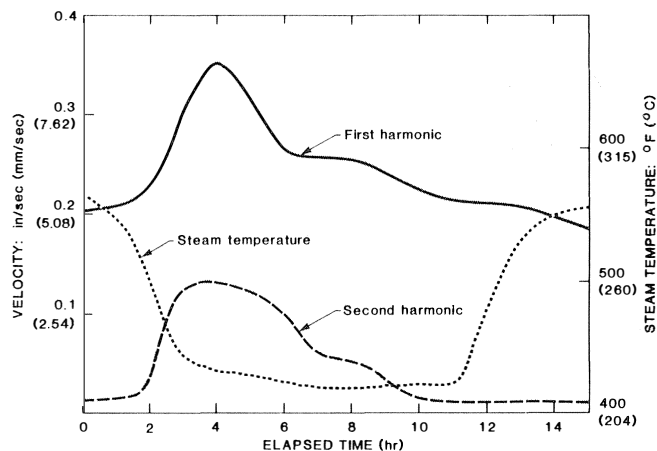
An example of the vibrational response associated with steam temperature variation is shown in Figure 24. Reduction

Figure 24. Vibration Amplitude of First and Second Harmonic and Inlet Steam Temperature vs. Time.

in steam temperature cools the surface of the shaft relative to the shaft bore. This condition produces tensile hoop stresses and tensile axial stresses of such a magnitude that a transverse crack in the shaft near the surface would open.

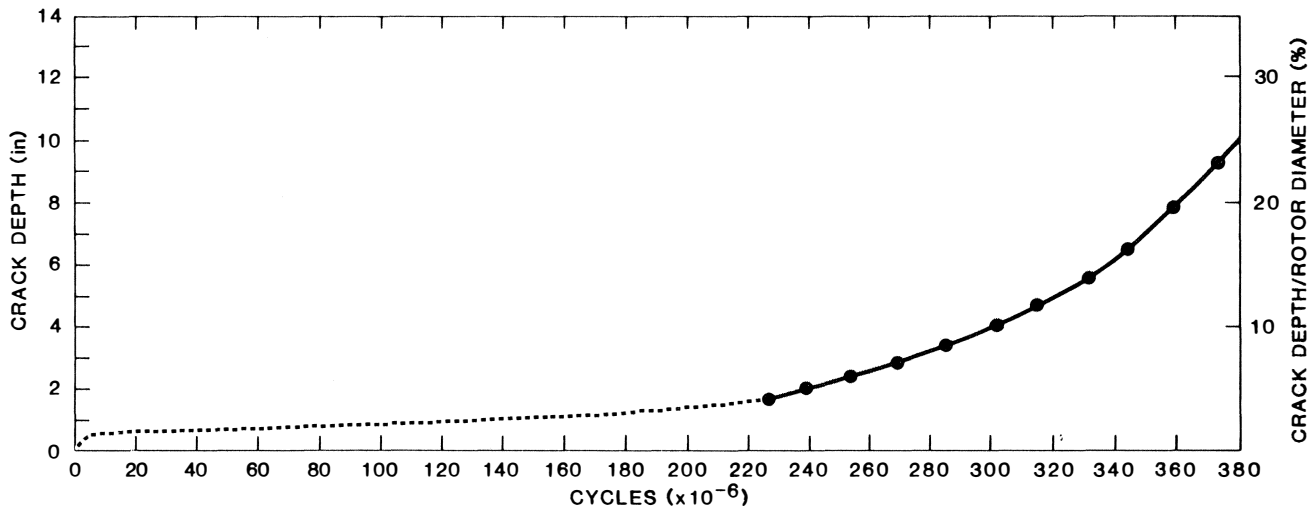
Utilizing BIGIF, the crack driving force (ΔK) was calculated, and the increase in crack depth caused by rotating bending during the periods of the high steady stresses produced during deslagging was determined. The results are shown in Figure 26.

Figure 26. Transverse Crack Growth Rate Due to Deslag Thermal Transients Predicted Using BIGIF Transverse Crack Model.

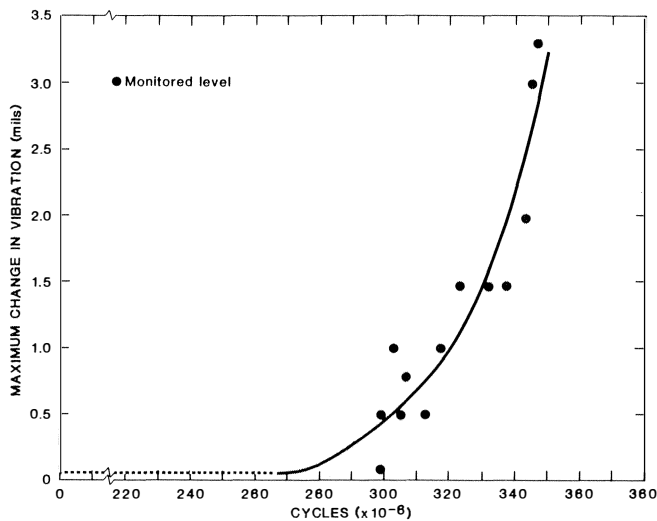
Figure 27. Maximum Changes in LP Turbine Bearing Cap Vibration During Deslag as a Function of Total Number of Cycles at Thermal Transient Stress State.

The calendar period over which these cycles occurred was reviewed and correlated to the maximum recorded increase in vibration during selected deslag operations. The form of the recorded data is unfiltered peak-to-peak displacement, in mils, as sensed on the No. 1 bearing cap in the vertical direction. A curve fit of these data as a function of cycles under the thermal transient conditions is shown in Figure 27.

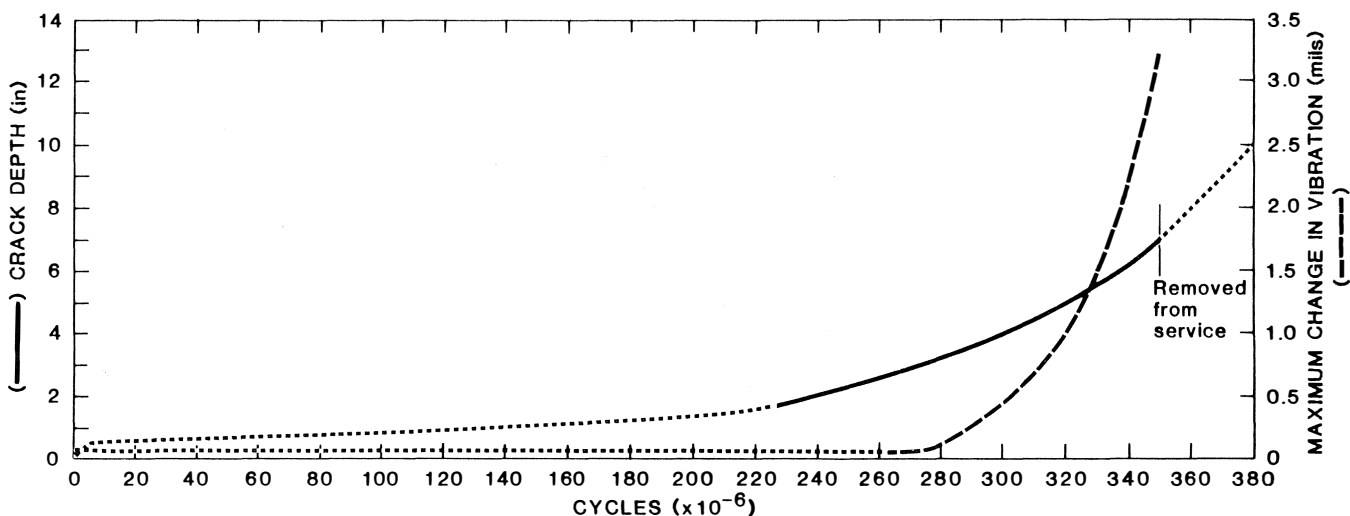
Figure 28 shows that the point at which the change in vibration becomes recognizable corresponds to a crack depth between 3 and 4 inches, or between 8% and 10% of the shaft diameter. This correlates very well with the crack depth (10% of rotor diameter) predicted analytically by Grabowski [20] as necessary for significant increase in rotor vibration response.

Figure 28. Correlation of Maximum Change in LP Turbine Bearing Cap Vibration During Deslag With Predicted Rotor Crack Growth.
