ANALYSIS OF THREE IMPELLER FAILURES: EXPERIMENTAL TECHNIQUES USED TO ESTABLISH CAUSES

Charles Bultzo

Exxon Company, U.S.A.

ABSTRACT

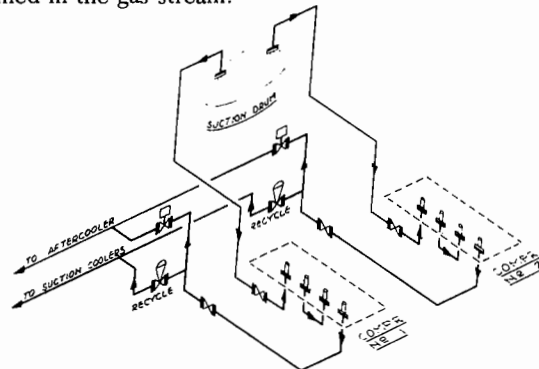
The general arrangement of the two compressors relative to their common suction drum and recycle facilities is shown on Figure 1. It should be noted that each compressor has its own line from the suction drum. This configuration was used for two reasons: (1) to reduce the possibility of surge on one machine if the speed increased suddenly on the other and (2) to more uniformly distribute the velocity profile across the internal demister when both compressors were in operation. By definition of service, the gas is near its dew point. Numerous flash calculations made on the gas indicated that at the inlet to the compressor the gas was within 10 degrees of its saturation temperature. It is not unlikely that despite this theoretical approach to superheat that a very fine mist of liquid would be entrained in the gas stream.

Figure 1. Wet Gas Compressors Piping Arrangement.

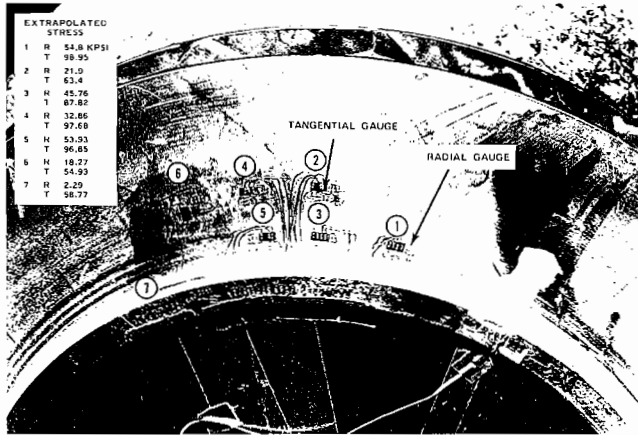
In an attempt to better understand the actual stress levels being experienced in the failed impellers, the third first-stage impeller, which was part of the original and was also made of K-Monel, was also removed from its rotor and subjected to a series of tests. This included mounting strain gauges to indicate radial and tangential strains as the impeller was being rotated. The mounting of the gauges is shown on Figure 3. To insure that proper techniques were employed, the first set of strain gauges was installed by a consulting firm to insure maximum credibility of the resulting data. A telemetry system was used to transmit the strain from the gauges to a receiver to permit actual rotation of the impeller as shown on Figure 4. After the strain gauges had been put in place, the impeller was mounted on a motor shaft. A plug was installed at the impeller eye to reduce the air flow during the test. The motor was designed for 2,300 volts, but was tied into the 440-volt system. This permitted slow acceleration during the start-up. The complete test setup is shown on Figure 5. Because of the mass of the impeller and the low voltage, a maximum speed of only 2,700 rpm was reached. This represented approximately 32 percent of the maximum continuous speed of the impeller. However, as shown on Figure 6, a plot of the microstrain versus speed showed that this relationship followed a predictable path. The lower speed also enhanced credibility of the data by lessening the mass effect of the interconnecting wire and strain gauges, which might affect the results obtained. Because the impeller was being rotated in open air, there was no heating thus negating strain resulting from temperature gradients despite temperature compensation. As can be seen from Table II, the extrapolated stress level was substantially above that which had been predicted by not only our in-house impeller computer analysis program, but also the vendor's calculations.

Figure 3. Gauge Locations for Stress Analysis.

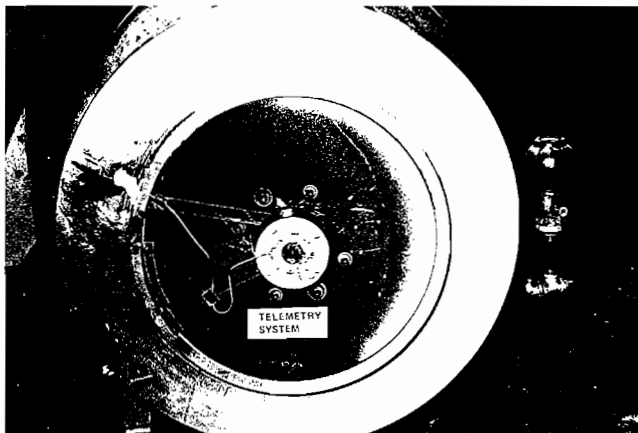
Figure 4. Telemetry System for Strain Gauges.

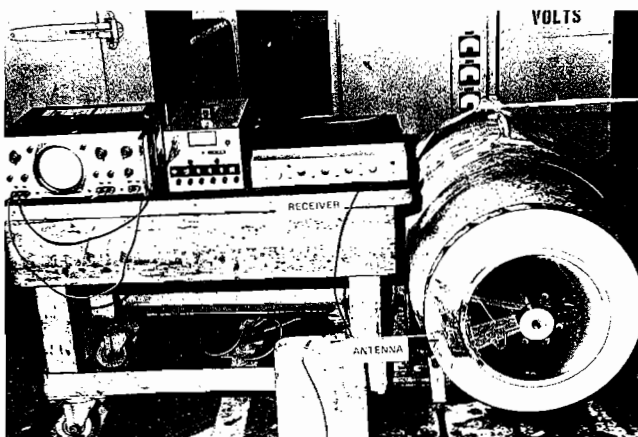
Figure 5. Test Set-up for Obtaining Stress Levels in Impellers.

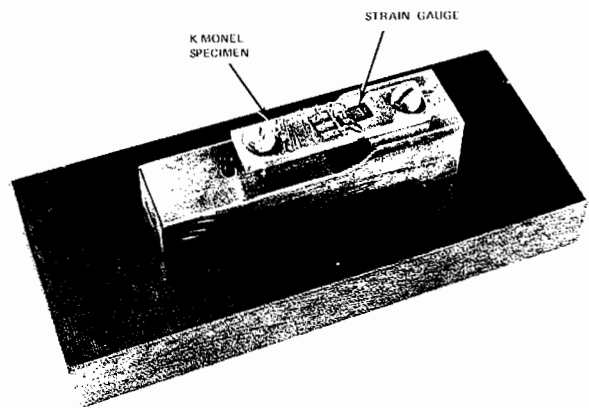
Calibration of the strain gauge data was achieved by use of a static test device shown on Figure 7. Use of the small screw caused the test specimen to go in tension at the location of the strain gauge. With the gauge connected to the telemetry system, the required load was applied to generate approximately 303 microstrain, which was the approximate maximum impeller strain measured at 2,700 rpm. This was transmitted to the telemetry readout system. While in the strained position, the strain gauge leads were transferred from the telemetry system to a static strain meter. Initial loaded and subsequent unloaded strains were recorded and showed a differential of 287 microstrain. After both systems had been corrected for strain gauge factors, the final correlation indicated 286.5 microstrain on the telemetry system, which is remarkable agreement.

Figure 7. Static Test Device for Calibration of the Strain Gauge.

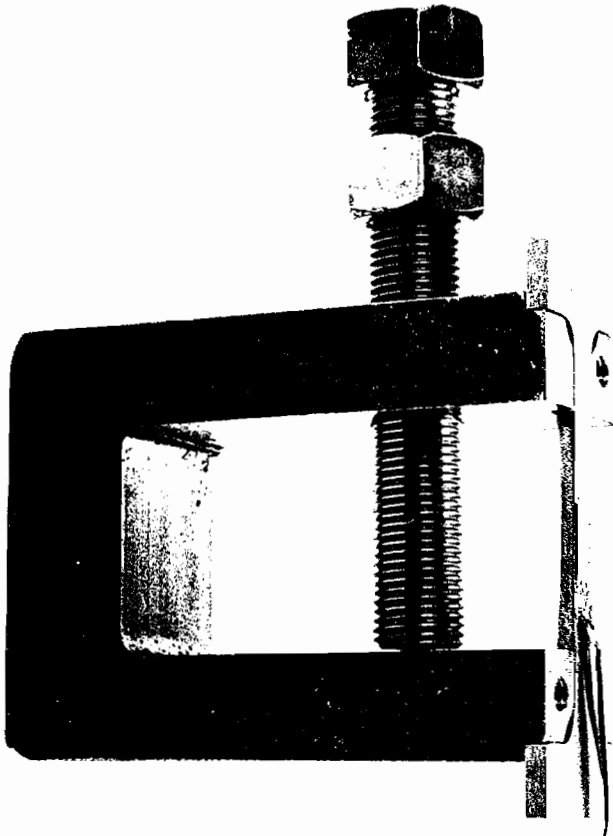
Subsequent to the stress analysis, another technique was attempted to see if the presence of hydrogen sulfide and water in the gas might accelerate the fatigue phenomenon. A test specimen cut from the cover of second failure impeller was arranged as shown on Figure 8. The bolt used to apply a tensile load to the specimen was bored to permit flow of hot and cold water. The test arrangement is shown on Figure 9. The timer was set to permit hot water to pass through the bolt for approximately one minute. This caused the bolt to expand. In this manner, additional tensile load was put on the test specimen. Subsequent to the heating cycle, cold water was passed through the bolt for 14 minutes allowing the coupon to return to its ambient preload of approximately 70,000 psi. This cycle loading was conducted with the test coupon emersed in a bath of hydrocarbon condensate removed from the compressor suction drum. The specimen was subjected to approximately 3,000 cycles. The stress level was increased approximately 8,000 psi with each heating cycle; no significant distress due to corrosion was found on the specimen after it was removed for examination. Further, samples that were stressed to 70,000 psi

Figure 8. A Test Specimen Cut from the Case of a Second Failure Impeller.

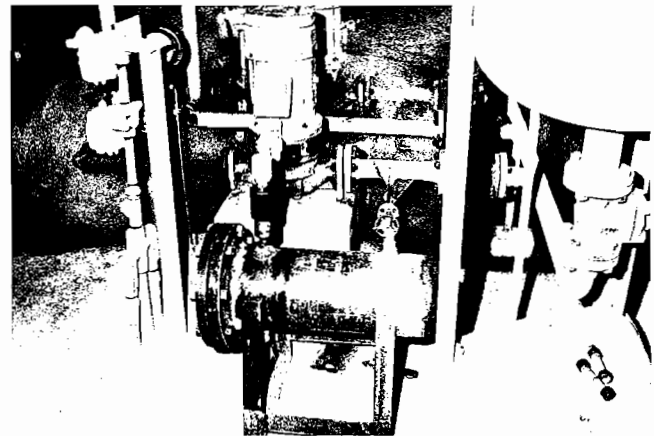
Figure 10. Test Arrangement Showing a Sample Being Stressed to 70,000 psi and Placed in a Solution of Corrosive Hydrocarbon Condensate.

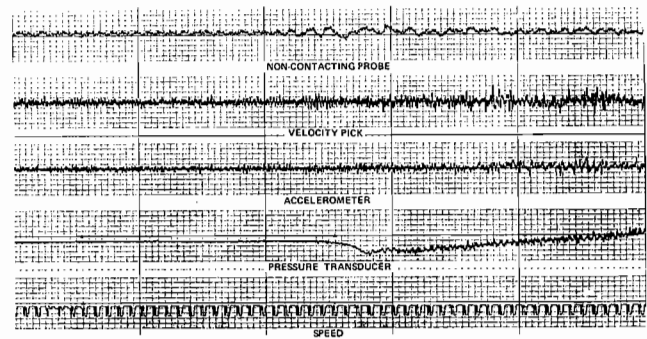
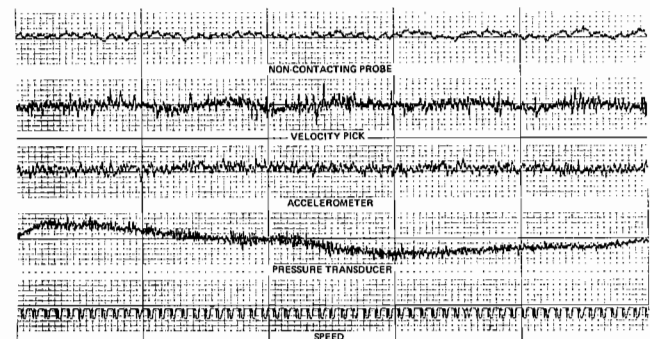
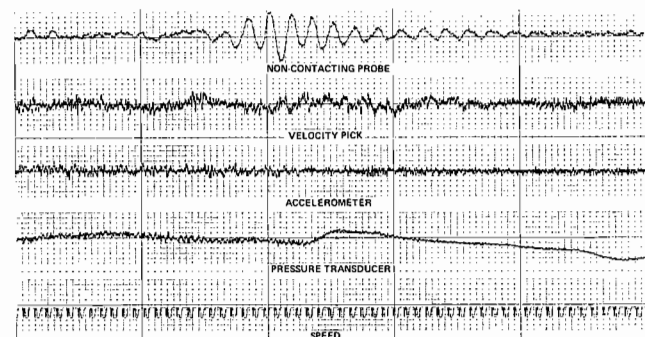
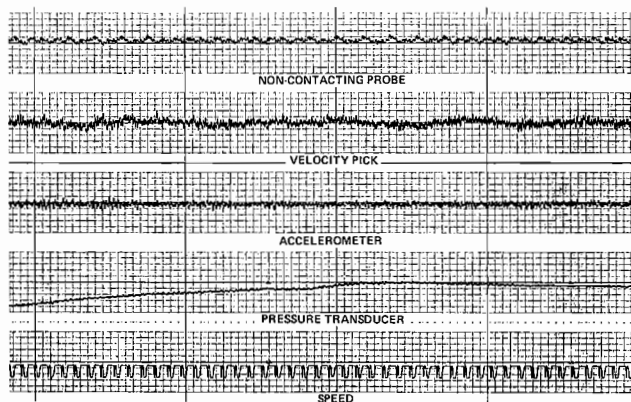
Figure 16a. Compressor Analysis Data as Compressor is Approaching Surge; at Reduced tape Speed.

Figure 16b. Compressor Analysis Data as Compressor is Approaching Surge; at Reduced tape Speed.

Figure 16c. Compressor Analysis Data as Compressor is Approaching Surge; at Reduced tape Speed.

Figure 16d. Compressor Analysis Data as Compressor is Approaching Surge; at Reduced tape Speed.

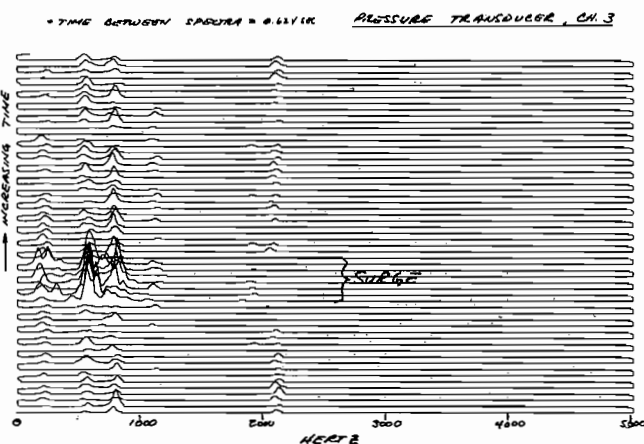
Figure 17. Real Time Analysis of Surge.

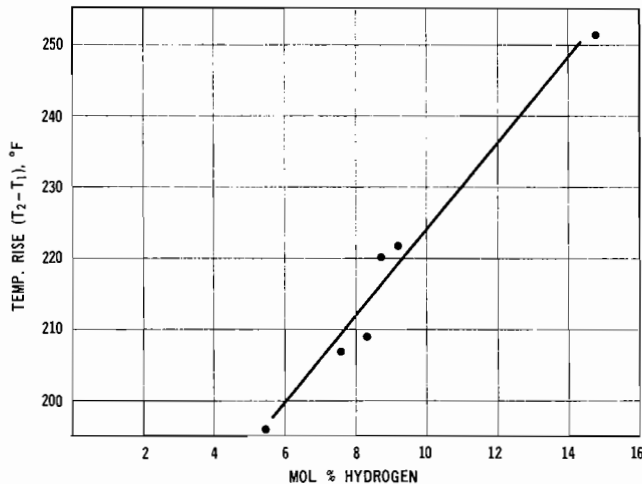
The test work mentioned above indicated a rather remarkable correlation between the presence of hydrogen in the gas stream and a change in the temperature across the compressor. At first, an attempt was made to correlate a change in K value of the gas and the presence of hydrogen and performance. However, because of the complex correlation curve generated, it was discarded in favor of a simple curve that shows the relation of ΔT and the amount of hydrogen present in the gas. This correlation is shown on Figure 20. It should be noted as the ΔT rose, the percentage of hydrogen also was found to increase. Utilization of a computer designed for machinery monitoring permitted close observation of the ΔT on each compressor. When this differential reaches a maximum of 225° F or the equivalent of 10 percent hydrogen, an alarm is now sounded that permits the operator to start taking remedial action to reduce the amount of hydrogen present in the wet gas going to the compressors. Using this technique, we have not experienced any surging since implementation of the program.

Figure 20. Wet Gas Composition Correlation.
