UPTHRUST PROBLEMS ON MULTISTAGE VERTICAL TURBINE PUMPS

Donald R. Smith

Stephen Price

Engineering Dynamics Inc.

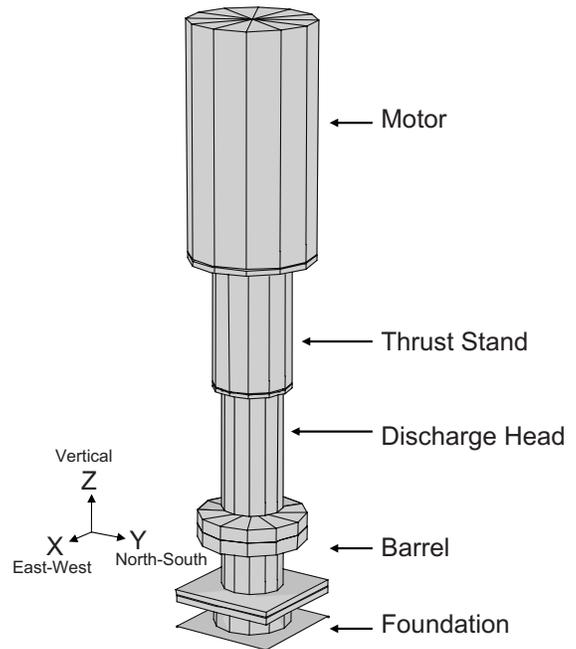
Figure 5. Pump/Motor ODS Model.

The ODS model is shown in Figure 5. A selected single frame of the vibration animation at 1× running speed is shown in Figure 6. Note that the vibrations are exaggerated in the plot to allow the ODS to be easily visualized. As shown in the ODS, the maximum vibration levels were measured near the top of the motor in the N-S direction. The maximum vibration levels were approximately 6.3 mils peak-to-peak (1.2 in/sec zero-to-peak).

The ODS indicated that the motor was “rolling” or “wobbling” on top of the thrust stand. In addition, slipping was observed between the flanges connecting the discharge head to the barrel. Subsequent to the ODS testing, several of the flange bolts were determined to be loose and were tightened; however, tightening the bolts did not reduce the vibration to acceptable levels.

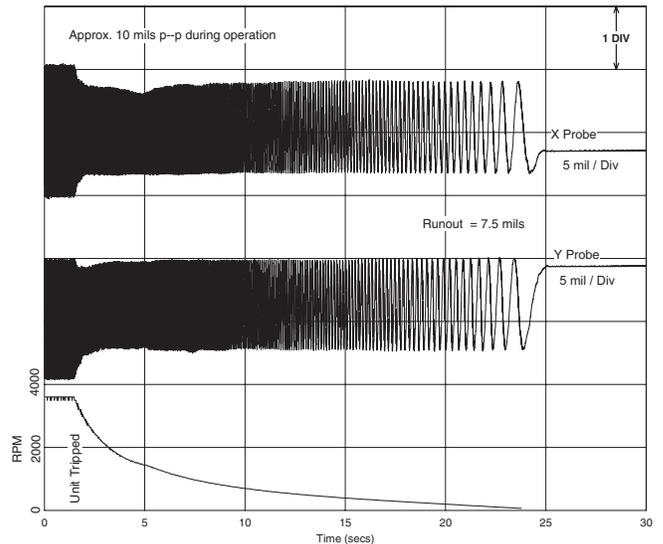
Figure 9. Time-Domain Plot of Pump Shaft Vibration and Pump Speed During Coastdown.

Pump C had not been run; therefore, it was decided to measure the pump shaft runout prior to starting the pump. The shaft was rotated by hand and the shaft runout at the seal was measured to be approximately 1 mil peak-to-peak, which was considered to be acceptable. The pump was subsequently put into operation and the shaft vibration reached approximately 10 mils peak-to-peak at 1× running speed. Figure 9 is a time-domain plot of the shaft vibration and pump speed just prior to shutdown and during the coastdown. As shown, the runout increased to approximately 7.5 mils peak-to-peak after operation, which indicated that the shaft was bowed or cocked during this short run.

The pump manufacturer recommended that the pump shaft be raised approximately 3/16 inch, which also required adjusting the seal position. When the pump was restarted, the vibration levels immediately increased to approximately 18 mils peak-to-peak. After operating for a few seconds, the mechanical seal began to smoke and the pump was shut down.

It was determined that the mechanical seal was destroyed and the pump could not be operated. It was unknown whether the high shaft vibration contributed to the seal failure (especially since the other pumps could operate with shaft vibration levels of approximately 31 mils peak-to-peak without immediately destroying the seal). The plant personnel thought that the seal failure was due to improper adjustments of the seal set screws after the pump was raised.

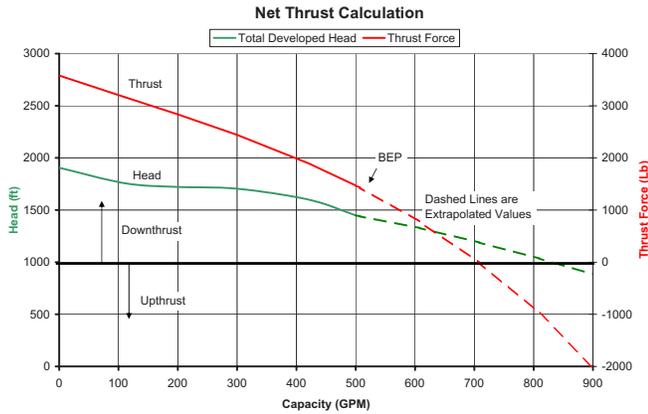
Figure 12. Computed Thrust Values and Total Developed Head Versus Flow Rate.

In the design stage, the pump manufacturer performed a hydraulic analysis of the pump to compute the thrust for a wide range of operating conditions. Computed thrust values and total developed head for flow rates from zero to 504 gpm at the minimum suction pressures are plotted in Figure 12. The downthrust values ranged from a maximum of 3585 lb (closed discharge, zero gpm) to a minimum of 864 lb (maximum suction pressure and 504 gpm).

The thrust values were extrapolated for high flow rates beyond the BEP (Figure 12). As shown, at the higher flow rates the thrust changed from downthrust to upthrust. The pump manufacturer did not compute the thrust forces for the conditions with zero

differential pressure, or for discharge pressure less than the suction pressure, because these conditions were not normal operating conditions.

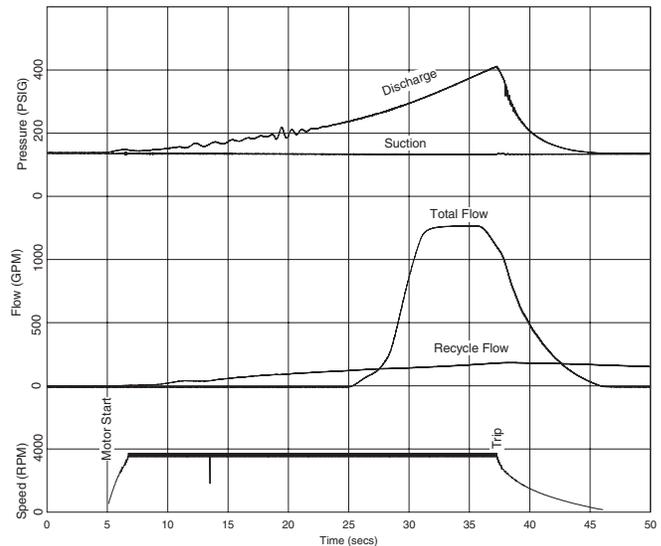
Figure 17. Time-Domain Plot of Pressure, Flow, and Speed During First Startup of Pump C with Fully-Open Discharge Valve (Vapor or Flashing in Piping).

The pump reached full speed in approximately 1.75 seconds. However, the discharge pressure increased very slowly and required approximately 30 seconds to increase to 400 psi (Figure 17).

The flowmeter, which senses flow to the plant (total flow), did not indicate any flow until approximately 20 seconds after the pump started (Figure 17). The flowmeter indicated that the flow rate increased over a 30 second interval to a maximum of approximately 1200 gpm, which caused the pump to be tripped by the DCS on excessive flow rate. It is felt that this indicated flow rate was too high and was incorrect because this flow rate was well beyond the pump maximum flow rate. The high indicated flow rate could have been due to vapor or flashing in the piping that could have caused the orifice flowmeter to read incorrectly.

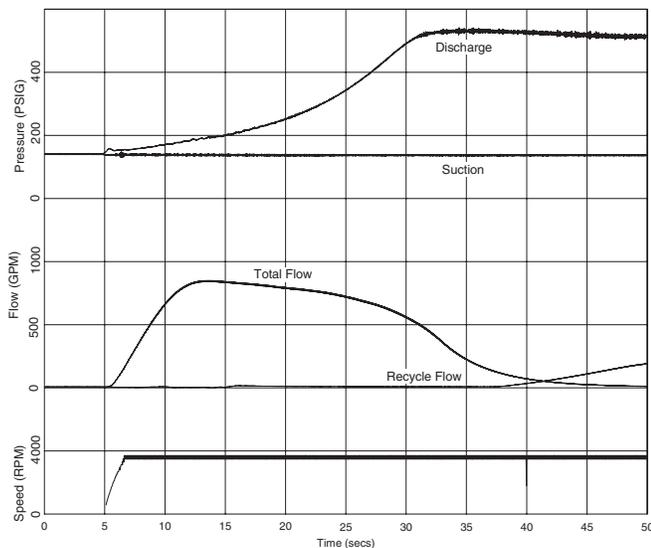
Figure 18. Time-Domain Plot of Pressure, Flow, and Speed During Second Startup of Pump C with Fully-Open Discharge Valve (No Vapor in Piping).

The pump was started using the same procedure with the discharge valve fully-open. Again, the discharge pressure increased very slowly and required approximately 25 seconds to reach 500 psi (Figure 18). During this start, the maximum indicated flow rate was approximately 850 gpm, which could have been the actual flow rate. The motor current data shown in Figure 19 did not remain constant and the motor amps reduced slightly during this period of high indicated flow rate, which suggests that these flow rates were real.

The shaft was in the upthrust position for approximately 15 to 20 seconds until the discharge pressure increased above 200 psi. As shown in Figure 19, the shaft vibration decreased as the pump discharge increased above 200 psi, because the pump downthrust increased with the higher discharge pressure. As discussed, the pump is designed to operate in downthrust with the shaft in tension.

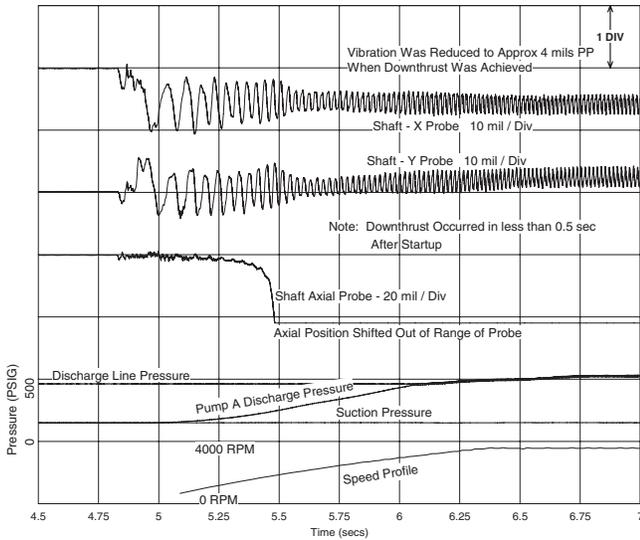
Figure 21. Time-Domain Plot of Shaft Radial Vibration, Shaft Axial Position, Pressure, and Running Speed During Startup of Pump A with Pump C Operating.

Prior to startup, the shaft was rotated by hand and the runout on the pump shaft at the mechanical seal was measured to be approximately 4 mils with no suction pressure. The runout was increased to approximately 12 mils when the shaft was in upthrust with 180 psi suction pressure. This increase in runout was due to the shaft being in compression in the upthrust condition.

Pump A was started with pump C in service. Since another pump was in service, the pump was started with the discharge valve fully-open. As shown in Figure 21, the pump shaft shifted to the downthrust position in approximately 0.5 seconds after the startup. The discharge pressure began to increase immediately as the pump running speed ramped to full speed. After the pump shifted to the downthrust position, the vibration levels were immediately reduced from approximately 9 mils peak-to-peak to the original runout value of 4 mils peak-to-peak.

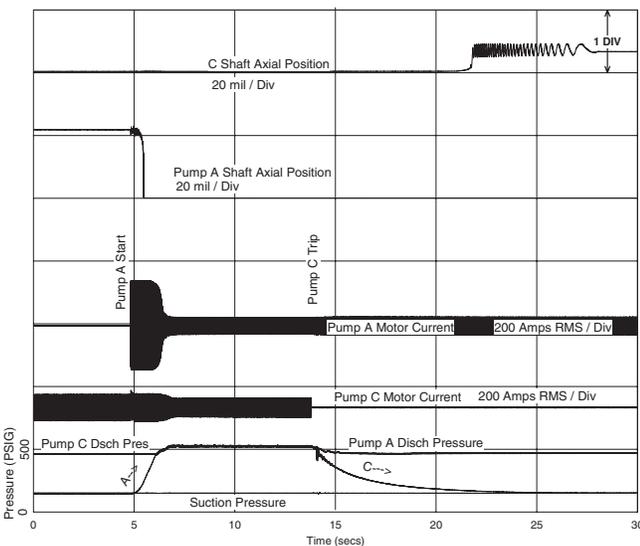
Figure 22. Time-Domain Plot of Flow, Shaft Axial Position, Pressure, and Motor Amps of Pumps A and C During Startup of Pump A with Pump C Operating and Shutdown of Pump C.

Pump C was tripped approximately nine seconds after pump A was started. After pump C tripped, the pump C shaft axial position switched to the upthrust position when the discharge pressure was reduced to the suction pressure (Figure 22).

When pump A was shut down, the vibration levels again increased to approximately 11 mils peak-to-peak during the coastdown when the pump returned to the upthrust condition. This shaft vibration was almost identical to the runout measured before the startup when the shaft was in the upthrust condition, which indicated that the shaft was not bent during the startup or during operation.
