# A CASE HISTORY-IMPROVEMENTS TO AN EXISTING COOLING TOWER SUMP AND HORIZONTAL SPLIT CASE PUMPS

In adding a second urea plant in 1974 at a Midwestern nitrogen plant, higher cooling water requirements necessitated the construction of an additional cooling tower. A 130 million Btu/hour cooling tower was installed with two 18×20-22H horizontal split case pumps rated for 13,000 gpm at 115 ft total dynamic head.

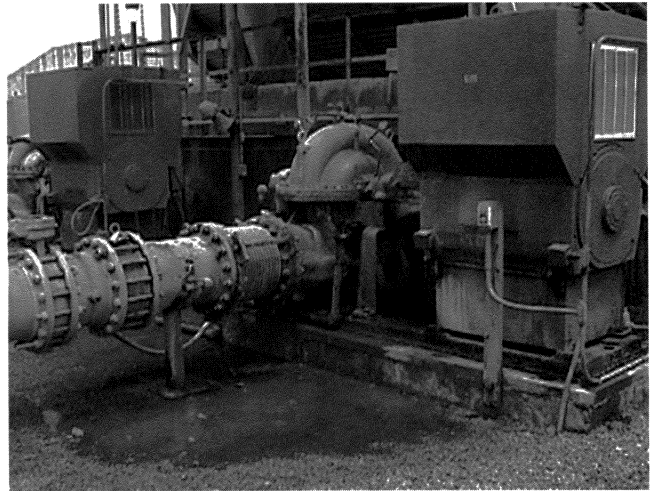
Figure 6. Pump and Cooling Tower Basin Installation.

The construction of the new urea plant and cooling tower basin took place within the company's existing property. It must be noted that ample space was available for the construction of the basin and location of the pump units. Figure 4 (Plan View) and Figure 5 (Elevation View) show the original layout of the pump suction inlet area of the cooling tower basin. Figure 6 shows a view of the pump unit and cooling tower basin installation. Figure 7 is a view of the pump suction inlet piping.

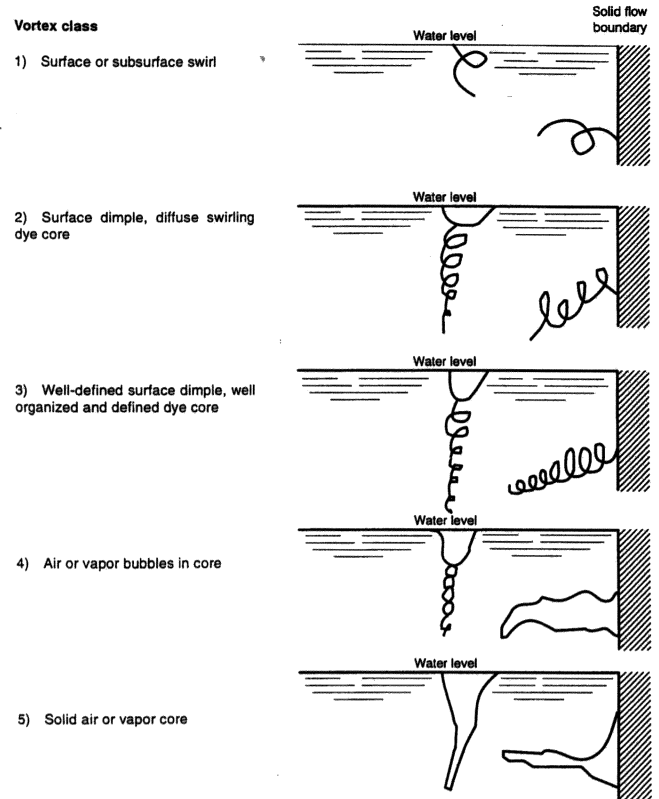
Figure 9. Vortex Classification System. (Courtesy of the Hydraulic Institute)

Figure 8. Based on Hydraulic Institute's (1994) Vortex Classification System, as shown in Figure 9, the vortices were a Class 4, due to the air/vapor bubbles observed in the core. Occasionally, Class 5 vortices were also observed. As this chart depicts, large amounts of air and any top-water floatables would be immediately pulled into the vortex, and eventually into the pump.

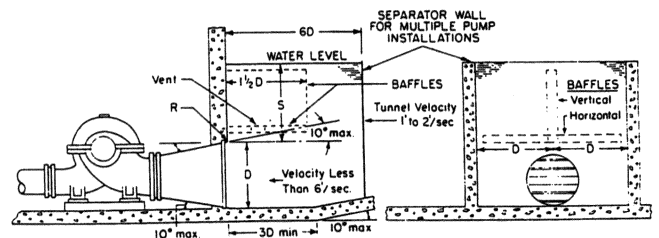
Figure 10. Inlet Basin Recommendations—Elevation. (Reprinted with permission from Cameron Hydraulic Data, Seventeenth Edition, Second Printing. Copyright Ingersoll-Dresser Pump Company, Liberty Corner, New Jersey.)

Utilizing the Hydraulic Institute's *American National Standard for Centrifugal Pumps* and Ingersoll-Dresser Pump Company's *Cameron Hydraulic Data*, the existing cooling tower basin design and dimensions were compared with those published in these references. Figure 10 provides typical dimensions for horizontal pumps in dry pit sumps. Figure 11 provides information on recommended sump dimensions based on flow. Figures 12 and 13 are used to apply the recommended dimensions from Figure 11.

Utilizing Figure 10 and Figure 14, modifications were made to the sump to reduce or eliminate vortices. Four modifications were made to the cooling tower basin at the pump suction inlets as described below and shown in Figures 15 and 16.

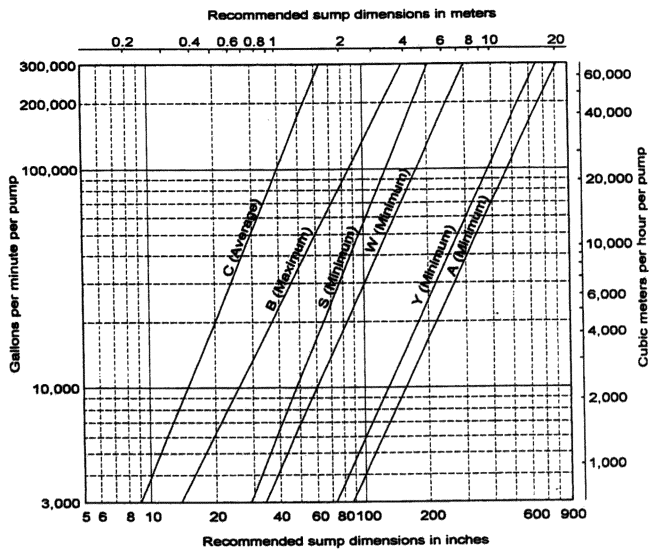
Figure 11. Sump Dimensions versus Flow. (Courtesy of the Hydraulic Institute, 1994)

The actual and recommended dimensions are shown in Table 3. These are based on the revised capacity of 9000 gpm and inlet diameter (D) of 36 inches.
