AN INNOVATIVE UPGRADE AND PERFORMANCE RERATE OF LARGE, HIGH SPEED, HIGH TEMPERATURE, MULTISTAGE BARREL PUMPS

BP Oil Grangemouth Refinery Limited

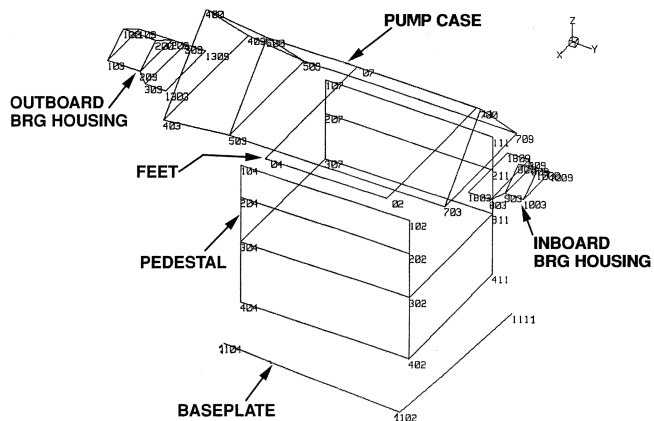
Figure 11. Geometrical Wireframe Model.

The modal analysis on unit P-302 revealed several resonance frequencies. Measurements were taken at 47 response locations in three directions, giving in total 141 DOF. Figure 11 shows the wire frame model.

Excitation with an instrumented impact hammer was done at three locations, indicated by an arrow in Figure 11, to ensure that every mode was excited. All measured FRFs are curve fitted and the modal parameters were determined and are shown in Table 6.

Figure 12 gives the mode shape of the 90.25 Hz mode, which shows large deformation of the inboard housing out of phase with the pedestal deformation.

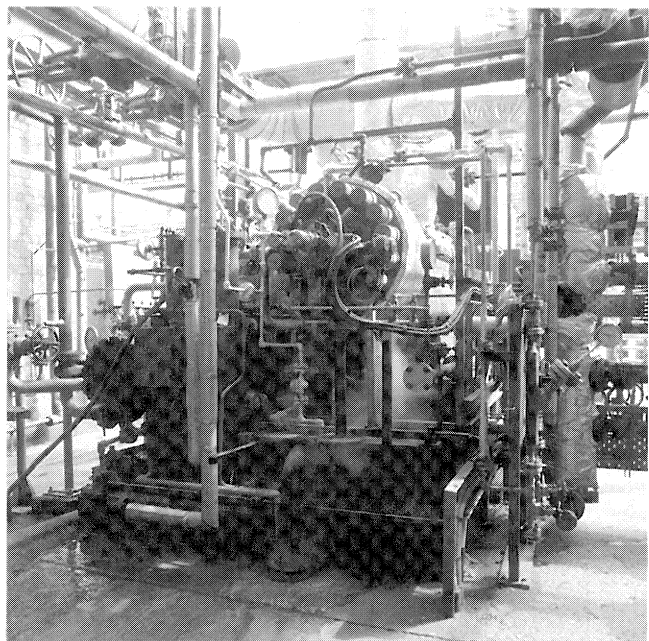
Figure 15. Modified Pump Installation.

Figure 15 shows the modified pump installation.

of purchasing complete new units. The rerate project also successfully included the elimination of two existing problems:
