THE USE OF BASIC HYDRAULICS TO SOLVE FIELD PROBLEMS: THREE CASES

CASE 1: COOLING WATER PUMP CASE STUDY— CAVITATION PERFORMANCE IMPROVEMENT

CAVITATION DAMAGE AS RELATED TO OPERATING POINT

CASE 3: USE OF BASIC PUMP HYDRAULICS TO SOLVE PUMP MAINTENANCE PROBLEMS

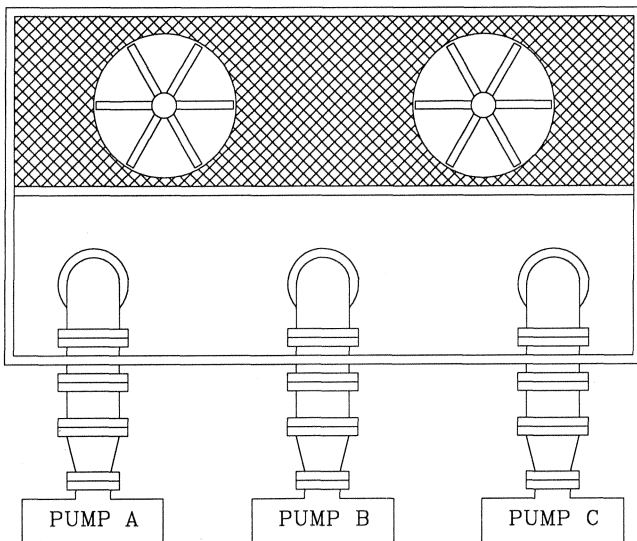
Figure 1.

The overall view of the cooling water tower is shown in Figure 1 with three pumps. Depending on load, one or two pumps are operating, with the third a spare. The total flow requirements vary between 16,000 to 25,000 gpm, based on the process heat exchangers load, ambient temperature, system minimum settling flows, and other considerations. This translates into the requirements for each individual pump to operate between 8,000 to 17,000 gpm. These double suction pumps are running at 1180 rpm, have 23.25 in impeller OD. Specific speed $N_s=2260$, and suction specific speed is $N_{ss}=10,050$ (flows used in calculation of N_s and N_{ss} are per impeller eye, i.e., half total flow).

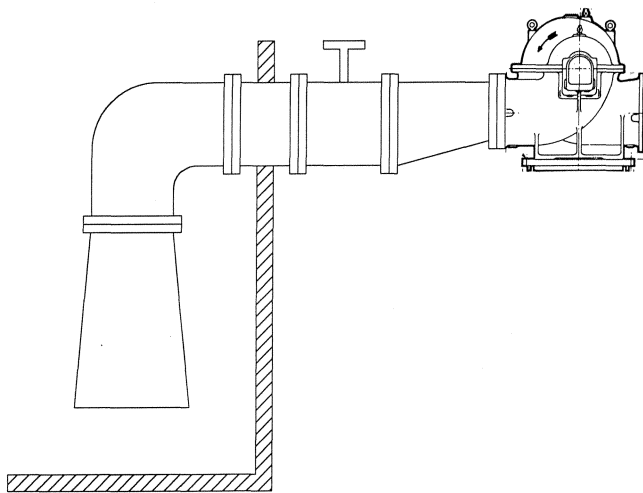
A detail of an individual pump is shown in Figure 2. The sump was designed to ensure convenient pump flooding by just opening the butterfly valve, since the water level in the sump is above the impeller centerline. At first, the pump piping was suspected as

causing a problem. The incoming sump velocities are very low (under 1.0 ft/sec), and no visual vortices were noted. The 36 in elbow and the bell were removed and the pump tested, indicating no appreciable difference in noise. The butterfly valve was installed in horizontal and then vertical stem orientation, both in the field and in the manufacturer's test facility. In the field, no noticeable change in noise was observed; in the test facility, the horizontal stem orientation was less noisy than the vertical (as expected), but the difference believed to be not significant enough to be a cause of the noise and damage. The original pump impellers were of cast iron, which is known to have poor cavitation resistance properties. From the hydraulic design standpoint, the impeller eye size was too big for the range of N_s and N_{ss} , as applied to cooling water pumps. As shown on Figure 3, and can be calculated from Fraser's data [1], the onset of the suction recirculation starts at around 13,000 gpm. At flows lower than that, the cavitation damage becomes quick, especially in light of poor metallurgy. The pump performance with operating flow range is shown on Figure 4.

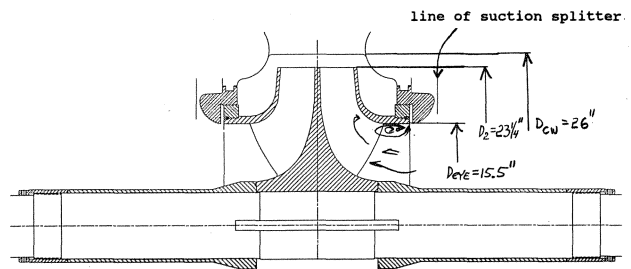
Figure 3. Existing Pump.

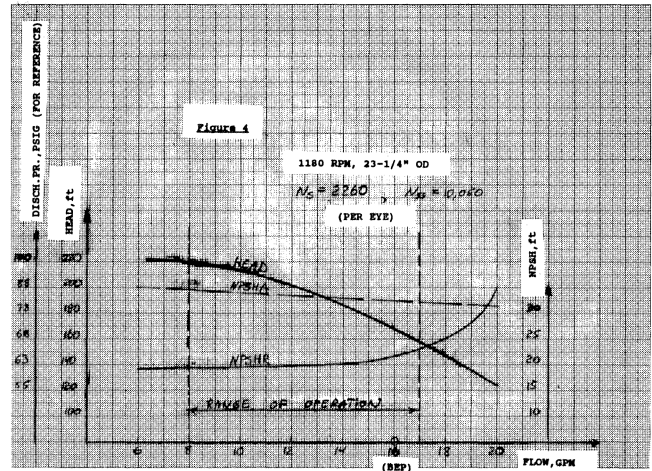
Figure 4. Pump Performance Curve.

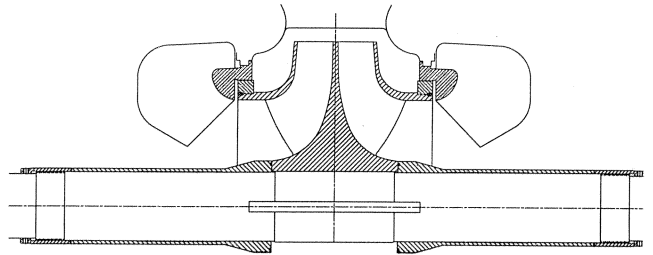
The following modification was aimed at improving flow distribution around the impeller inlet. The original suction splitter is only 15 degrees from the vertical line, and was shaped poorly, as shown on Figure 8 (left). Much better designs are given [3], and these guidelines were followed, as shown on Figure 8 (right)—much better contouring, and spitter centerline moved to 55 degrees from the vertical. In order to accommodate such modification in the field, the old suction splitter was ground off, and a new one was attached to the casing ring (Figure 9). The noise data for this modification is shown on Figure 6 (squares). Note that the whole noise curve is shifted downwards by about 3 dBA, and gets even more significantly better at the very low flow.

Figure 8. New Splitter: Repositioned, and having Better Contour Shape (Ref. Figure 7).

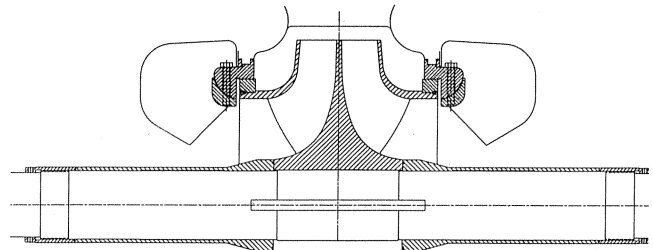
Finally, a combination of a new suction splitter and a bullring was tried (Figure 10). The noise signature became the lowest at low flows (up to 12,000 gpm), and then reached the nonmodified configuration at 14,000 gpm, and further increased above 14,000

Figure 9. Bullring with Splitter Modification.

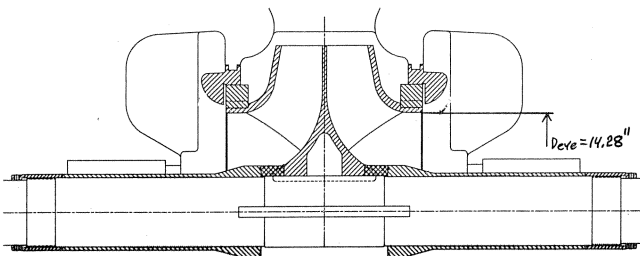
At that point, it was decided to design a new impeller, based on the information learned in previous testing. This new design impeller has smaller eye (14.28 in), and features a special profiled "P-blades" [4], as shown on Figure 12. Due to smaller eye, the N_{ss} value is smaller, $N_{ss}=9500$. From the discussion above, it is clear that if this impeller was made in cast iron, a direct estimate of the design improvement would be possible. However, the additional cost and time could not be justified at that time, and the impeller was made from duplex stainless steel CD4MCu, which is believed to have somewhat better cavitation characteristics as compared to even 316ss. Keep in mind that the old design impeller made of 316ss (pump "C"), experienced little damage after six months of operation, and is estimated to will have last for the total of about three years, i.e., somewhat below the customer target of five years.

Figure 11. New Impeller Design (Smaller Eye and Special "P-Blade" Inlets)

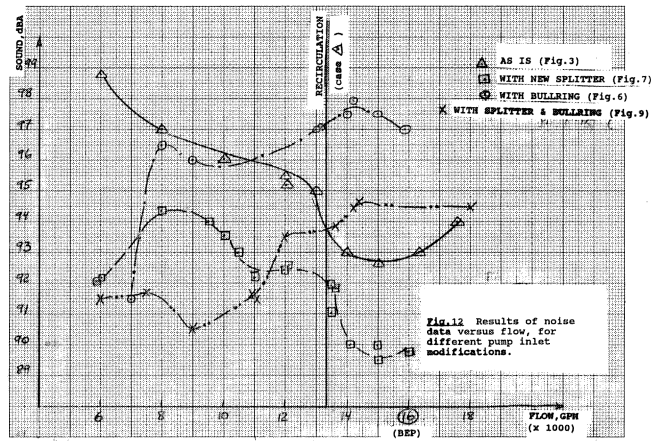
Figure 12. Results of Noise Data vs Flow, for Different Pump Inlet Modifications.

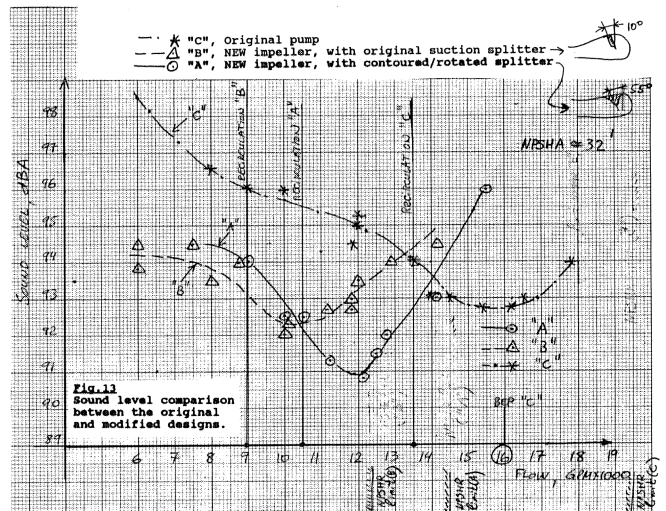
The comparison is shown in Figure 13 in noise levels between the old impeller design (pump "C") and the new one (pumps "A" and "B"). The noise was lowered for a new design - both for "A"

and "B" pumps. Pump "B" had a new impeller with smaller eye and special "P-blades" [4], but the casing still had the original blunt suction splitter (Figure 8, left), while pump "A" had also a contoured splitter (Figure 8, right). The combination of the new impeller design and contoured splitter resulted in lowest noise level. The smaller eye impeller requires higher NPSH_R though, which is the reason for the noise curve to begin to rise at the lower flow than the original impeller. This was not a problem in this case due to sufficient NPSH margin available, and the desired operating flow below 12,000 gpm. The contoured splitter offsets this disadvantage somewhat, as can be seen on Figure 13 (pump "A").

Figure 13. Sound Level Comparison between the Original and Modified Designs.

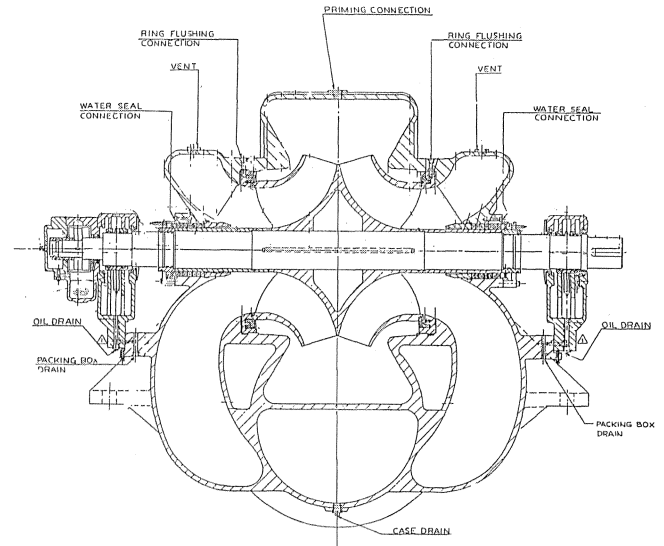
Large single stage, double suction circulating motor driven water pumps, as shown in Figure 14, were supplied to provide cooling water to power plant condensers. These pumps are relatively large motor driven pumps, having a suction flange diameter of 60 in and a discharge flange diameter of 54 in. They have horizontally split cases with a double volute discharge. The pump has two ring oil lubricated split sleeve radial bearings and a double acting tilting pad thrust bearing. The pumps were originally specified to deliver a head of 120 ft at a flow of 120,000 gpm with a required NPSH of 31 ft. The performance curve is shown in Figure 15.

Figure 14. Cross Section View of a W 60/54 (60" Inlet, 54" Discharge) Single Stage, Double Suction Circulating Water Pump.

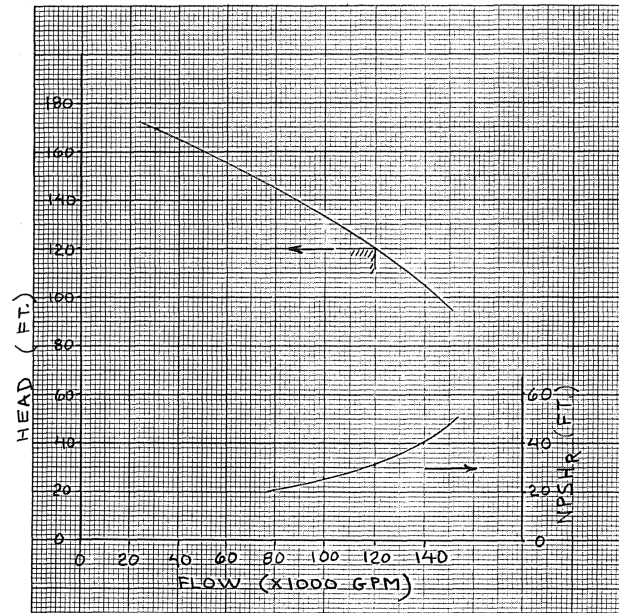
Figure 15. Performance Curve of the W 64/54 Circulating Water Pump.

After the pumps were installed at the power plant, the impellers were reported to have cavitation damage. Further investigation showed that the pumps were being operated at a higher flow than the design flow. This was because the head required at the field installation was less than that originally specified.

The performance curve of the circulating water pump is shown in Figure 2. This figure shows that the pump has a design head of 120 ft at a design flow of 120,000 gpm. At these conditions, the available NPSH was 38 ft. The required NPSH at this design condition is 31 ft. At this operating condition, there was no indication of cavitation damage.

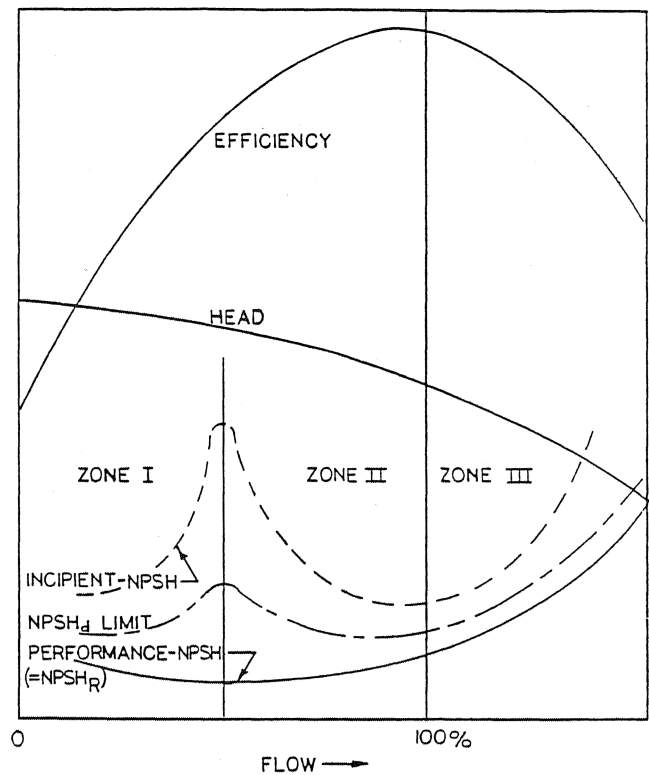
Consider a typical pump performance curve as shown in Figure 16. This figure contains five curves: a Head-Capacity curve, an Efficiency curve and three NPSH curves. The three NPSH curves are: 1) the Performance-NPSH curve, which is the amount of NPSH required to maintain hydraulic performance, 2) the NPSH curve, which is the amount of NPSH required to limit cavitation damage, and 3) the NPSH curve, which is the amount of NPSH required to prevent vapor bubble formation entirely.

Usually, the NPSH curves are developed for various percent of head loss at a certain flow utilizing test data taken by varying the pump suction pressure. If a pump is operated on the NPSH curve, there is a very high possibility that vapor bubbles will be formed and that cavitation damage will occur. Three types of cavitation zones are also shown in Figure 16. Zone I is the minimum flowrate area where backflow due to suction recirculation is well established. Cavitation damage appears on the pressure side or the non-visible side of the blade. Vapor bubbles are swept off of the suction side of the blade by the backflow and recirculated toward the pressure side of the blade where they implode and cause cavitation damage.

Figure 16. Typical Pump Performance Curve, Showing NPSH Required, a) to Maintain Hydraulic Performance or Pump Head, b) to Limit Cavitation Damage, and c) to Prevent Vapor Bubble Formation, Incipient NPSH. (Source: Cavitation Damage In Boiler Feed Pumps by Paul Cooper and Fred Antunes, Symposium on Power Plant Feed Pumps, June 1982).

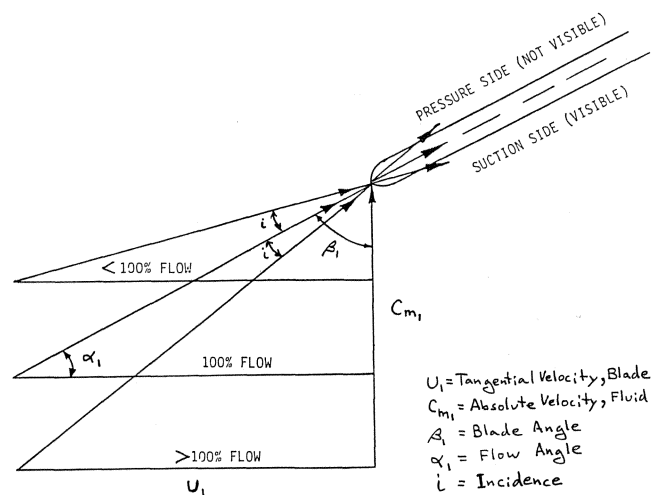
Zone III is the area that incurs runout cavitation damage that appears on the pressure side, or nonvisible side, of the blade. At higher than design flow, the angle of attack of the flow velocity vector on the blade leading edge will cause the flow to separate on the pressure side of the blade, as illustrated in Figure 17. Under

Figure 17 The Relation of Inlet Flow Velocity Vectors and Cavitation Assuming No Prerotations of the Inlet Flow.

low pressure conditions, vapor bubbles will be formed and carried downstream into higher pressure areas. When they implode on the pressure side of the blade, cavitation damage will occur. The cavitation damage will occur further downstream for higher values of incidence.
