# RELIABILITY IMPROVEMENTS TO A HIGH PRESSURE, HIGH TEMPERATURE, THIRTEEN STAGE CHARGE PUMP

**Dave A. Johns**

Shell Oil Company

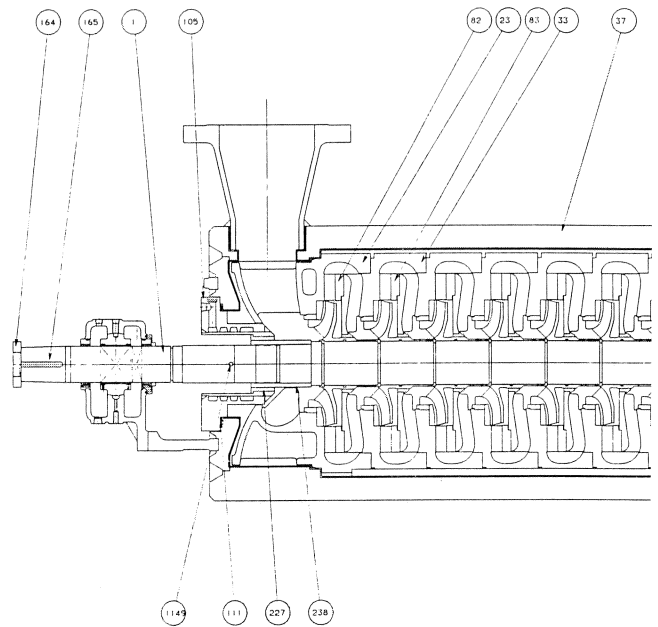
Figure 1. Pump Assembly.

Since installation in 1965, this pump has had a record of poor reliability with several seal failures resulting in fires. Previous

attempts to improve reliability have made some progress, but the pump was never able to run from turnaround to turnaround. The majority of the seal failures were on the coupling end and most of the failures occurred during pump startup.

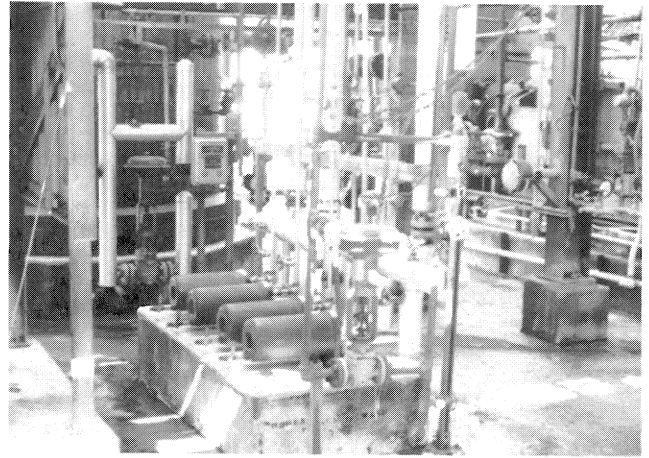
Figure 7. Water Cooled Seal Flush Coolers.

Seal flush piping is per API Plan 21 for normal pump operation. When this flow is not available, flush is provided from an external source per API Plan 32. Cooling is provided by a bank of natural convection fin tube exchangers and four shell and tube water cooled exchanges (Figure 7). Seal flush flow is maintained at 4.0 to 5.0 gpm per seal, via manually controlled needle valves. Desired temperature range is 200 to 250°F. The seals are quenched with low temperature steam.
