46<sup>TH</sup> TURBOMACHINERY & 33<sup>RD</sup> PUMP SYMPOSIA  
HOUSTON, TEXAS | DECEMBER 11-14, 2017  
GEORGE R. BROWN CONVENTION CENTER

# Vertical Seawater Lift Pump Reversible Performance Deterioration

# Problem

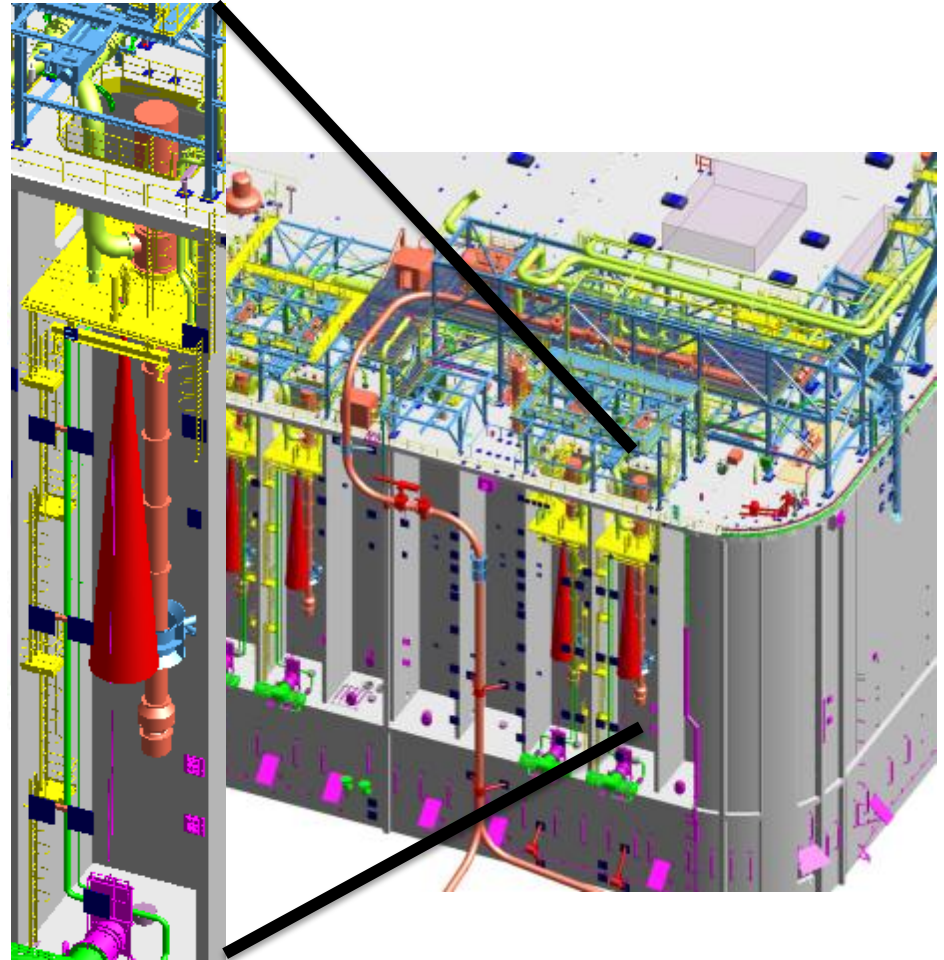
- SW vertical lift pump (24 m) inside a concrete basin
- Limited continuous operation due to reduced flow
- Reversible on each re-start
- Problem with 1 out of 4 pumps

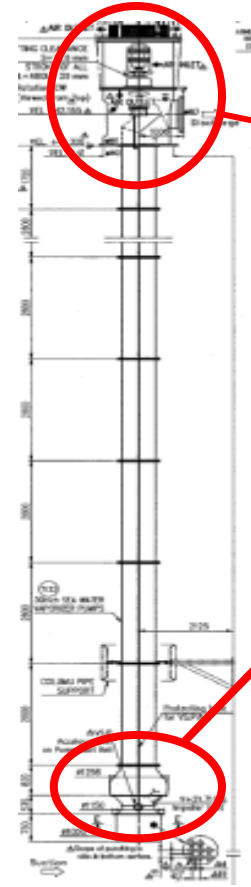
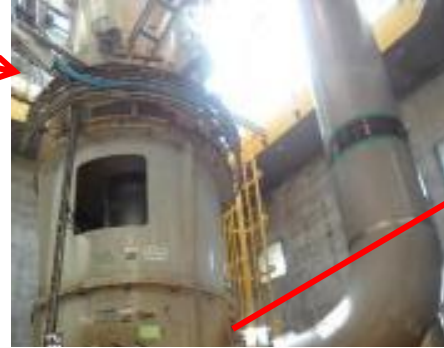
Camera inspection inside pump
