46TH TURBOMACHINERY & 33RD PUMP SYMPOSIA
HOUSTON, TEXAS | DECEMBER 11-14, 2017
GEORGE R. BROWN CONVENTION CENTER

STRATEGIES TO PREVENT SUDDEN CATASTROPHIC COMPRESSOR FAILURES DURING TRANSIENT OPERATING CONDITIONS

CASE STUDY 1: COMPRESSOR FAILURE DURING START-UP

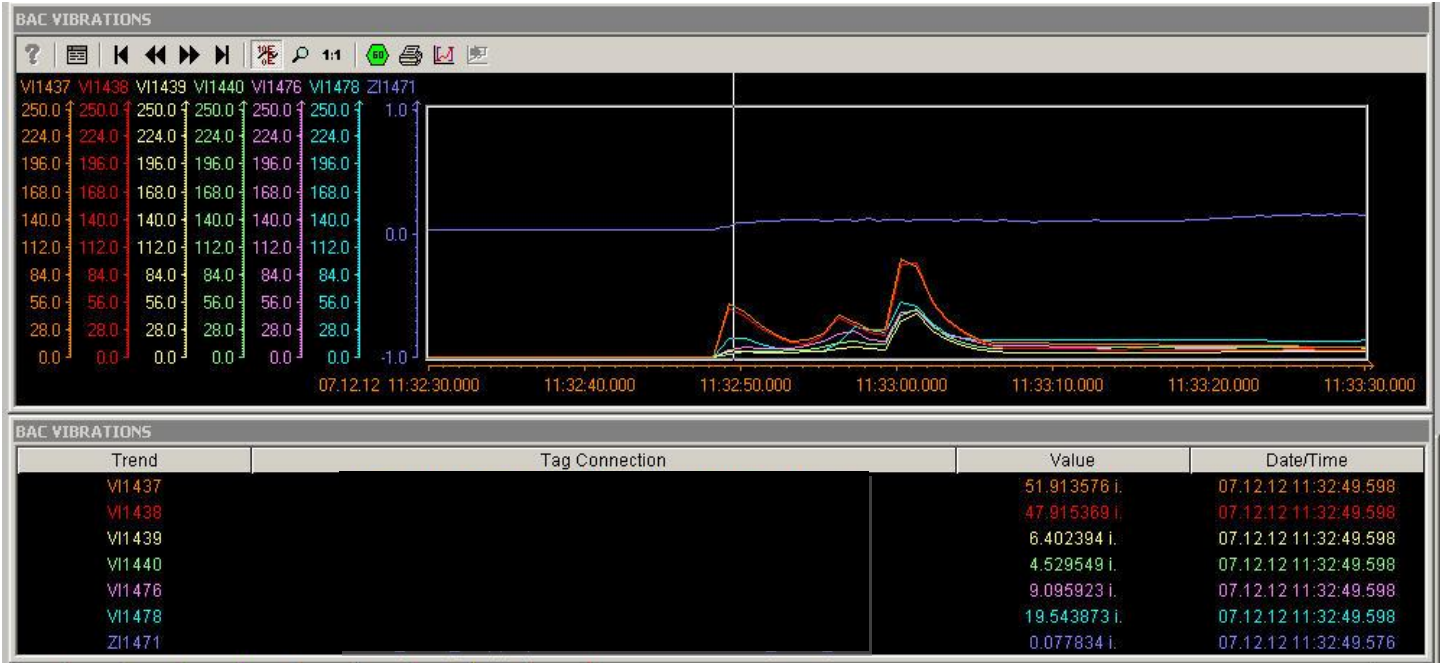
Figure 4: Normal Start-Up Vibration Trends

Figure 4 shows the vibration trends during the start-up prior to the failure. Figure 5 shows the vibration trends during the start-up when the failure occurred. Comparing the trends, the vibration levels for the start-up when the failure occurred were higher from the moment the compressor was started. And, about five seconds into the start, the vibration levels for stages one and two increased exponentially to 250 microns p-p, which is the full range of the transmitters. The vibration levels for stages three and four also increased exponentially to 250 microns p-p, but lagged behind the stage one and two vibration increase by approximately two seconds. The vibration levels for stages five and six showed the same trend, but lagged two seconds behind the stage three and four increase. Note that some of the vibration readings drop sharply before the machine trip. This is because these vibration signals went to bad quality. The compressor did not trip on high vibration because the vibration shutdowns were bypassed for 30 seconds during start-up.

Based on prior starts, the compressor reaches full speed in about 17 to 18 seconds. As shown in Figure 4, on the start-up prior to the failure, the vibration of all the stages spikes just before reaching full speed. It was determined that this was due to excitation from the train torsional natural frequency (TNF). The calculated TNF is 1250 CPM, which is 83% of the operating speed of 1500 RPM. A

As shown in Figure 4, the vibration levels for some stages on this machine spike momentarily during the start-up as the particular rotor accelerates through a resonant frequency. And, as noted above, the vibration on all stages spikes when the compressor accelerates through the train torsional natural frequency. The high vibration trip set points are set at values that are lower than some of these vibration spikes because the high vibration trip set points are based on operation at the normal operating speed. To prevent the machine from tripping during start-up, the control system was configured to automatically bypass the high vibration trips for 30 seconds. Although this is a common method to manage vibration spikes during start-up, it also eliminates the vibration protection for this period of time.

To prevent unnecessary high vibration alarms and trips on start-up and still provide high vibration protection, another option is to temporarily elevate the high vibration alarm and trip set points. This method is recommended by API and is described in API-670, "Machinery Protection Systems." The elevated vibration alarm and trip set points need to be set higher than the rotor's characteristic response at any resonances during the start-up, but the levels should be set as low as possible in order to maximize the machinery protection. In some machines, the alarm and trip points do not need to be elevated at all. In other machines, the alarm and trip set points may need to be elevated by as much as two or even three times the normal set points. However, if the set points need to be elevated more than this, there may be a problem and this requires further review.

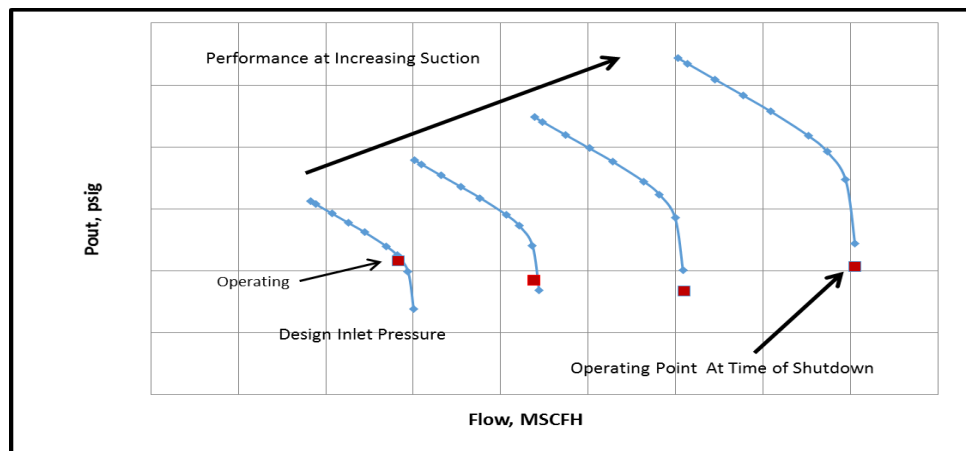
Figure 16: Compressor Performance During Event

After the initial drop in suction pressure, the suction pressure rose during the entire event. Using shop test data, a thermodynamic performance model was created to evaluate the overall operating conditions and interstage conditions leading up to the failure. As shown in Figure 16, the compressor was driven into a stonewall condition as the suction pressure rose. The interstage performance at different conditions had to be extrapolated from the shop test stage curves.

At the operating points shown on the performance curves, the calculated interstage conditions were used to estimate the thrust forces. Thrust forces are a combination of the differential pressure forces acting on both sides of the impeller and the gear reaction forces. Figure 17 shows a simplified model of the pressure forces acting on the impeller. The pressure forces drive the rotors towards the impeller end at normal operating conditions. For rotors one and two, the gear reaction forces are opposite in direction to the impeller pressure forces. However, at the design point, the gear reaction forces are less than 50 percent of the pressure forces acting on the impeller, and so the net force is still towards the impeller. Note that for rotor three, the pressure force and gear reaction force are in the same direction at normal operating conditions. At the higher suction pressure conditions, there is a modest increase in the calculated net rotor one axial thrust force while the corresponding calculated axial thrust forces for rotors two and three drops. The rotor one thrust force is still well within design limits. And, as shown in Figure 14, the shift in axial position on all the rotors coincided with machine shutdown. So, it is unlikely that the first and second stage inactive thrust bearing damage occurred before the shutdown.

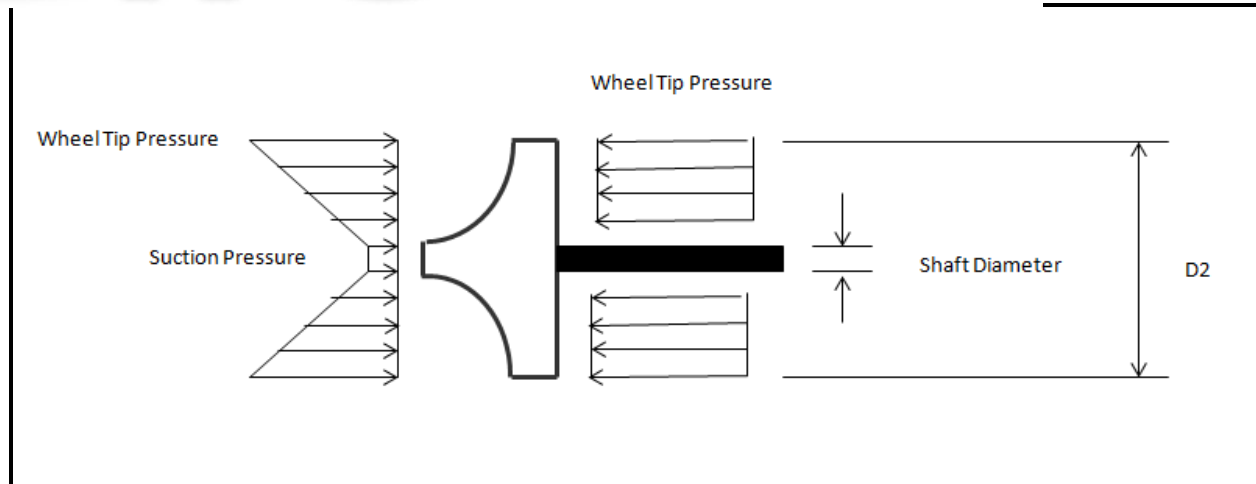
Figure 17: Pressure Forces Acting On Impeller

As the pressures in the compressor settle out, the pressure forces acting on the impellers will drive the rotors in the normally inactive direction, away from the impeller. As shown in figure 17, the face area on the front side of the impeller is larger than the back side due to the area taken up by the shaft. So, at settle out, the thrust force created by the pressure forces acting on the impeller is equal to the pressure times the cross sectional area of the shaft behind the impeller. At higher pressures, the impeller pressure forces in the inactive direction are higher and could be much higher than the forces at design operating conditions in the active direction. The gear reaction forces will also drop very quickly with speed.
