46<sup>TH</sup> TURBOMACHINERY & 33<sup>RD</sup> PUMP SYMPOSIA  
HOUSTON, TEXAS | DECEMBER 11-14, 2017  
GEORGE R. BROWN CONVENTION CENTER

# COMPANDER VIBRATION TROUBLESHOOTING

The “compander” is an integrally-gearred turbo machine with three warm compressor stages and one cryogenic expander stage. It’s used on LNG carrier to liquefy the boil off gas.(Brayton cycle)  
The factory acceptance test (FAT) troubleshooting concerns the last compander in a series of 8 identical machines.

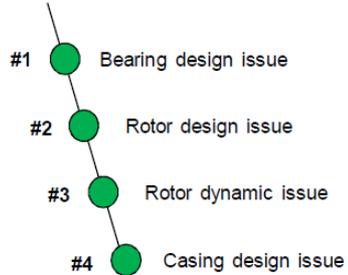
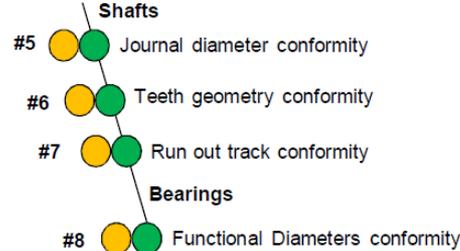
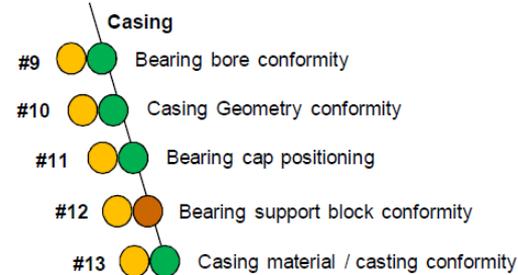
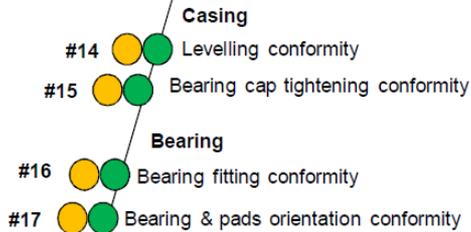
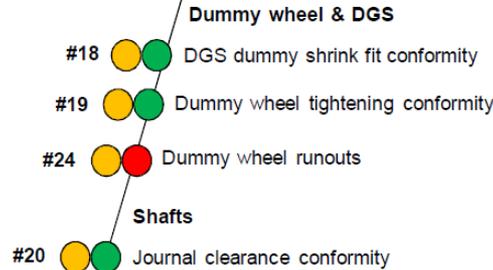
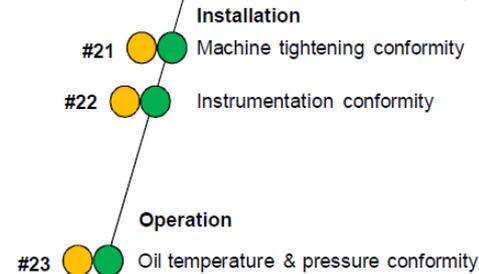
GBM Fishbone Diagram

**High Vibrations on HSS #2**

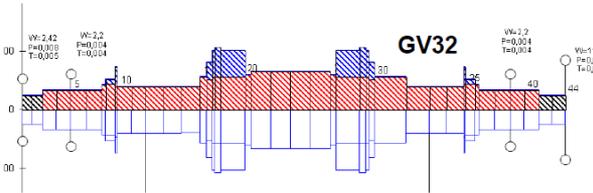
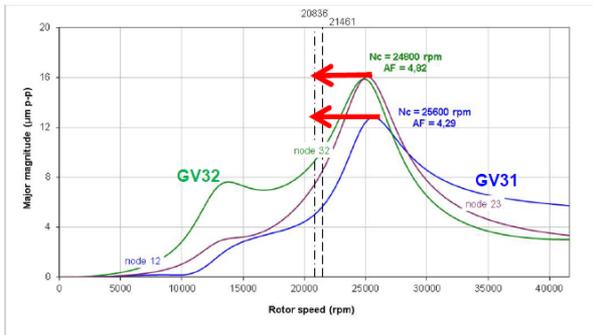
Lateral rotordynamic model and unbalance response

Rotordynamic behaviour: A loss of bearing stiffness may explain a shift of system critical speed, from above the operating speed range reducing towards the running speed. This effect arises from three possible causes:

50  $\mu\text{m}$  clearance between casing and bearing support block has been found. Putting shims between the casing and the support block did not improve the dynamical behaviour of Pinion 2

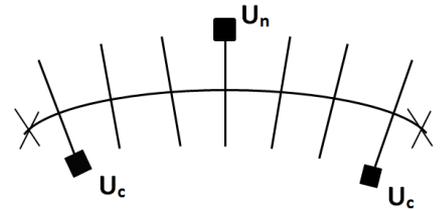
Low speed balanced for flexible shaft

Too large lateral and radial runout of the dummy wheels (48  $\mu\text{m}$  on Expander, 25 on C3, reduced to 4 and 8  $\mu\text{m}$  respectively). After having re-tested the machine, it can be stated that:

This issue is the most likely root cause

**Lesson learned:** For low speed balancing, the rotor behaves as a rigid body. Balancing is done, applying corrective unbalance weights,  $U_c$ , at two planes I and II. If the rotor later bends at high speed then the corrective weights could be useless. Incremental balancing during the assembly of the rotor is necessary to reduce axial distance between unbalance  $U_n$  and correction  $U_c$ . When the rotor residual unbalance is found out of tolerance. It's necessary to check the residual unbalance of each rotor element to specifically update the relevant ones.

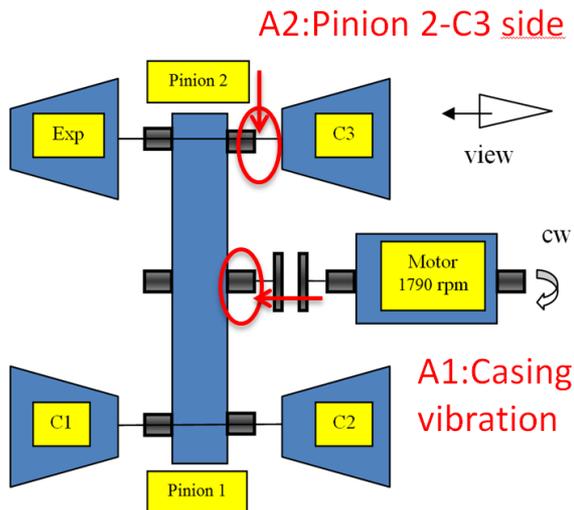
- The same phenomenon was present during previous tests but with a lower amplitude.
- Vibration reached 49  $\mu\text{m}$  pp just after speed ramp up from 10000 RPM to 19100 RPM.
- Not during critical speed crossing but 1 min after stabilisation at 19100 RPM.

Machine inspection found an oil deflector strain and plastic parts in the oil filter (coming from oil pump caps – Oil pump trip during first start up)

- Expander wheel unbalanced was a consequence of excessive vibrations.
- The excessive vibrations root cause was the pinion 2 rub in oil deflector.
