ASIA TURBOMACHINERY & PUMP SYMPOSIUM
MARCH 2018 | SUNTEC SINGAPORE

Investigation of High Bearing Temperature in Centrifugal Compressor

ExxonMobil
Chemical

**MITSUBISHI HEAVY INDUSTRIES
COMPRESSOR CORPORATION**

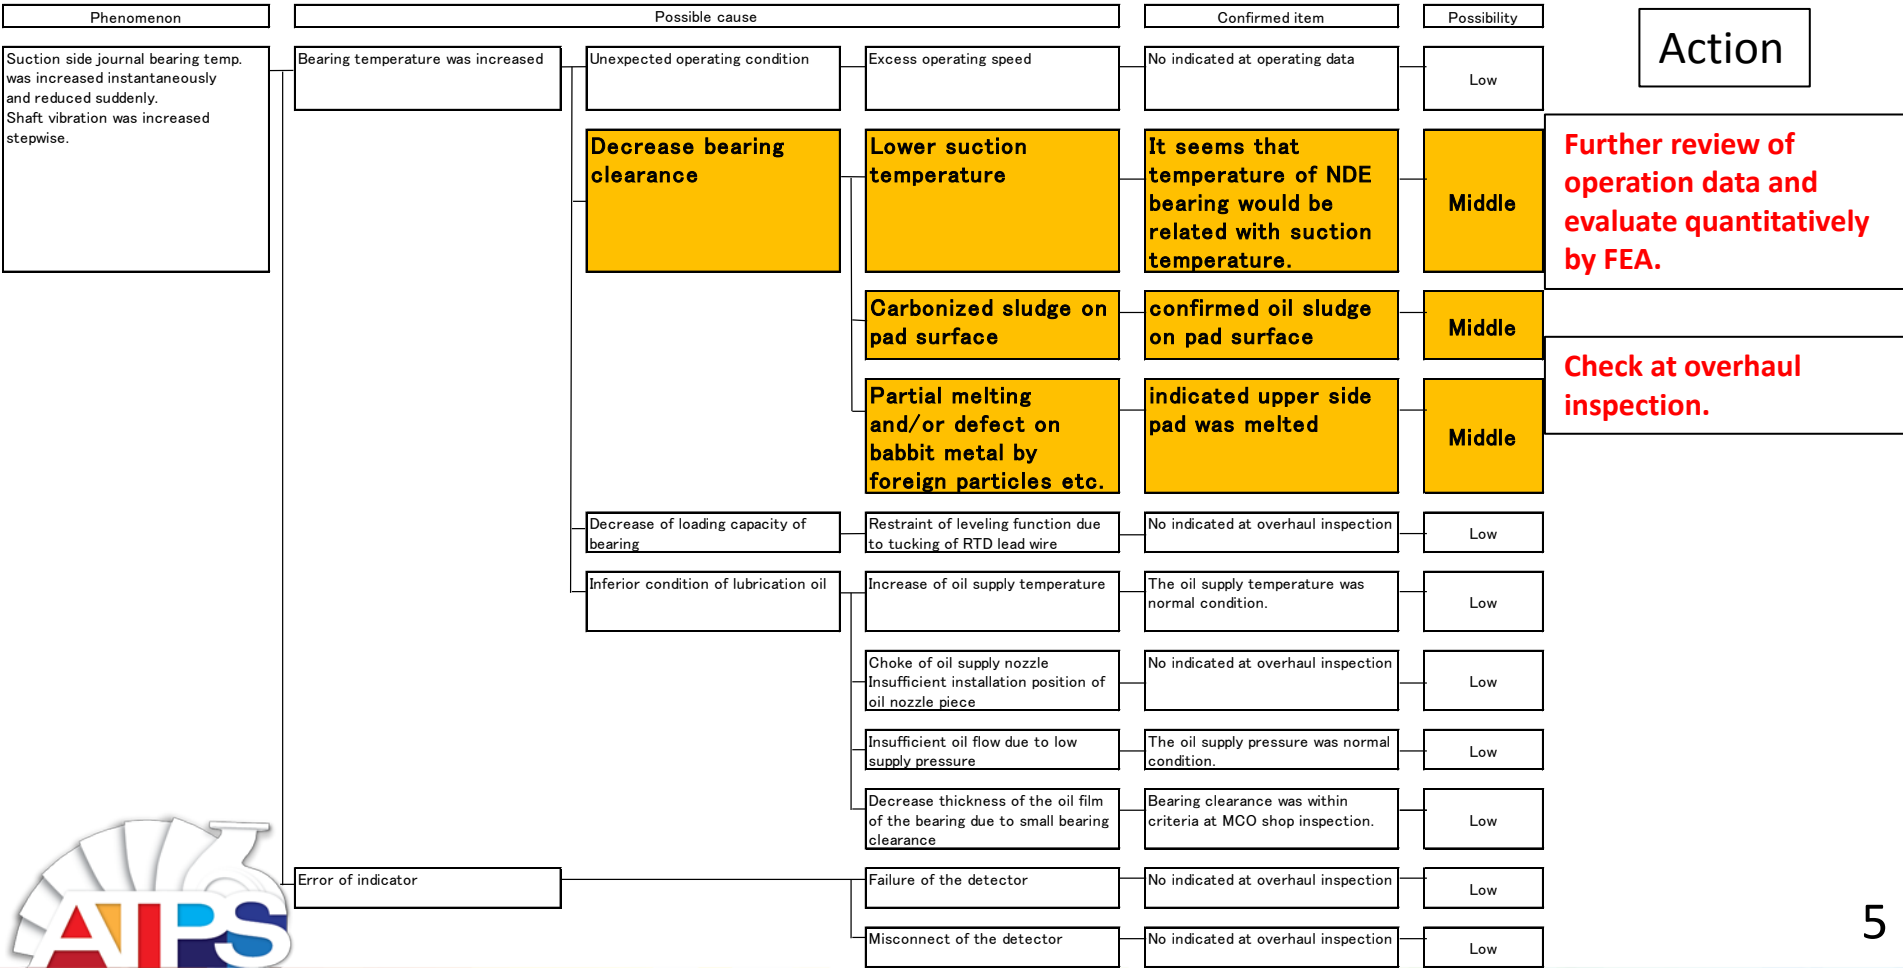
Observation at overhaul inspection

- Damage was identified on suction side journal bearing pad except for bottom pad.

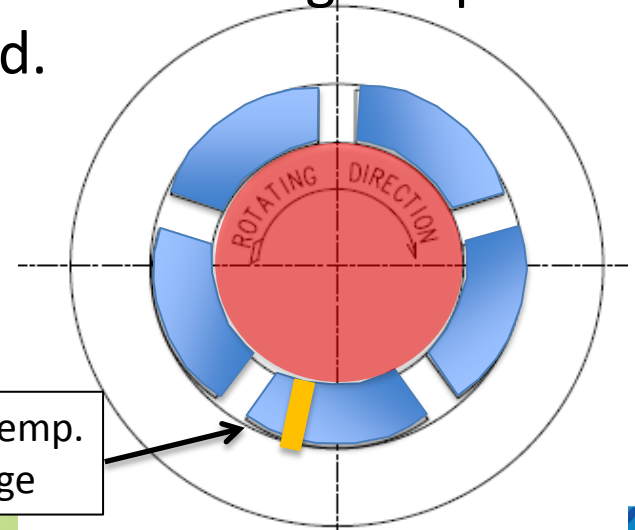
Observation at shaft vibration data

Shaft position moved only at suction side, discharge side was stable.

C) Shaft centerline moved downward 40µm during temperature decrease. This would be caused by bearing damage (reduce white metal thickness).
