ASIA TURBOMACHINERY & PUMP SYMPOSIUM  
MARCH 2018 | SUNTEC SINGAPORE

# UNEXPECTED VIBRATIONS IN GEARBOX CAUSED BY SYSTEM INTEGRATION ISSUES

This case study deals with a 24MW turbo-compressor unit composed of a gas turbine, a speed reduction gearbox with a lube oil pump mounted on its low speed shaft and two compressors in series. The unit was subject to high radial vibrations at the gearbox low speed shaft during initial running phase.

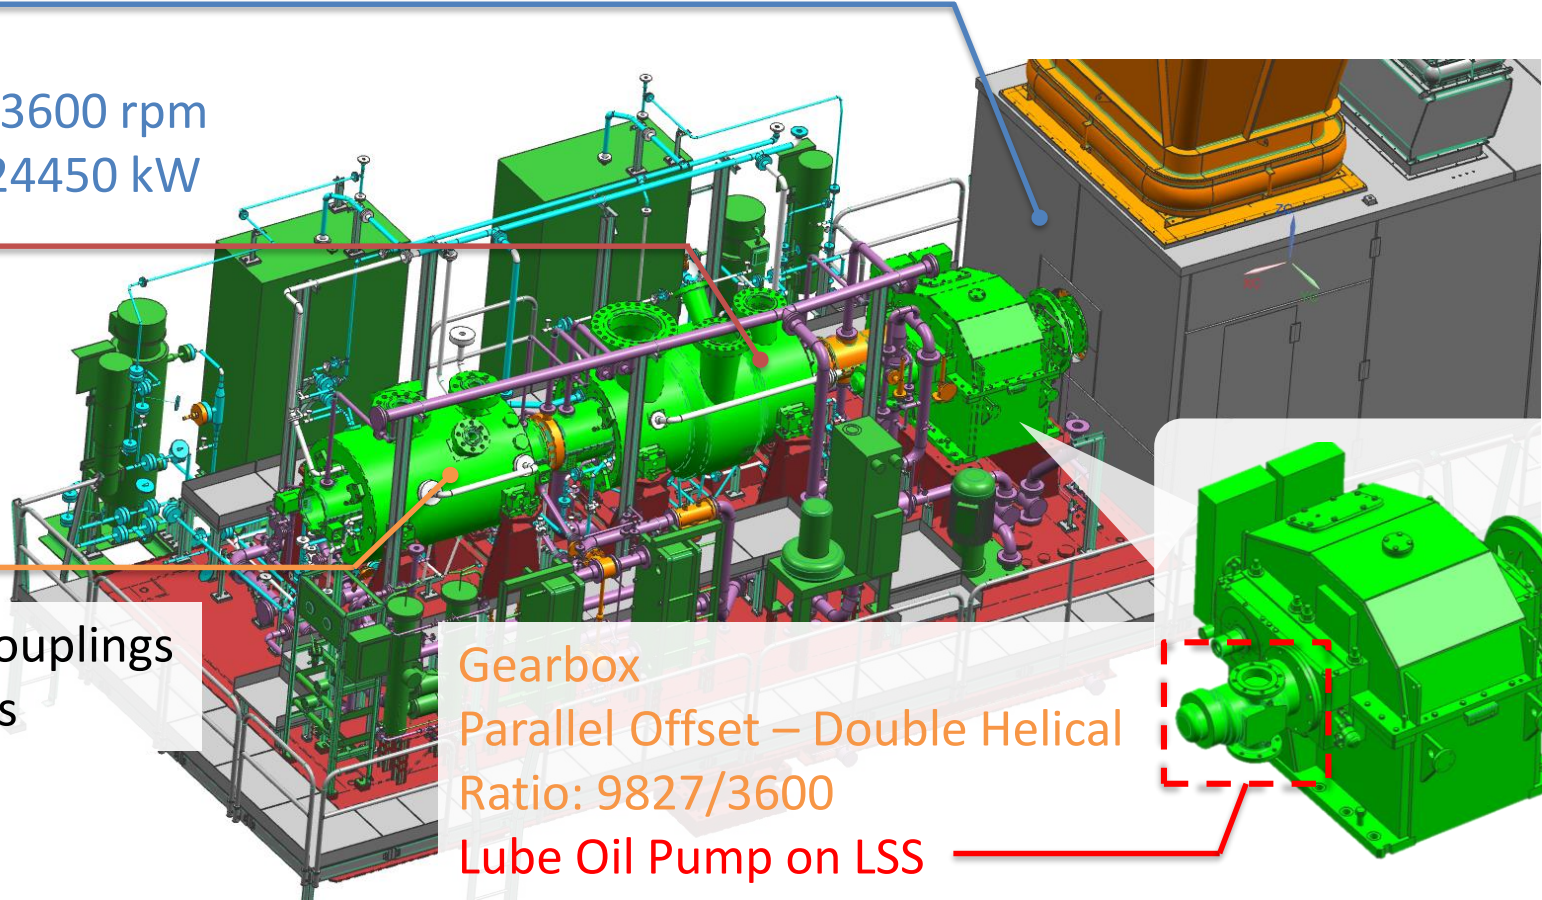
## 2. Train Configuration and Data

Gas Turbine

100% speed: 3600 rpm

Max power: 24450 kW

Gearbox

Parallel Offset – Double Helical

Ratio: 9827/3600

Lube Oil Pump on LSS

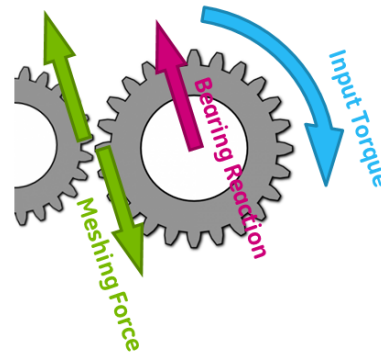
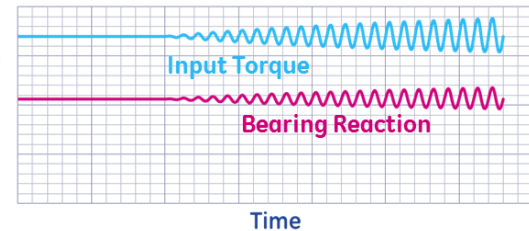
Gearbox radial vibration response at 1st Torsional Natural Frequency (TNF) was induced by torsional-lateral cross coupled effect, due to the kinematics of the geared system

- Kinematic phenomenon
- Lateral vibration is the effect of torsional vibration
- The radial component of the meshing forces represents the shaft excitation source

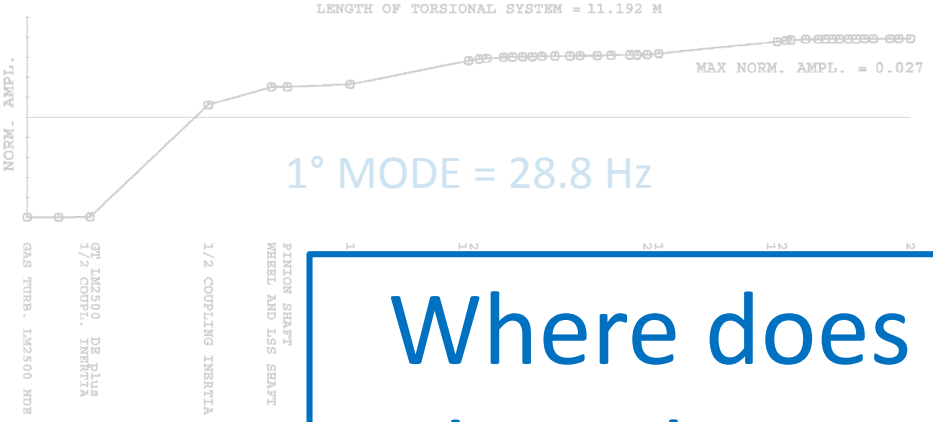
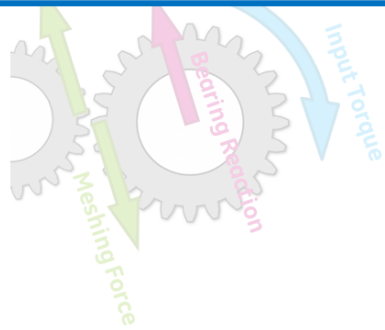
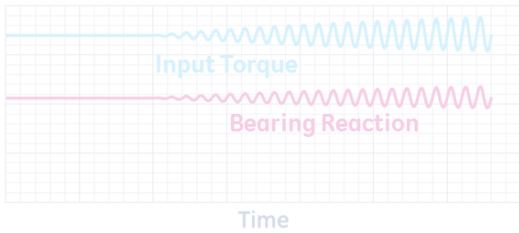
Gearbox radial vibration response at 1st Torsional Natural Frequency (TNF) was induced by torsional-lateral cross kinematics of

- Kinematic phenomenon
- Lateral vibration is the effect of torsional vibration
- The radial component of the meshing forces represents the shaft excitation source

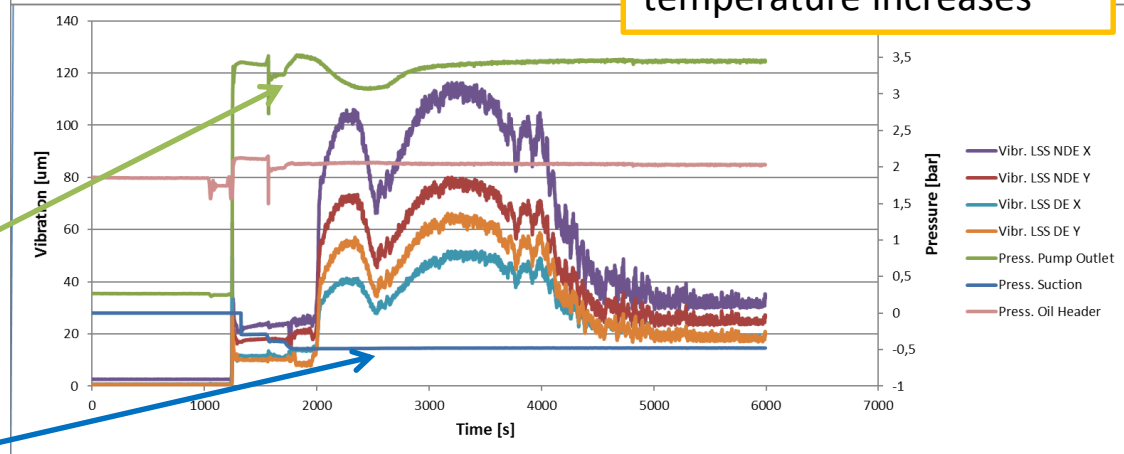
Vibration tends to decrease as oil tank temperature increases

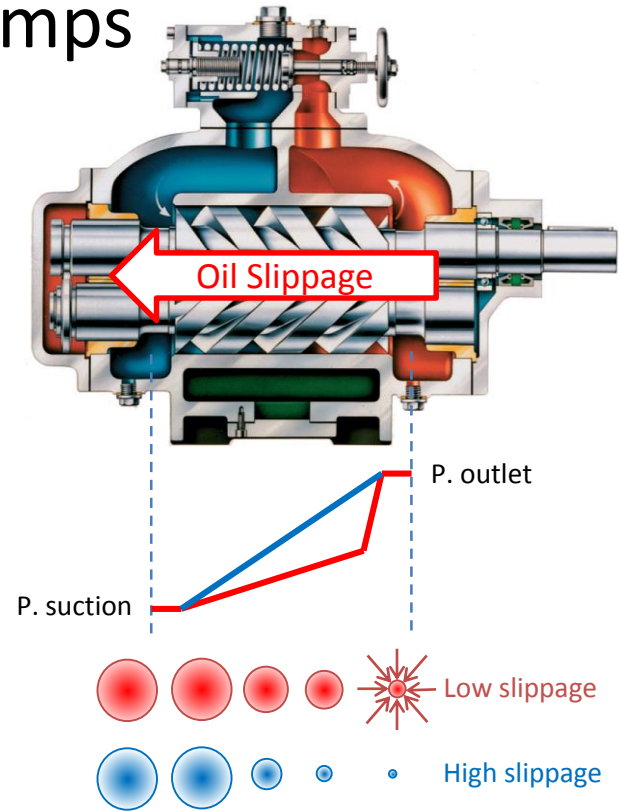
# 9. Aeration in screw pumps

- Aeration is caused by air normally present in oil (dissolved + emulsified air)
- Pressure drop at suction leads to formation of air bubbles
- Non-smooth pressure profile throughout the compression chamber leads to abrupt compression and implosion of air bubble
- Pumps are designed with some clearance to allow oil slippage and smooth pressure profile
- Aeration is tolerable by the pump, but leads to noise and vibrations -> **the torsional component of vibration excited the system's 1<sup>st</sup> TNF**

**NOTE:** Aeration (air bubbles)  $\neq$  Cavitation (vacuum bubbles)

Cavitation is much more severe phenomenon resulting in pump damage

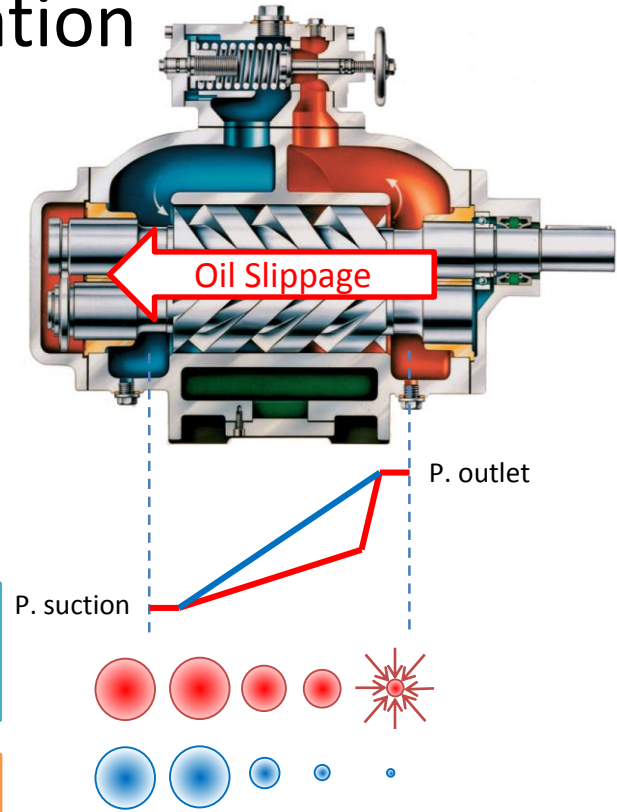
# 10. Factors influencing Aeration

Reduce pressure drop at suction  
(reduces bubble formation and  
volume)

Increase pump internal slippage:  
this lead to pump volumetric  
efficiency reduction

Increase outlet pressure  
(facilitates slippage)

Increase oil operating  
temperature (decreases viscosity  
and facilitates slippage)
