# ***Gearbox Misalignment on Combustion Gas Turbine Generator***

*Mohammed Al-Hajri*

**Abqaiq Plants-Saudi Aramco**

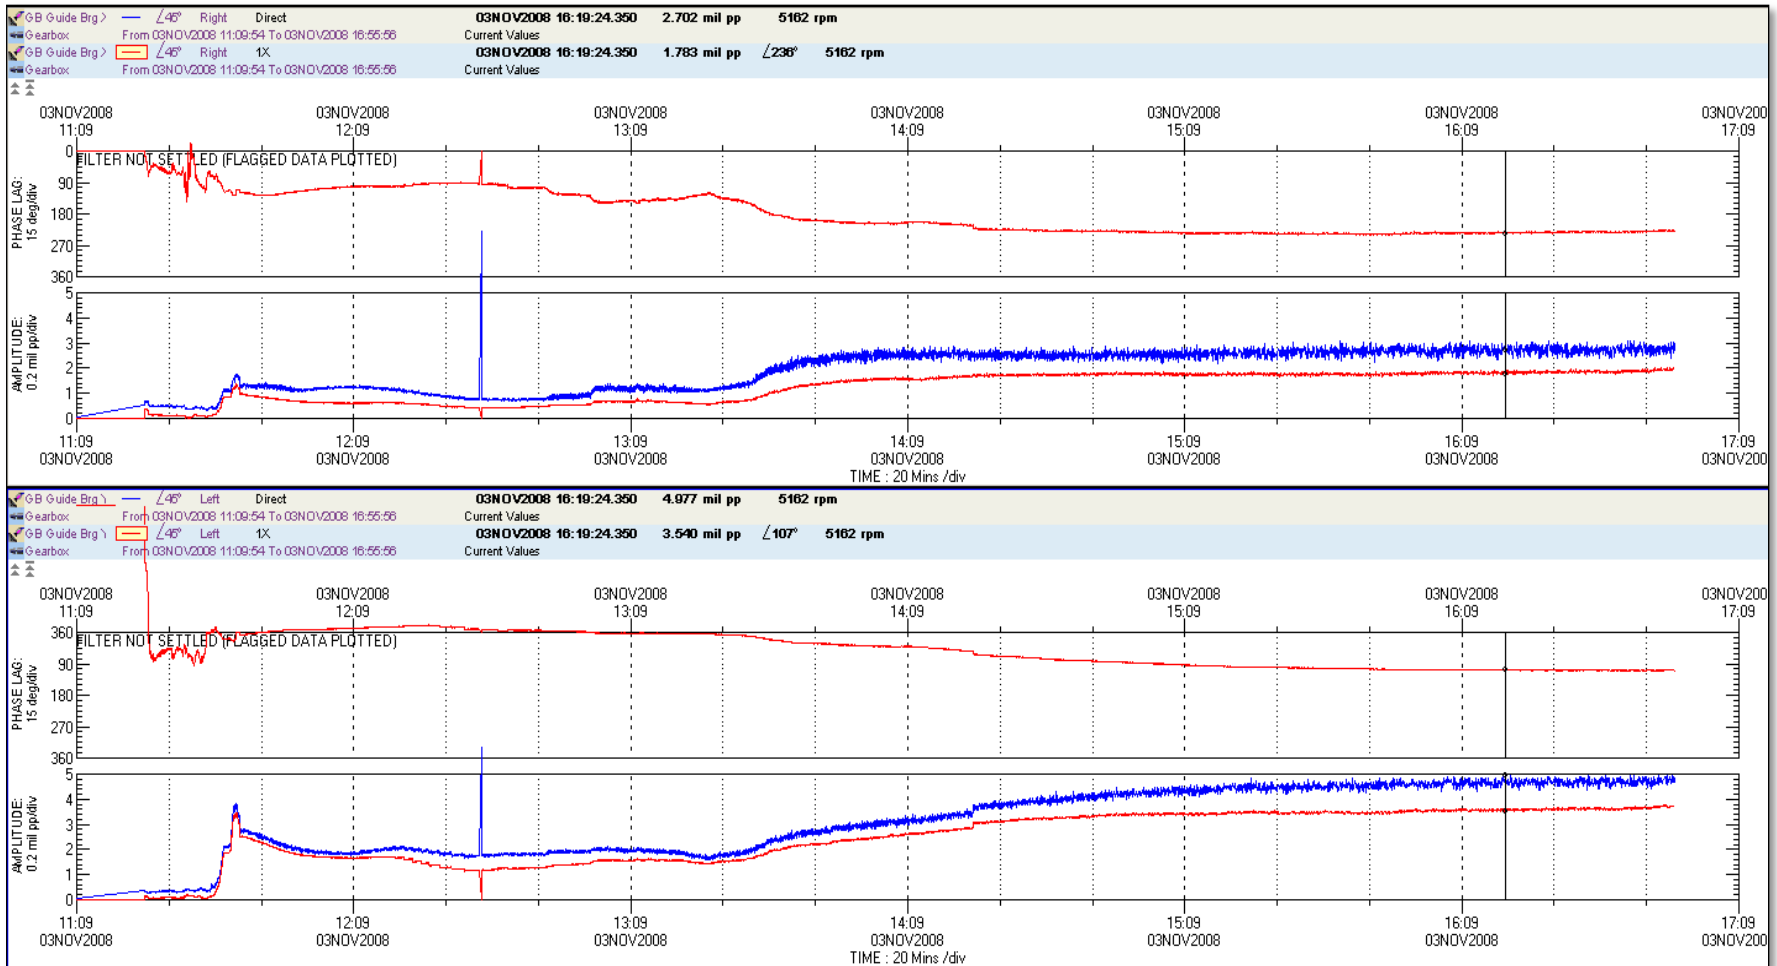
## 2) Trend Plot

- High vibration at the Gearbox HSS guide bearing reached 5.2 mils Pk-Pk (alarm is 4.9)

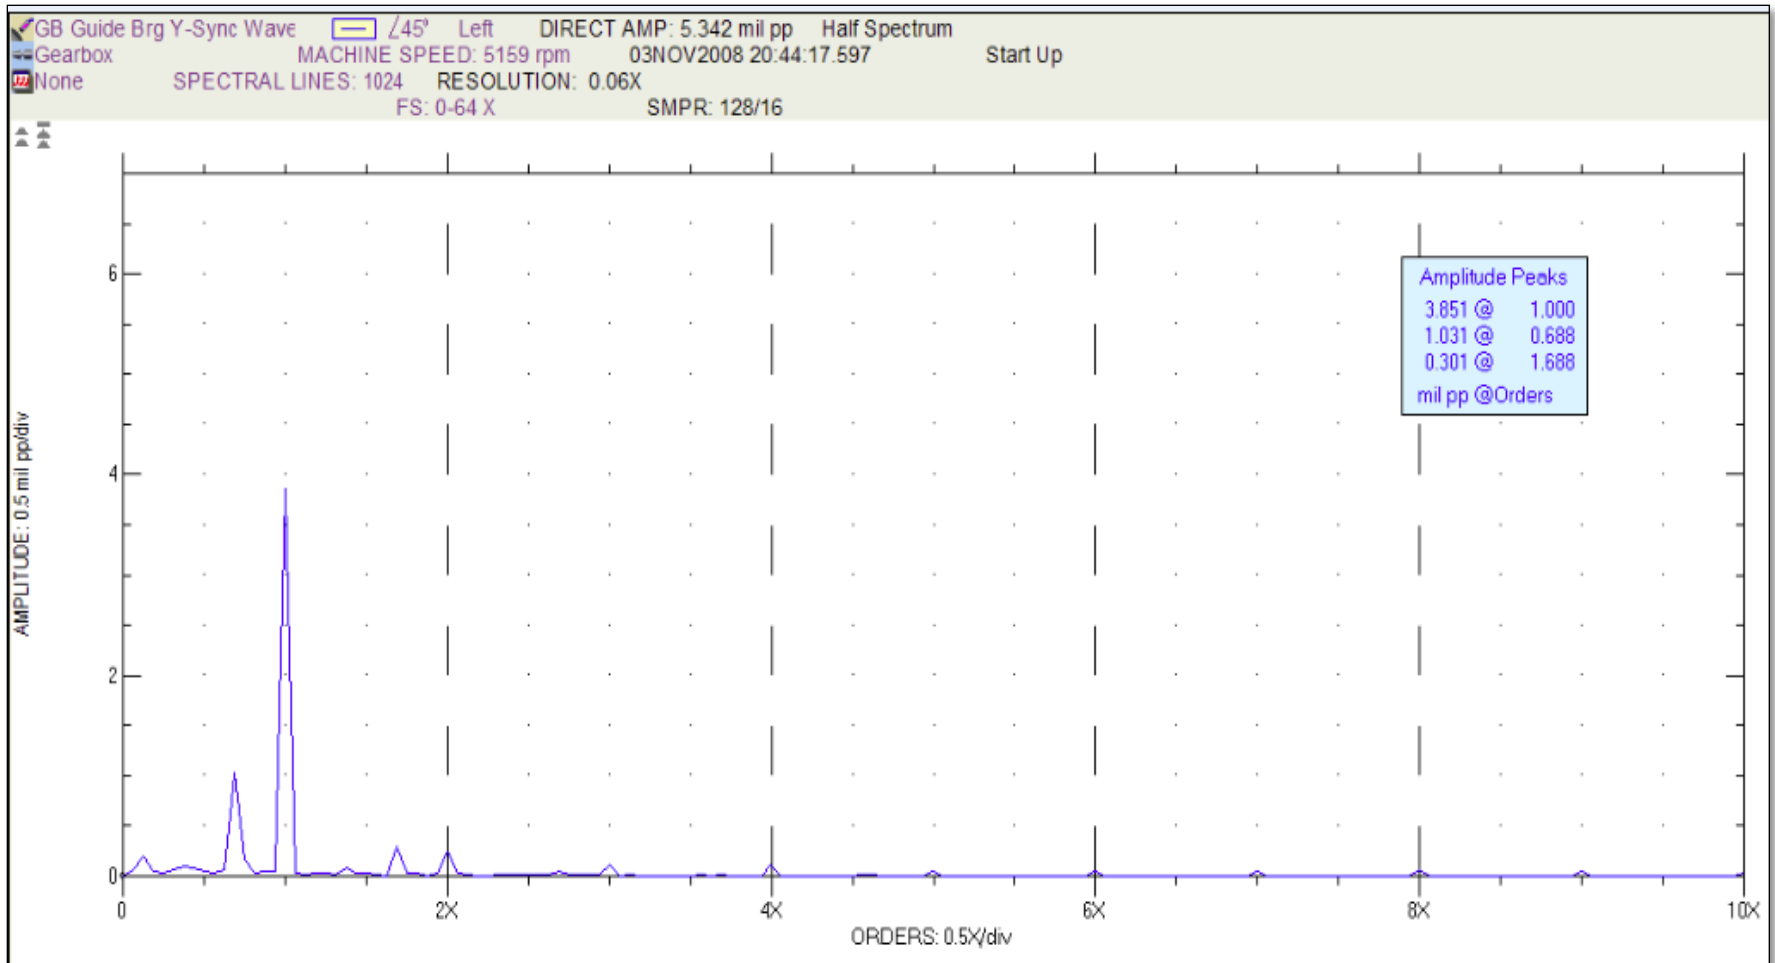
## 4) Spectrum Plot (Y Probe)

- The thermal behavior observed on the Gearbox HSS guide bearing, the heavy multiple preloaded orbit and the presence of 2/3 X component could be due to hot misalignment to the turbine
- The gearbox acceleration vibration signature indicated high frequency components related to gear mesh frequency and its harmonics. This signature is most likely due to teeth wear or misalignment

1. Inspect the condition & clearance of the guide bearing
2. Check the condition of the meshing teeth of the gear and pinion shafts
3. Check the alignment between the gas turbine and gearbox high speed shaft, and correct as necessary
