# “Beating” Effect Caused by Two Closely Spaced Mechanical Frequencies Observed on Two-Shaft, Gas Turbine Drive

By Robert X. Perez, machinery engineer working for a midstream energy company in the USA,

Andrew Conkey PhD, Assistant Professor of Mechanical Engineering, Texas A&M University at Qatar

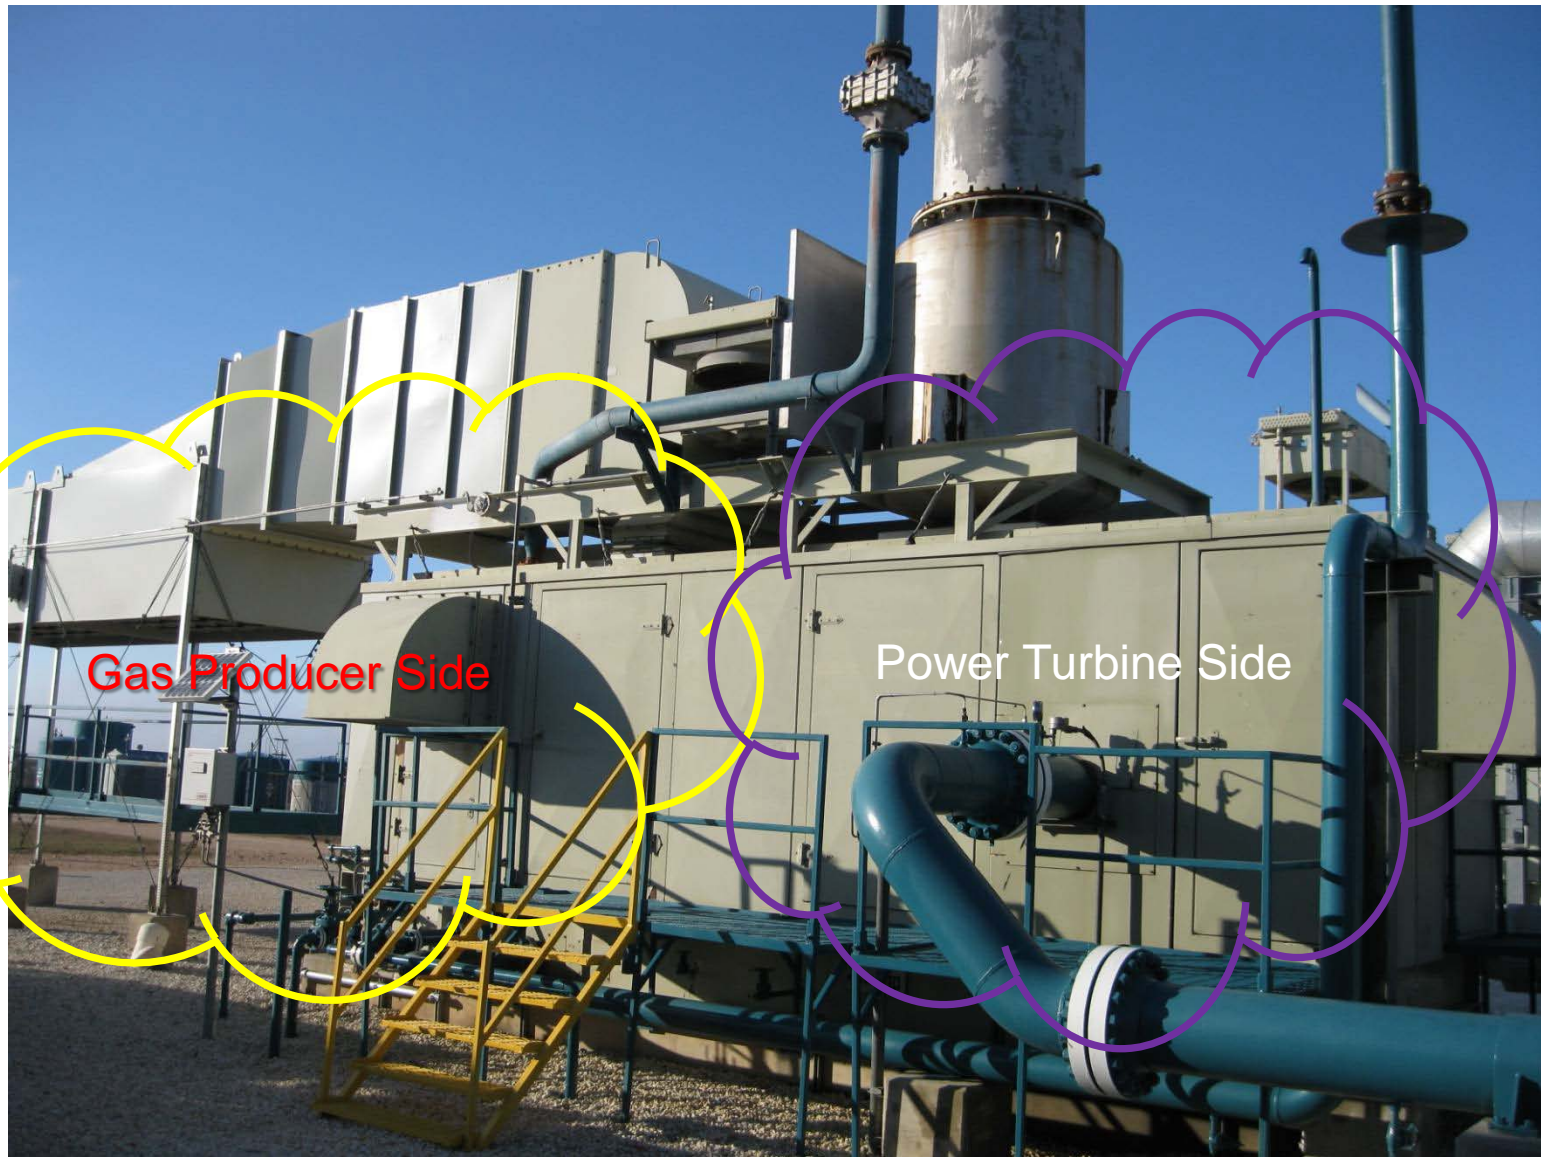
# Photo of Gas Turbine/Compressor Enclosure

Gas Producer Side

Power Turbine Side

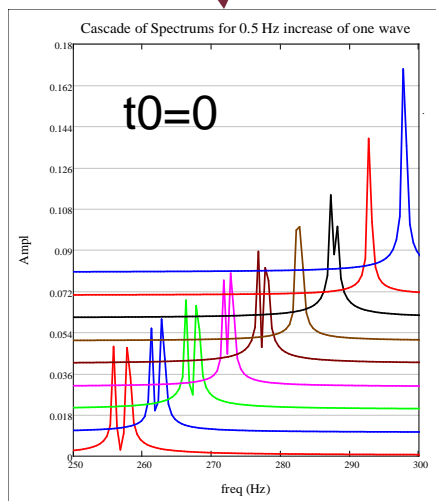
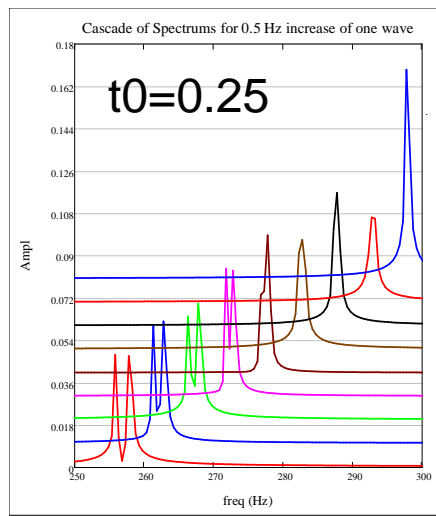
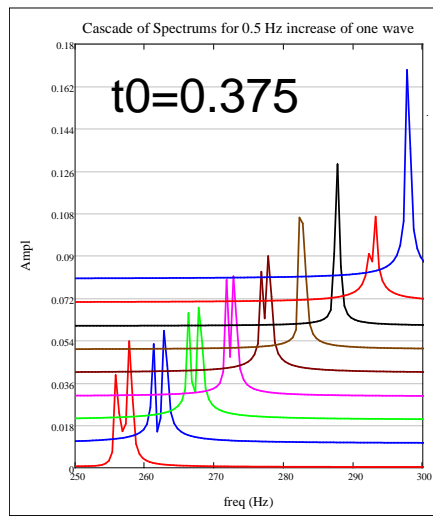
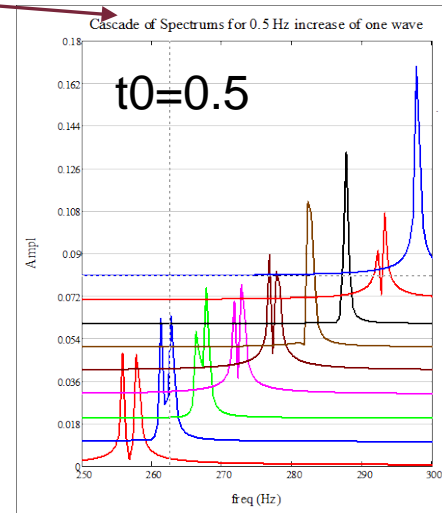
Fixed frequency  
 $f_2=258$  Hz

The time waveforms on the left are the composite wave as the first waves' frequency changes.

The four figures on the bottom are the spectrums if the start time of the 1 sec. sampling shifts to the right. This is essentially a phase change. No 1X pick up on PT-GP system.
