Turbo-Expander Compressor Active Magnetic Bearing Trips Reduction - A Case Study

RasGas

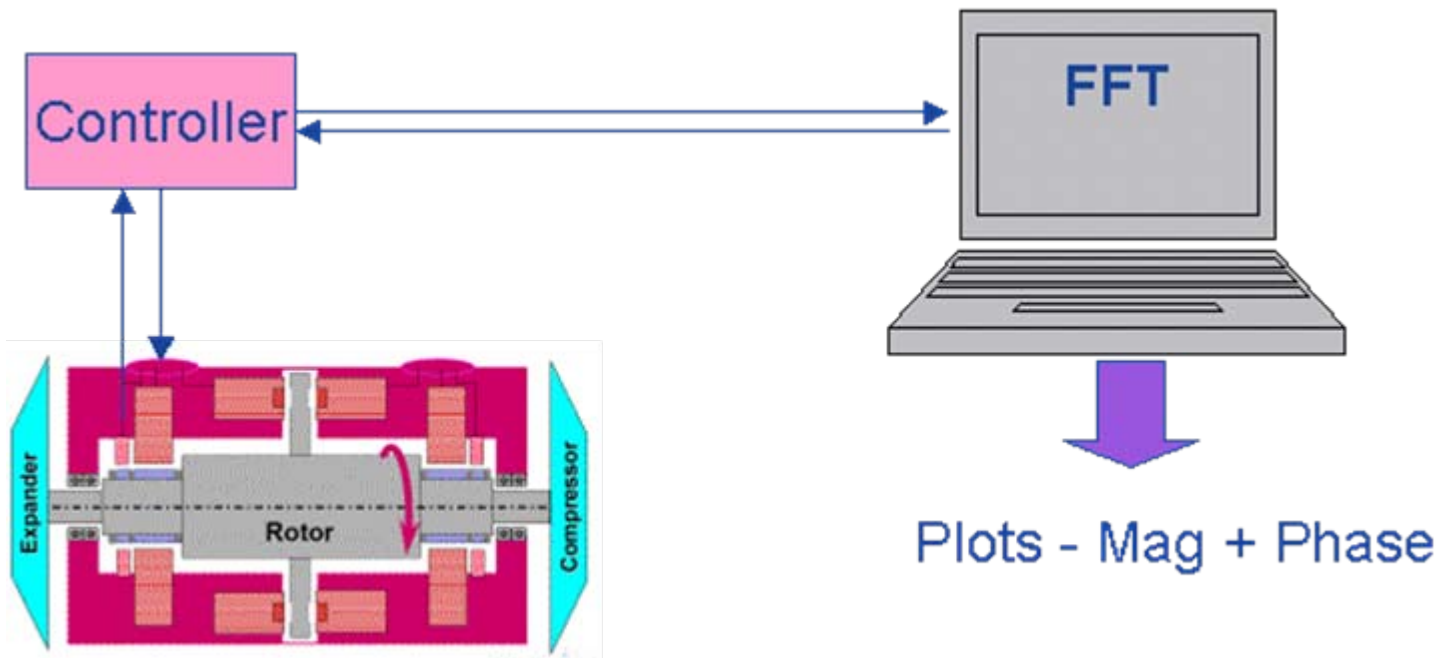
- Control Loop Transfer Function (TF) Changed
 - TF is the ratio of output of a control system to its input; once set up, it represents the system signature (ie, natural frequencies)
 - Change of TF during active operation is rare, but RasGas experienced twice in 2009
