Steam Turbine Blade Failure

Qatar Chemical Company, QATAR

MIDDLE EAST TURBO MACHINERY SYMPOSIUM - 2011

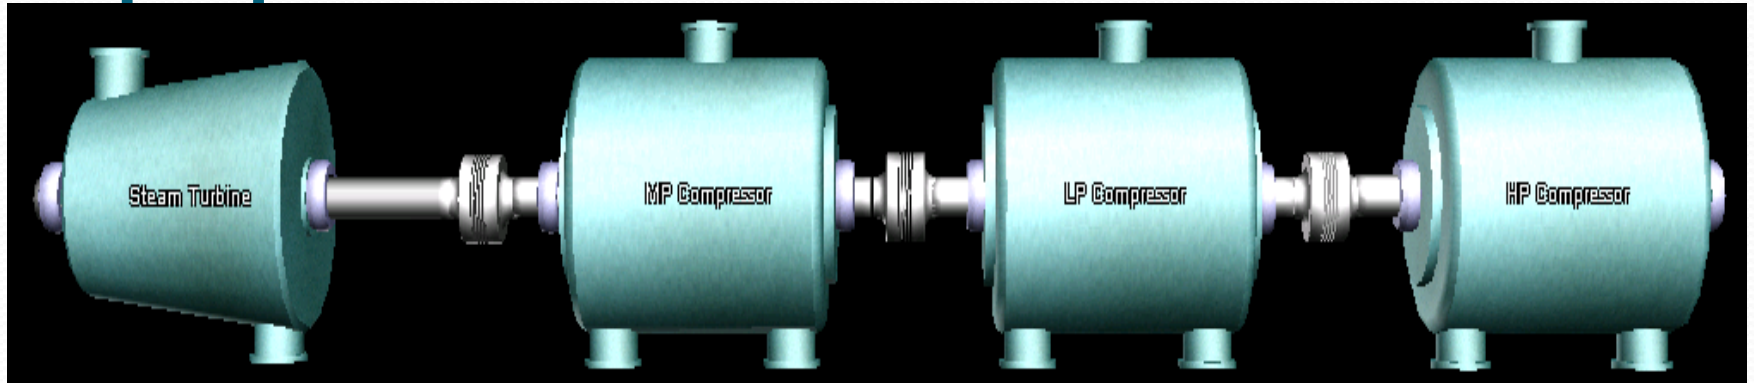
Equipment Data

Turbine	
Media Handled	Steam	Note: This 12 stage turbine was commissioned in February 2003 and since then in continuous operation. Machine vibrations were smooth, right from commissioning (Maximum shaft vibration of 12 microns Pk-Pk.)
Capacity	26.5 MW	
Inlet Condition	103.5 kg/cm ² A, 493 °C, 190 T/Hr	
Outlet Condition	44 kg/cm ² A, 383°C-Extraction 102 mm HgA, 50°C-Condenser
