Pitting Corrosion on Fr6B Gas Turbine Axial Compressor Blades: Investigation and Preventive Measures

Authors:

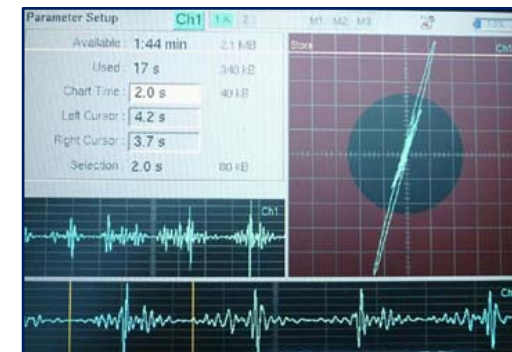
Sample ET Snapshot

Pitting corrosion observed on 1st four rows of Rotating and Stationary blades
Leading Edge:

- From root to tip in multiple and cluster formations
- Volumetric dimensions of the pits estimated between 0.25x0.25mm and 0.5x0.5mm (FBH reference)
- External dimensions of the pits up to 1.5mm
- Liquid erosion was detected as well

- Corrosion pitting was affecting area 2 and 5 in multiple and cluster types with estimated volume between 0.25x0.25mm and 0.5x0.5mm

- Premature replacement of affected rotors was therefore carried out with refurbished ones. Also impaired stationary vanes (S1-S4) were replaced with new ones.
- Thorough checks and cleaning of filter house carried out and filter cartridges replaced.
- Sample rotor blades (R1-R4) and stationary vanes (S1-S4) removed from affected turbines as well as dirty filter cartridges were thoroughly investigated at OEM laboratory to find out root cause of pitting corrosion failure.
