# Head-flange O-rings on Barrel Type Centrifugal Compressor Units at RasGas: issues & resolutions

Quraisy Shatri, Rajeshkumar Rajani, Dr. Basel Wakileh (RasGas)  
Leonardo Baldassarre, Andrea Cianti, Alberto Armenzani (GEO&G)

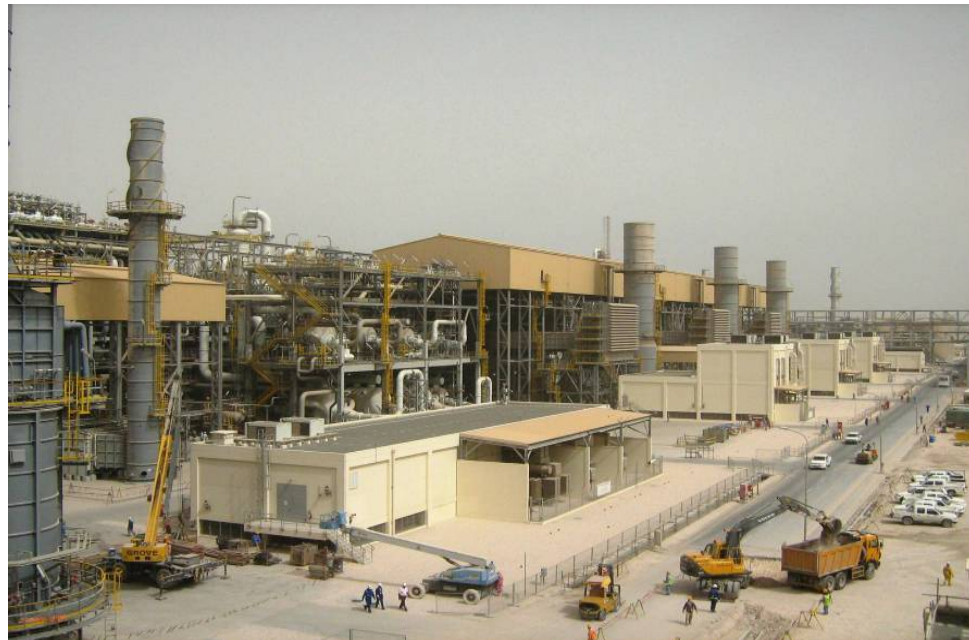
Site view: compressors driven by F6B and F9E

*During commissioning of mega LNG trains in 2009, gas leak from barrel end-wall was experienced during pressurization process. This problem was also noticed on existing compressors which were in operation for about 5 years.*

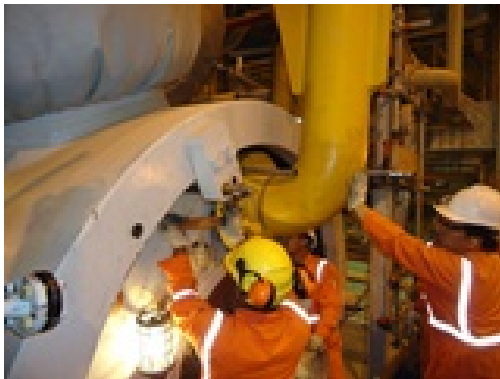
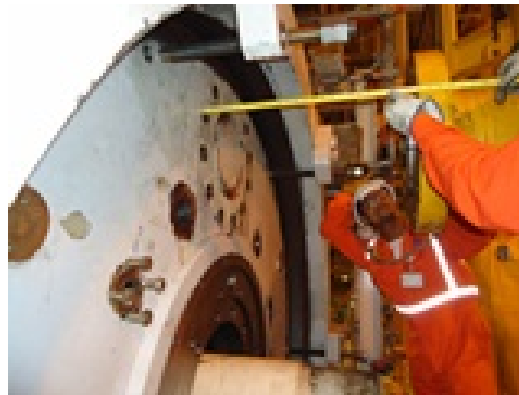
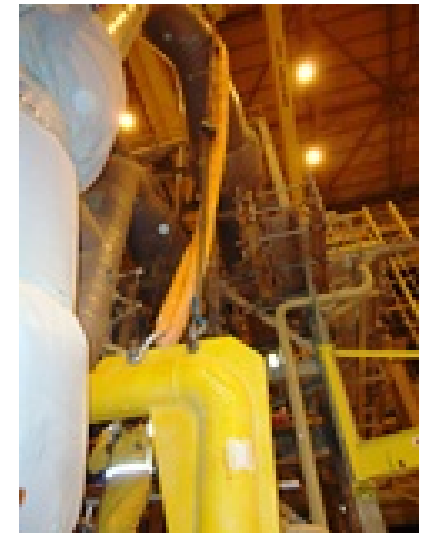
- Time
- Large size, heavy components and assemblies
- Tooling for HF removal
- Space
- Risks associated during removals / installations HP couplings, bearings and seals, shear and shim rings

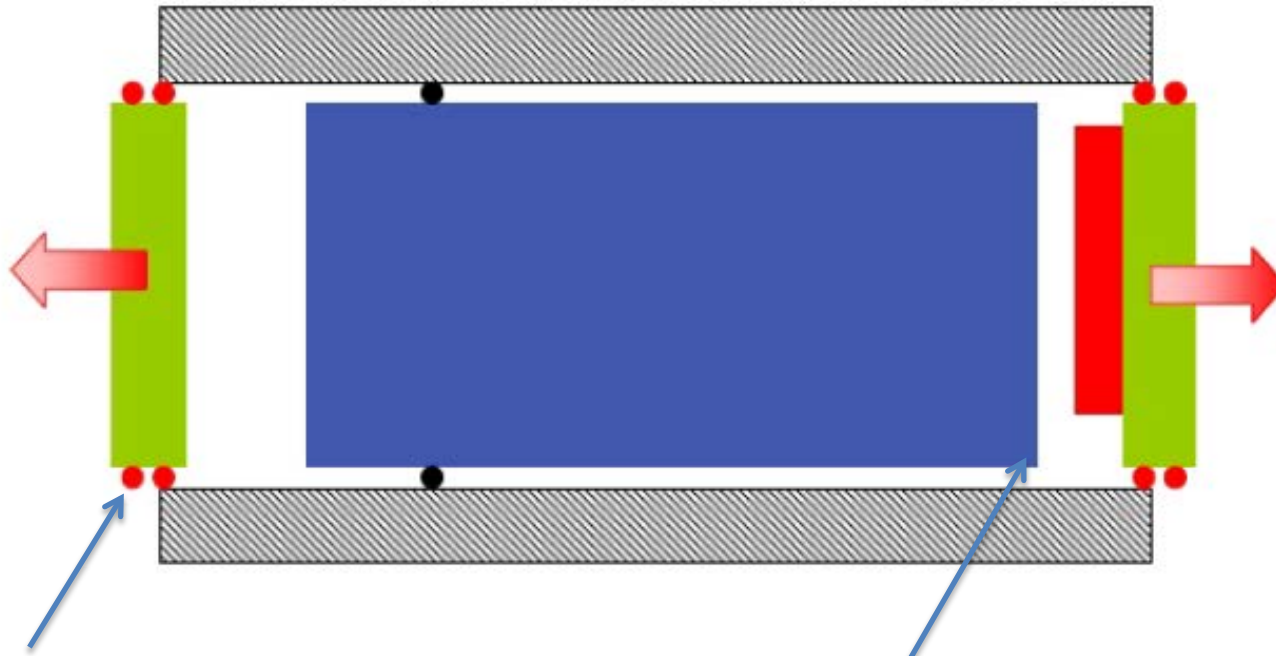
# Typical BCL compressor diagram

Head-flange / end-cover O-rings,  
used earlier was split design.

Compressor bundle with  
O-ring.
