Advancement in Vibration Monitoring Techniques to Identify and Prevent Motor Failures on MOL Pumps at QP Offshore

Isham Sudardjat
Reliability Engineer
QP Offshore Operations

Sankar Ganesh
Lead MDS Engineer
GE-Bently Nevada

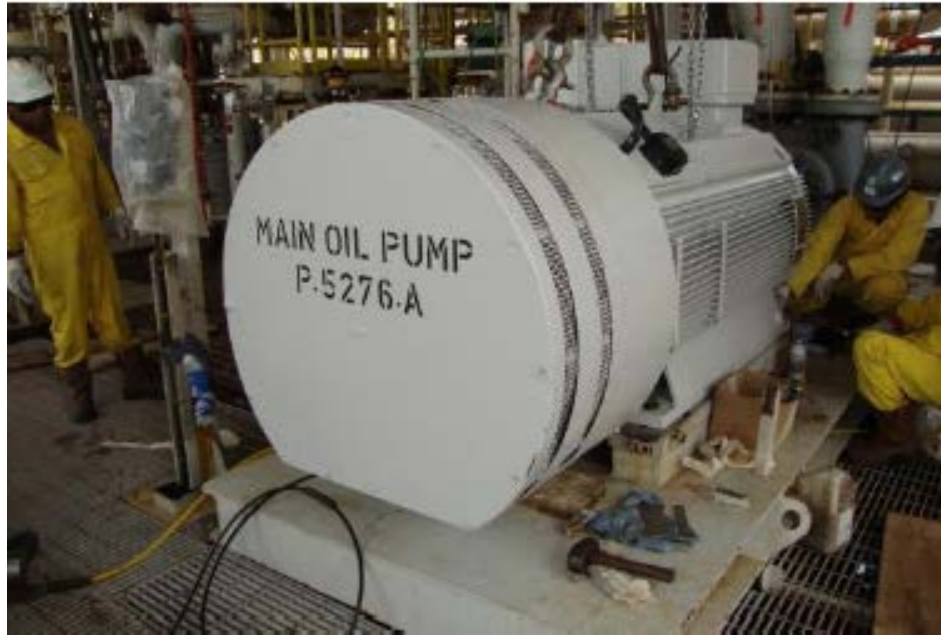
Machine Description

- **Motor - Induction type, 486 kW, 3300 Volts, 50 Hz, 2971 RPM**
- **Pump – Capacity 358 m³/hr**
- **Motor Bearings – Ball / Roller Bearings**
- **Pump Bearings – Radial sleeve, Thrust Ball Bearings**
- **Motor & Pump Assembly mounted on a common skid**
- **Baseplate Welded to Structural beams using pads**
