RIVER RESTORATION OF THE UPPER REACH OF THE SAN MIGUEL RIVER,  
COLORADO: A POST APPRAISAL GEOMORPHOLOGICAL ANALYSIS

A Thesis

JAMES A. S. HOOTSMANS

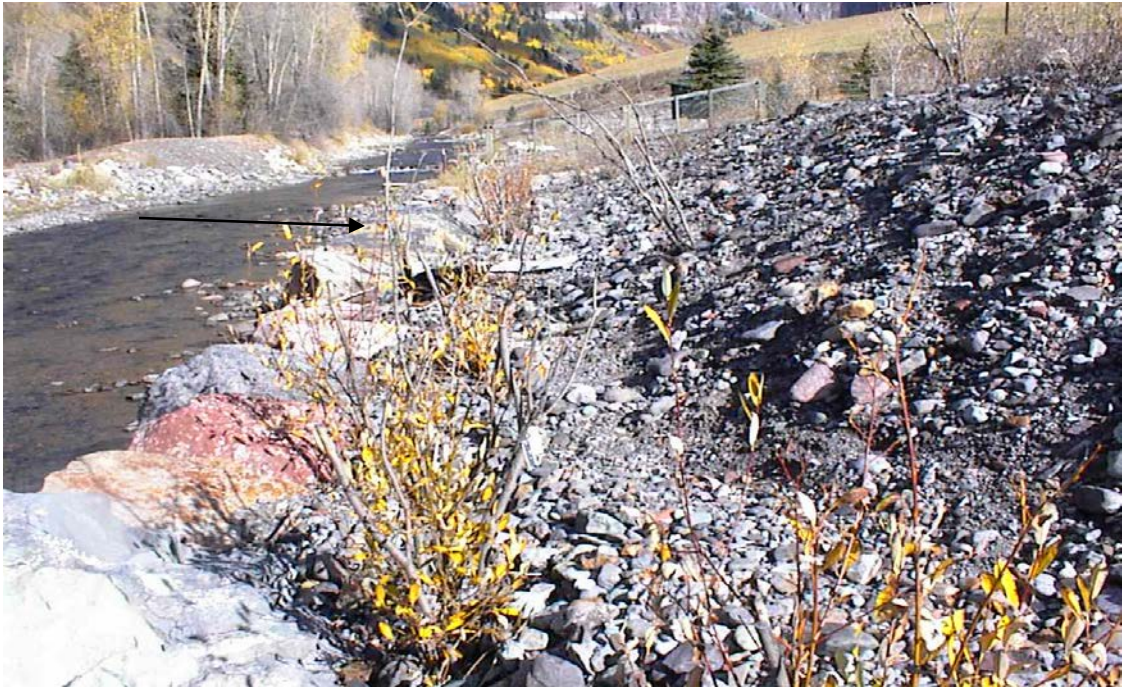
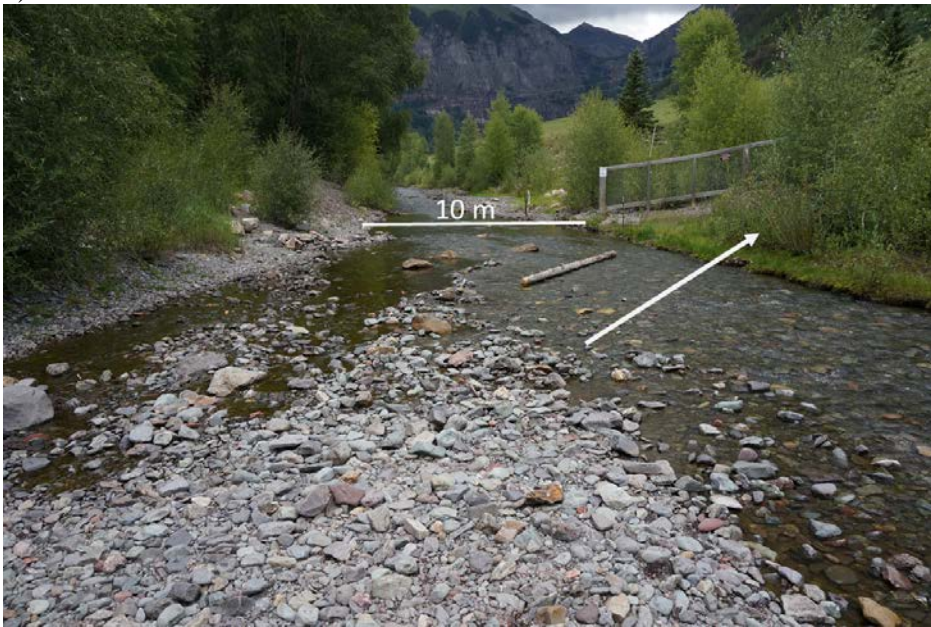
**Figure 38: Upper San Miguel South Side Riparian Area (HA1), a) looking east, October 2003, b) looking east, August 2014. Arrow points to place of comparison. The river at the fence line has a bank-to-bank width of ~10 m for scale.**

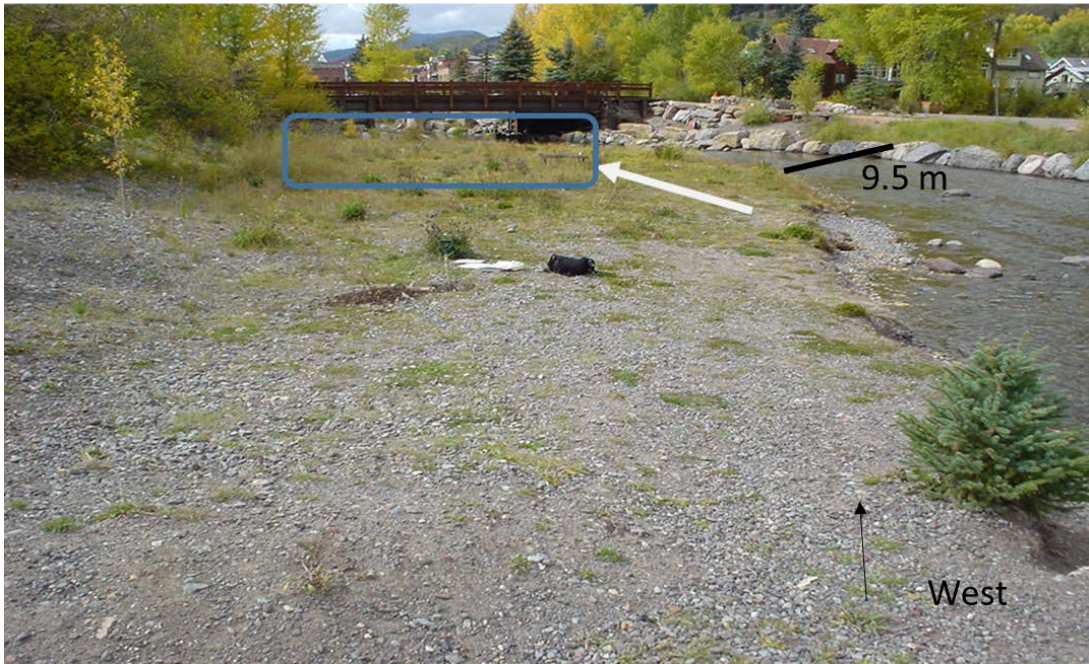
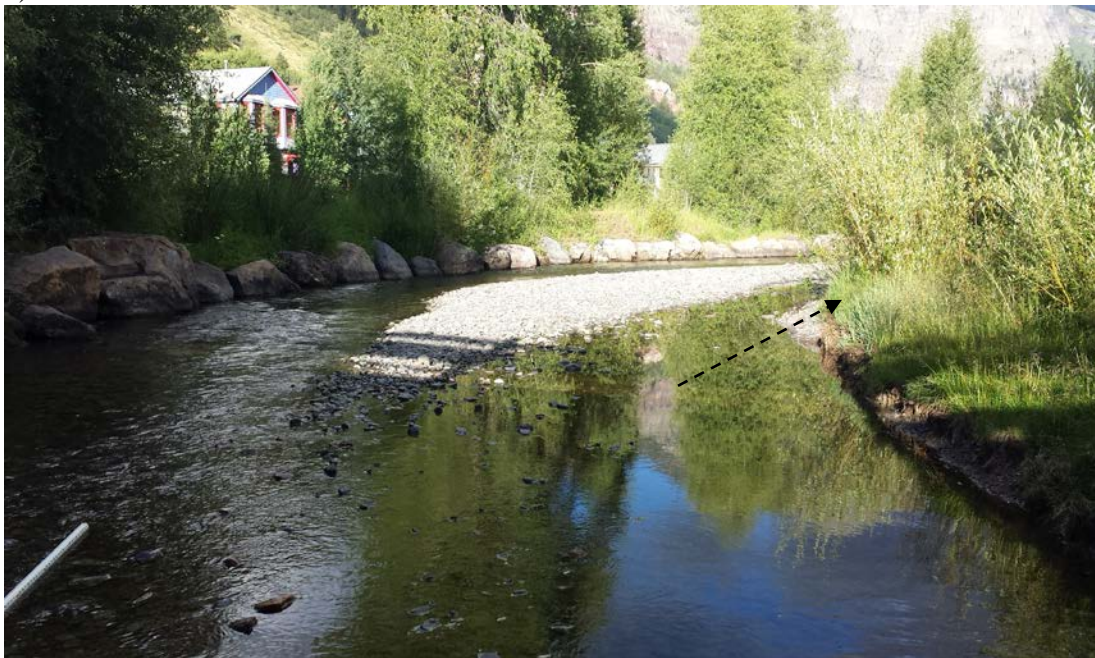
**Figure 39: Town Park Parking Lot South Side, HA18 (upstream of Town Park/Maple Street Vehicle Bridge), a) looking west towards bridge September 2004, b) looking northeast away from bridge August 2014. Arrow points to place of comparison. The bank-to-bank width at the bend is ~ 9.5 m.**

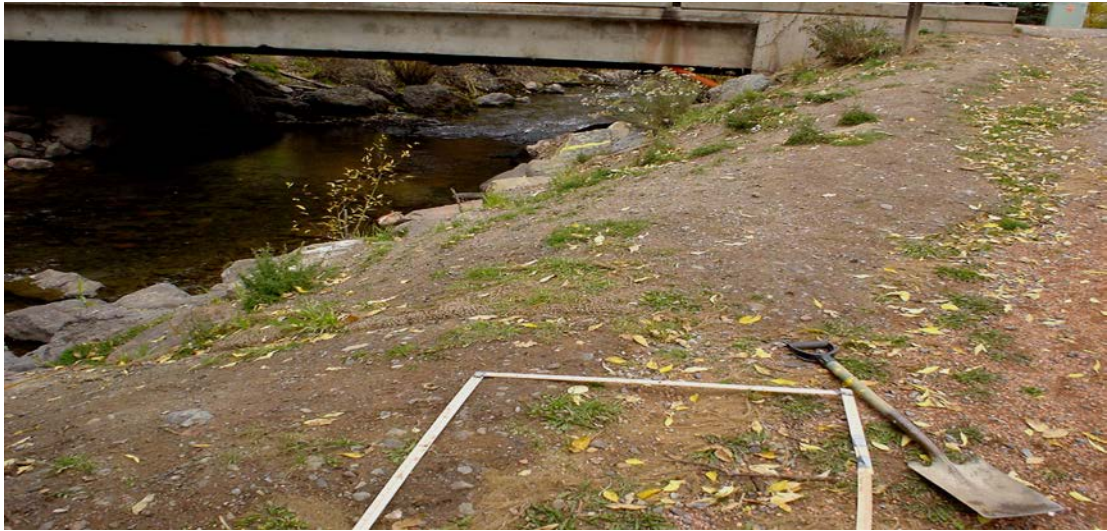
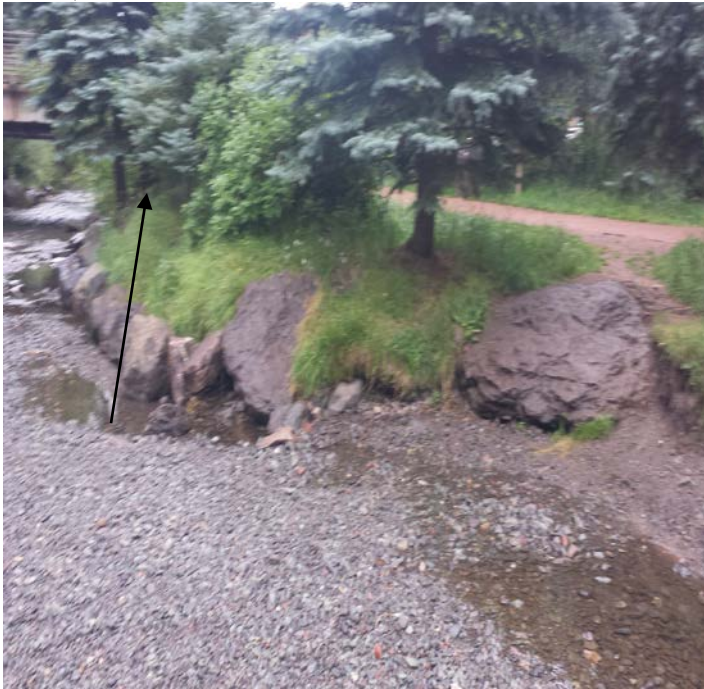
**Figure 40: Pine Street Northeast Riparian Area between river trail and river upstream of bridge (HA30), a) looking southwest, September 2004, b) looking southwest towards Pine Street Bridge, August 2014. Note an abundance of grass and shrubs 14 years later.**

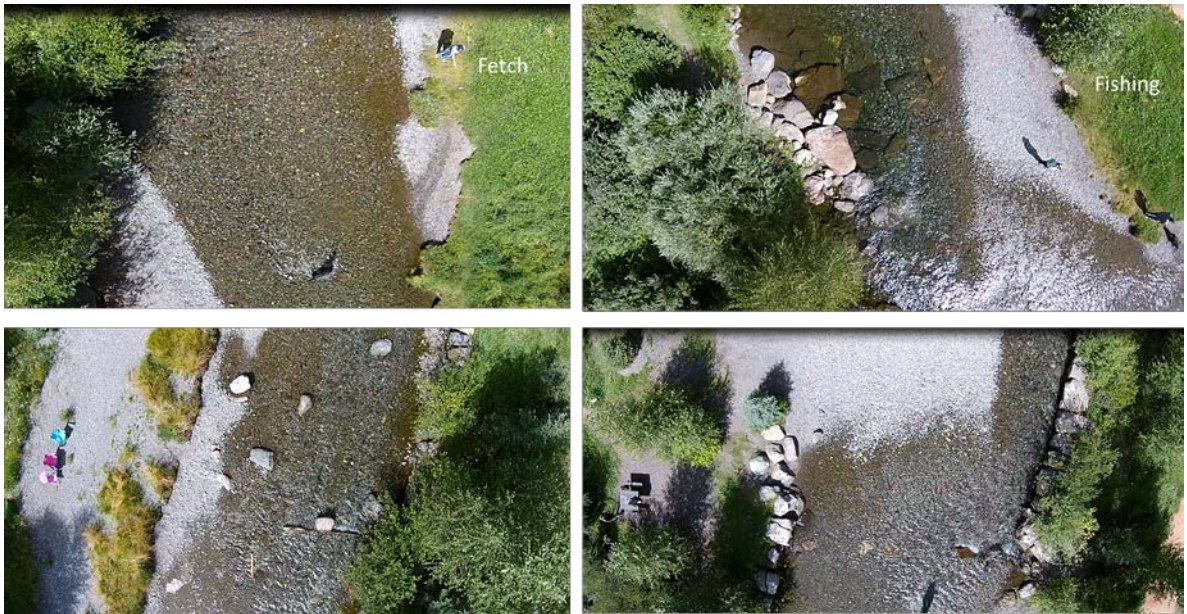
**Figure 42: UAV Imagery (~ 18 meters elevation) depicting human use of river: Person playing with dog in upper left; Fishing in upper right, lawn chairs in lower left; and picnic in lower right. People, chairs and tables are used for scale.**

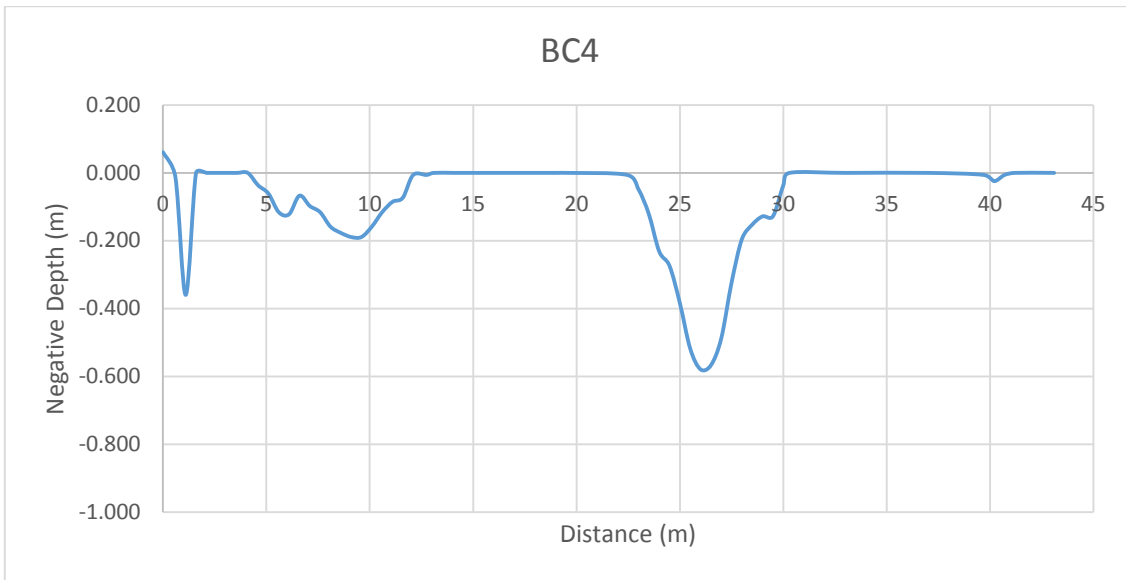
Figure A4: Channel bed geometry at waypoint BC4 (N 37°56.080, W 107°48.213), at the confluence of Bear Creek and San Miguel River. This is the location of the Instream Sedimentation Basin.
