THE HISTORY OF GALVESTON'S CONCRETE SHIPS

A Thesis

DOROTHY ANNE ROWLAND

December 2018

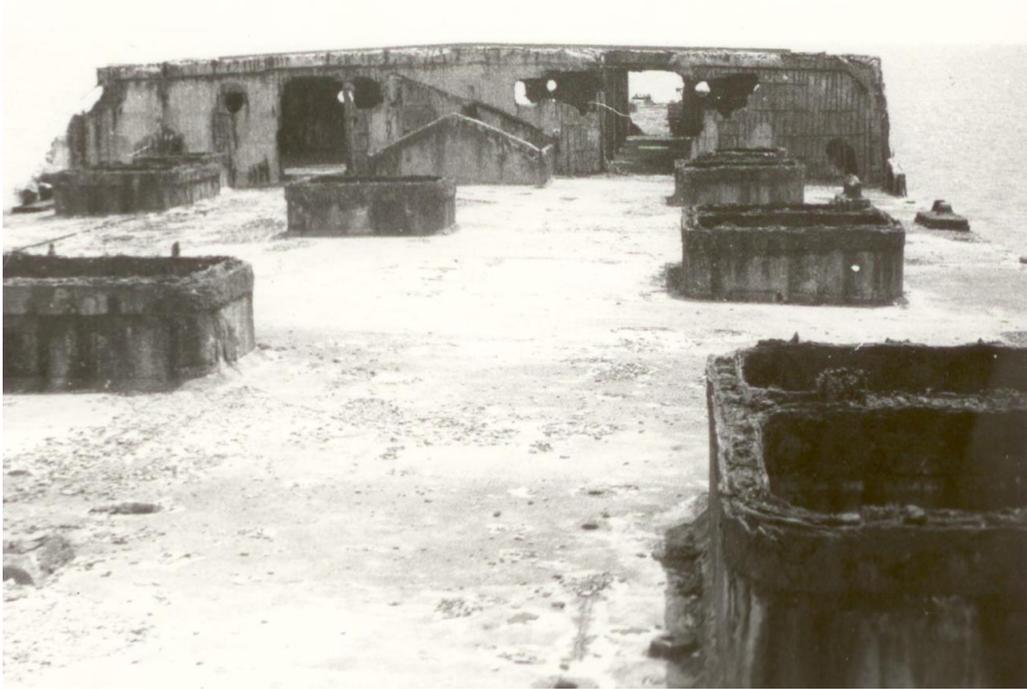
Figure 12. Deck of *Selma* facing aft. Reprinted with permission of Corpus Christi Public Libraries .¹⁰⁰

Figure 12 was taken from just behind the foredeck looking aft on the port side. The deck is in relatively good shape, but the tops of the hatches are showing signs of deterioration. The concrete in these areas still appears to be in good condition with only a few areas where there might be the reinforcing steel showing. In much worse condition than the deck, the superstructure amidships (where the bridge was located) is still standing, but the bulkheads have chunks missing around the doorways and the reinforcing steel is visible.

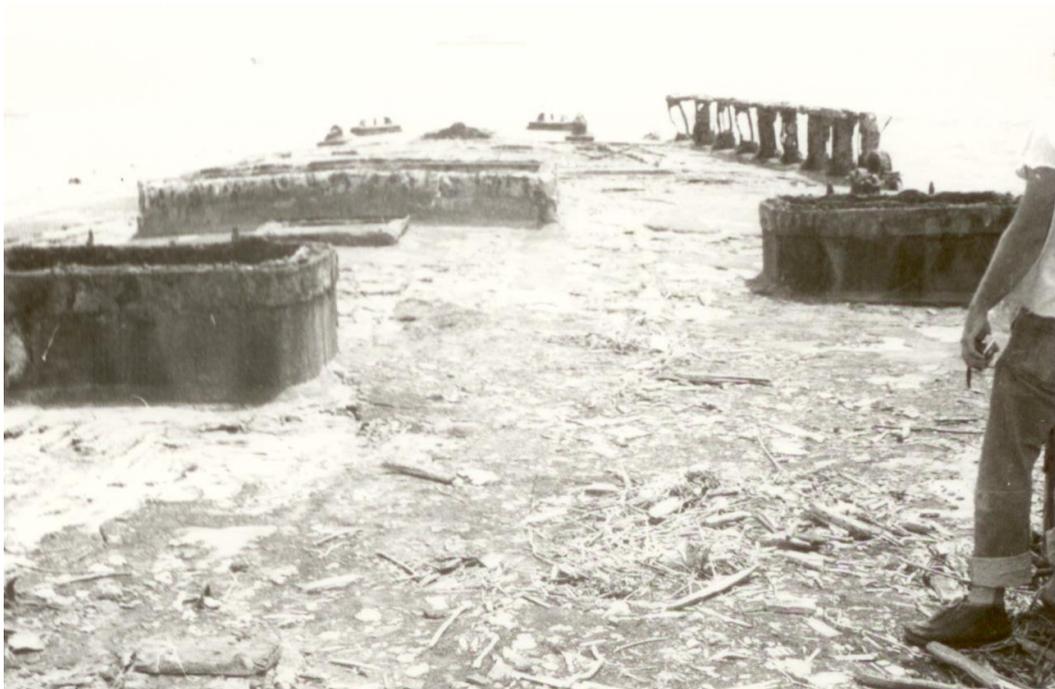
Figure 13. Stern deck of *Selma* from amidships. Reprinted with permission of Corpus Christi Public Libraries.¹⁰¹

The condition of the deck is very hard to determine in Figure 13, since there is a large amount of debris covering it. It seems to be in decent condition as the reinforcing steel is not obviously exposed. The clearest area of deterioration is the remainder of rail that once encompassed the stern of the ship.

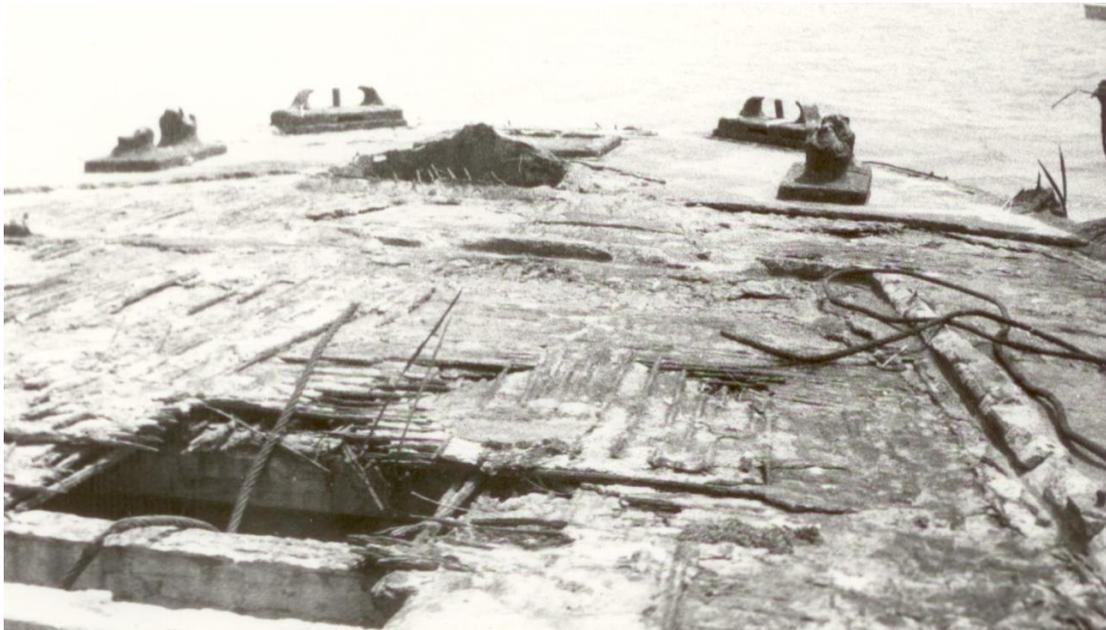
Figure 14. Stern deck of *Selma*. Reprinted with permission of Corpus Christi Public Libraries.¹⁰²

Figure 14 of the stern shows a grimmer image than the previous ones. The deck in the stern is in much worse condition than the forward deck. This section of the deck has almost no portion that is not damaged, with both holes and visible steel reinforcement. There are two sets of bollards visible, both with tops broken off, but the two chocks still appear to be in working order.

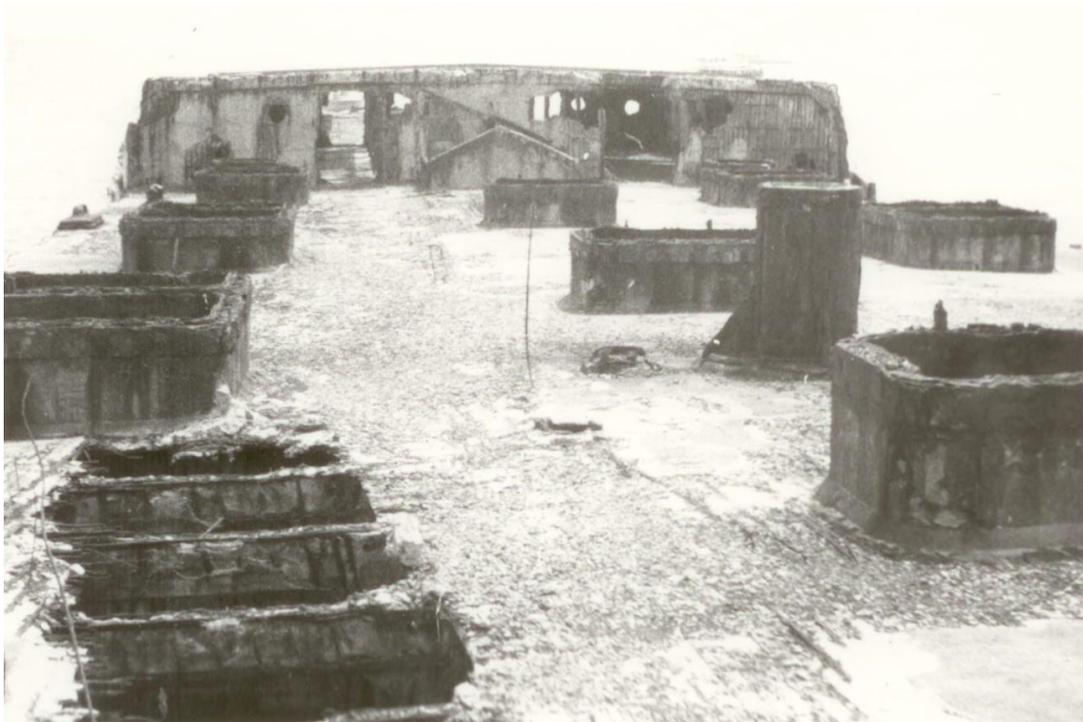
Figure 15. Deck of *Selma*, view aft. Reprinted with permission of Corpus Christi Public Libraries.¹⁰³

In this image of the starboard side (Figure 15), the deck is in much worse condition than on the port side. The reinforcing steel is showing though almost everywhere and there is a large hole in the deck exposing five beams. Interestingly, the starboard side of the upper structure is in much better shape than the port. Only one section of concrete is missing and almost none of the reinforcing steel is visible in this area.

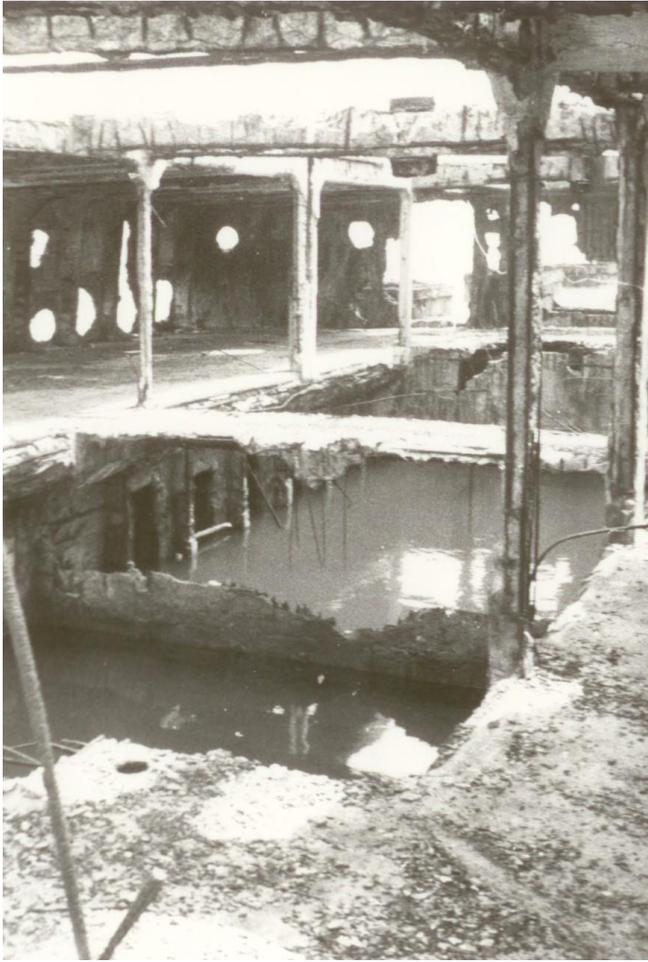
Figure 16. Inside *Selma* superstructure. Reprinted with permission of Corpus Christi Public Libraries.¹⁰⁴

Figure 16 shows a considerable amount of damage within the central superstructure. A section of the deck is missing, part of the bulkhead is gone, and reinforcing steel is visible. This is the area above the engine room, and it is possible the damage occurred when fittings were removed prior to scuttling. There was also damage

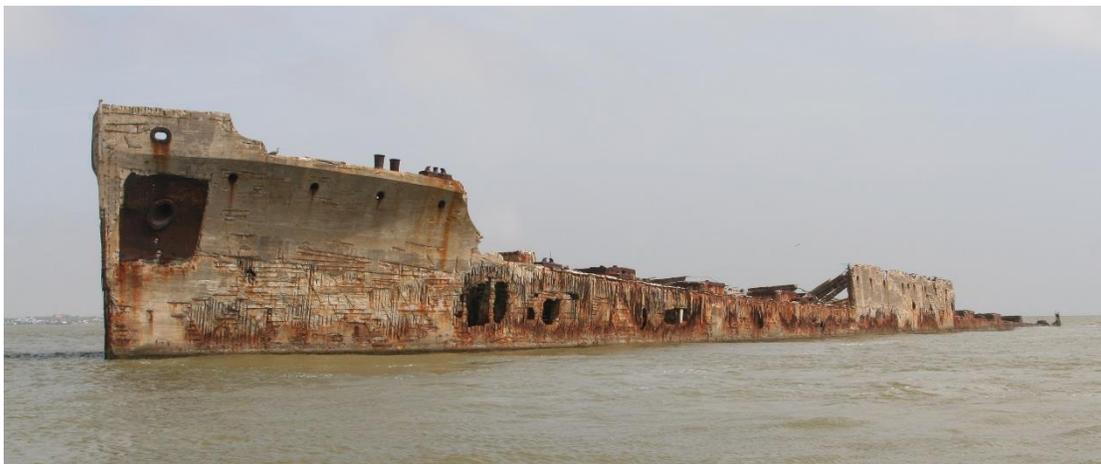
Figure17. View of *Selma* from port side, 2007. Reprinted with permission of Amy Borgens.¹⁰⁶

The hull clearly shown in Figure 17 shows extensive erosion and collapse from water and wave action. The degradation of the metal is also quite obvious with rust stains running down the hull under the metal inserts. *Selma* is going to pieces.

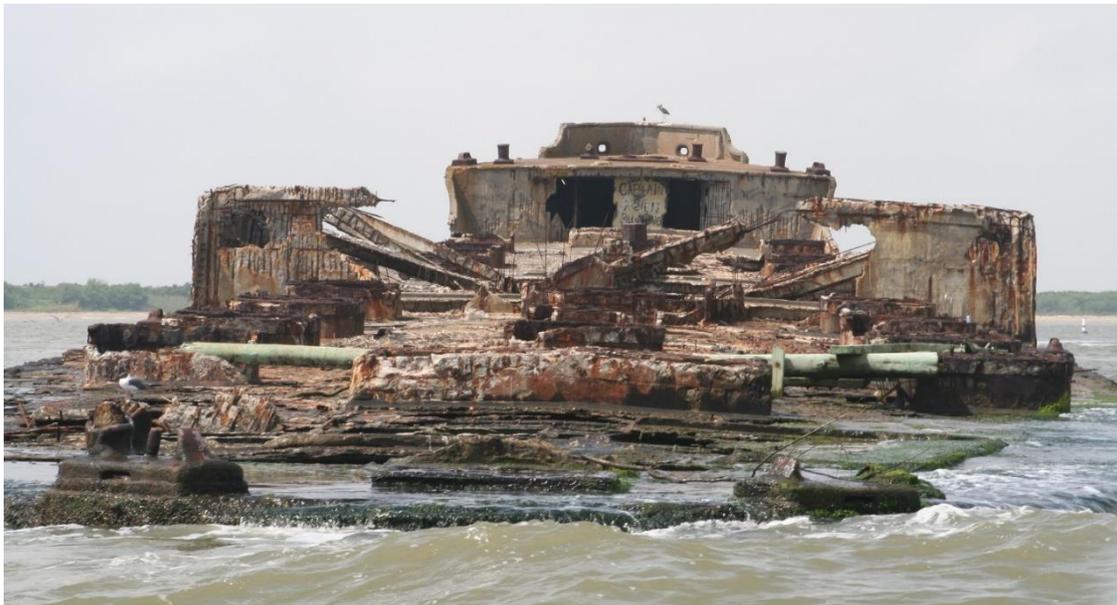
Figure 22. *Selma* from the stern, 2007. Reprinted with permission of Amy Borgens.¹¹¹

Figure 22 highlights the same areas as the previous photos, but shows additional details. The deck is clearly in worse shape than in the earlier photos. The back deck is

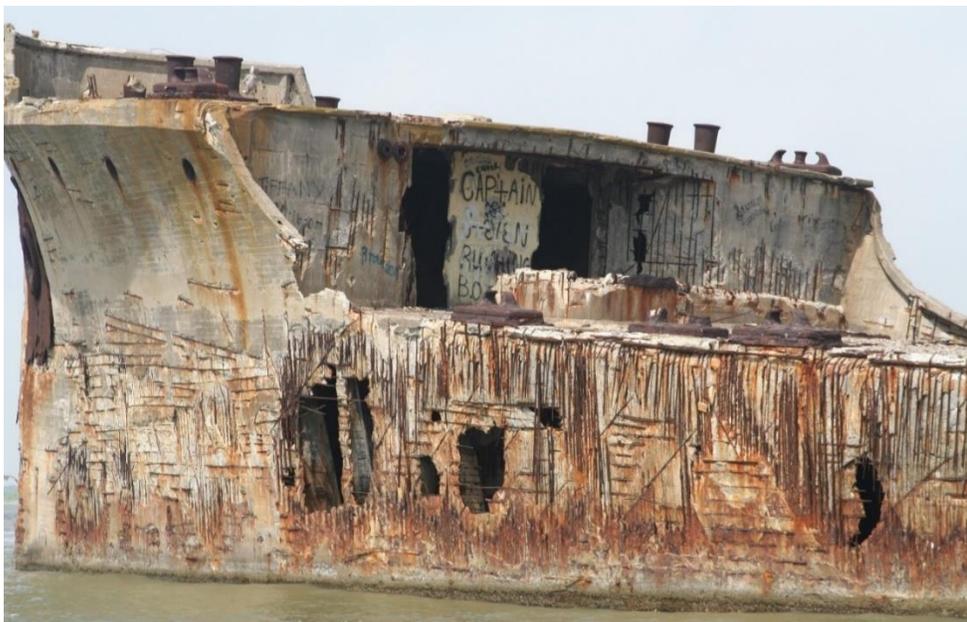
Figure 24. *Selma*, bow from port side 2007. Reprinted with permission of Amy Borgens.¹¹³

Figure 24 shows the aft bulkhead of the foredeck. The condition of the concrete above the wave action is still good. The metal bollards and chocks on the raised foredeck are in much better condition than those on the main deck.

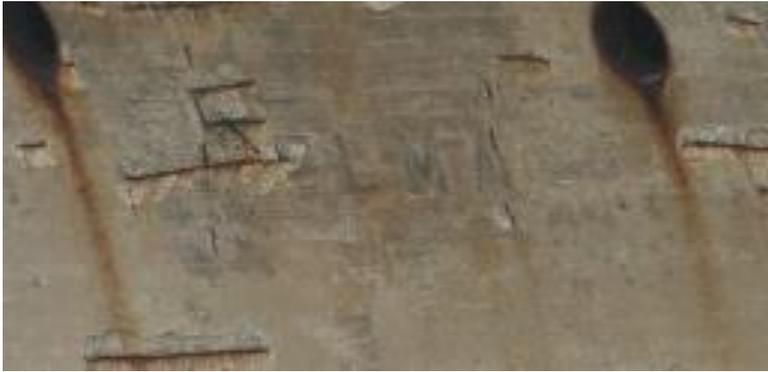
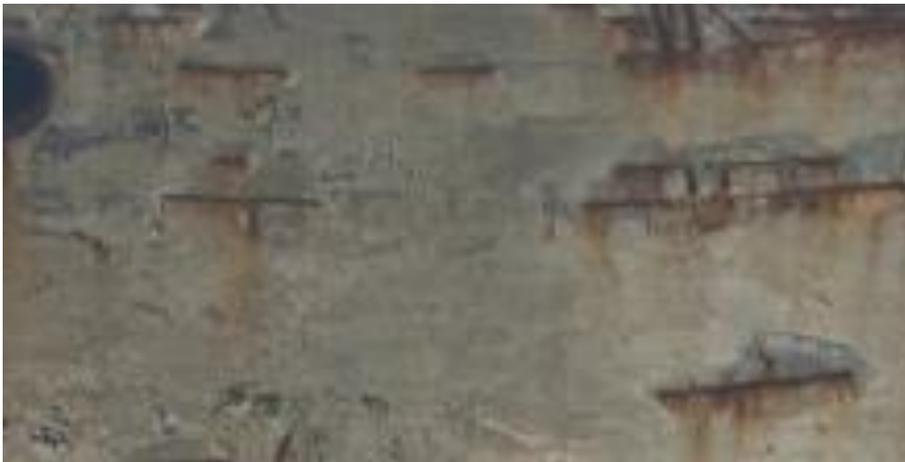
Figure 25. Close up of *Selma* name port, 2007. Reprinted with permission of Amy Borgens.¹¹⁴

Figure 26. Close up of *Selma* name starboard, 2007. Reprinted with permission of Amy Borgens.¹¹⁵

In Figures 25 and 26 'ELMA' is still readable on the port side and 'ELM' still readable on the starboard side. An image facing the bow of the ship (Figure 27) provides

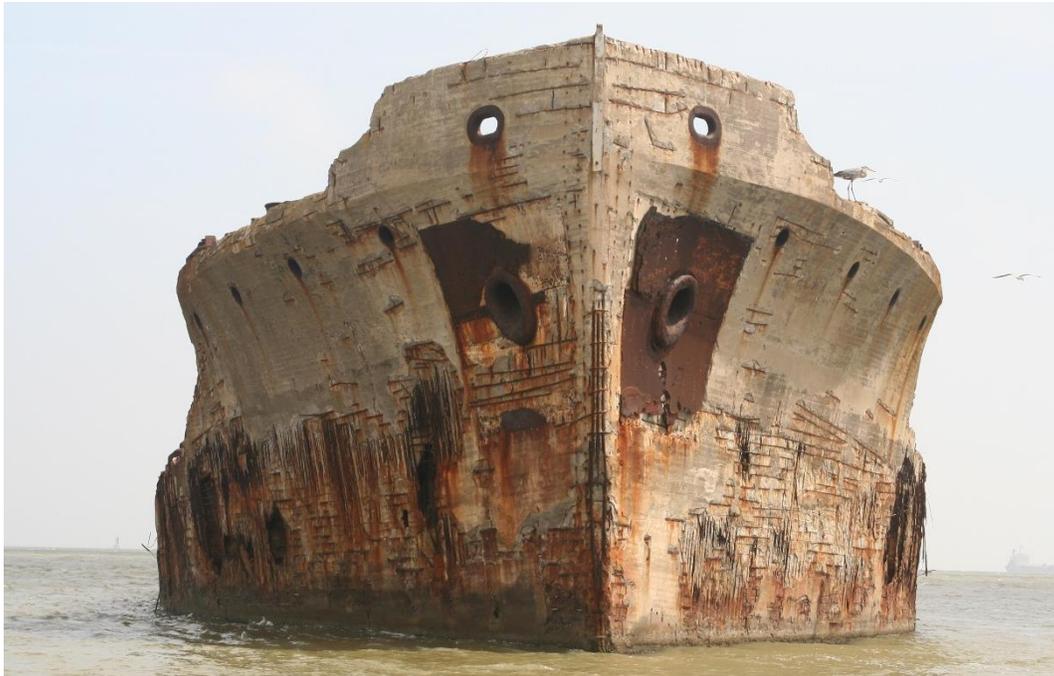
a good position to see how regular contact with the water has deteriorated the lower hull of *Selma*.

Figure 27. *Selma*, viewed from bow, 2007. Reprinted with permission of Amy Borgens.¹¹⁶

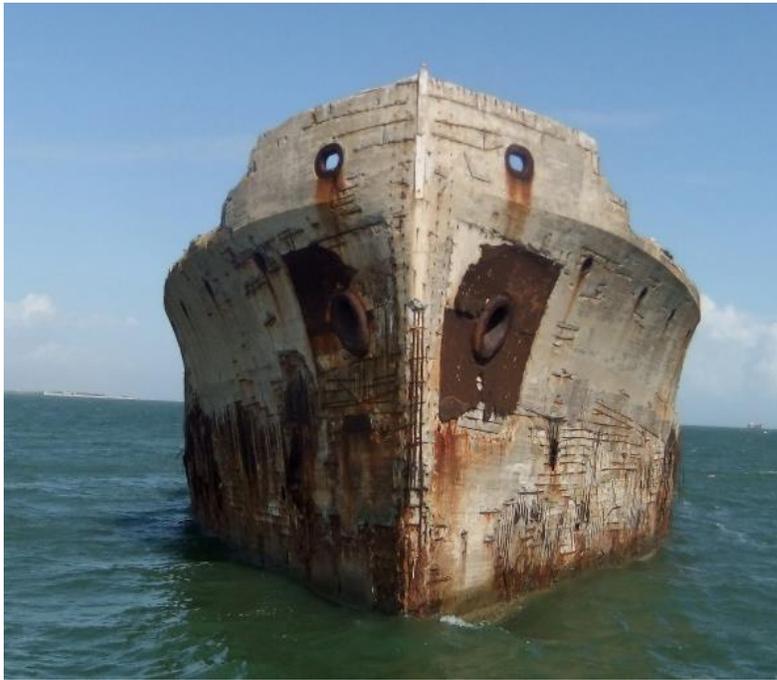
Figure 28. *Selma* viewed from bow, 2012.¹¹⁷

Overall, the fore of *Selma* looks remarkably unchanged from the 2007 to 2012 photo. The main difference is on the port hawsepiper bolster plate, where the upper corner is now missing. The area affected by the wave action still seems to be at approximately the same height. From this angle there are no obvious major changes in the condition of *Selma*.

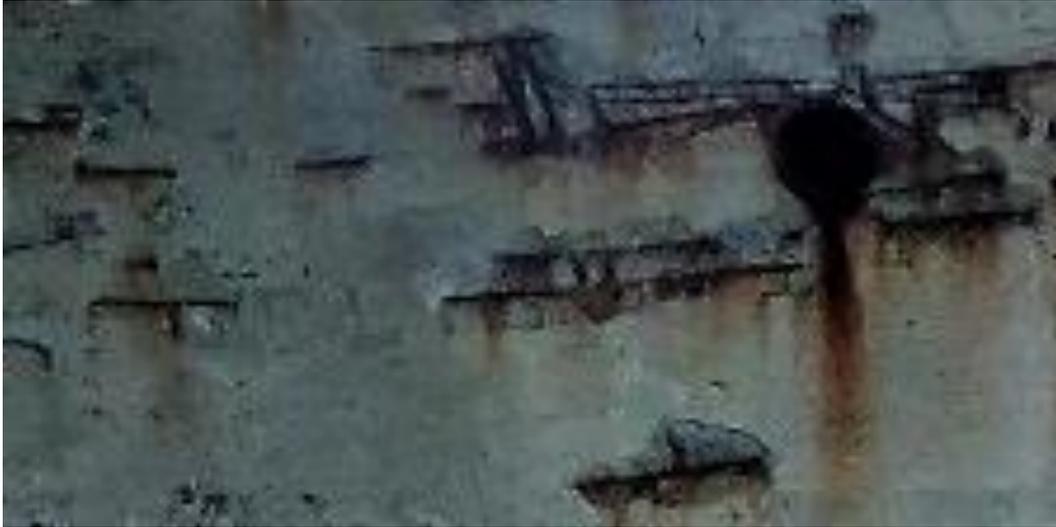
Figure 29. Views of ship's name from starboard, 2012.¹¹⁸

The image of the ship's name in Figure 29 looks very similar to Figure 28, but only 'EL' is still visible. The reinforcing steel also appears to be in much worse condition with the rust much more apparent.

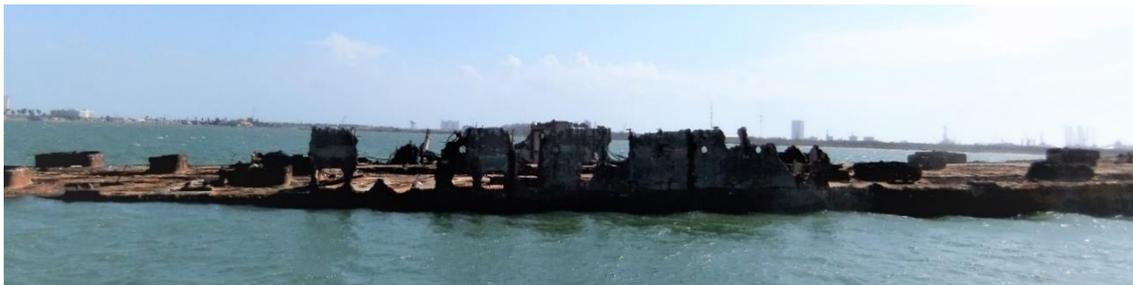
Figure 31. View of *Selma* amidships port side, 2012.¹²⁰

Figure 31 shows a significant change in the condition of *Selma* amidships. In the earliest photos (see Figures 12, 15, and 16) the side of the island superstructure was largely intact to its upper support beams. In 2007, the sides were still standing with some sections of concrete missing and the forward and after bulkheads largely gone. In 2012, the walls are clearly falling apart with large holes riddling the structure.

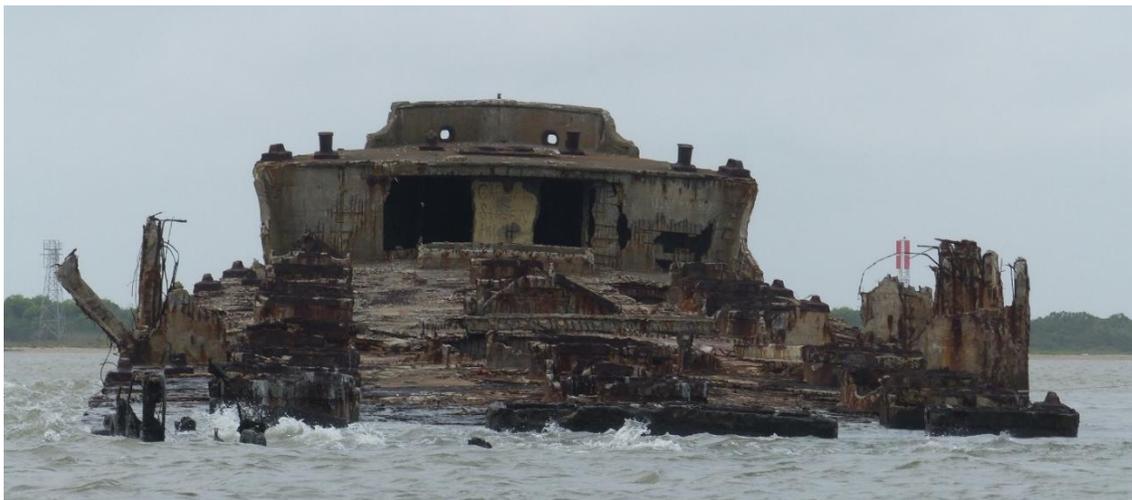
Figure 32. View of *Selma* from stern, 2018.¹²¹

Figure 32 shows the good and the bad. The raised foredeck still appears to be holding together, but the rest of *Selma* looks more like what would be expected from a ship that has been sitting in the water for ninety-six years. As seen in the 2012 photos, the stern of the ship is settling further under the water. There is more of the reinforcing steel showing and the opening in the foredeck bulkhead has gotten larger.

As seen in both Figures 32 and 33, there is still one remaining piece of stern railing standing, although it is looking less sturdy than in earlier photos. The hatch coamings are also showing significant wear with almost all missing concrete around the top. The stern of *Selma* is clearly affected by its contact with the water.

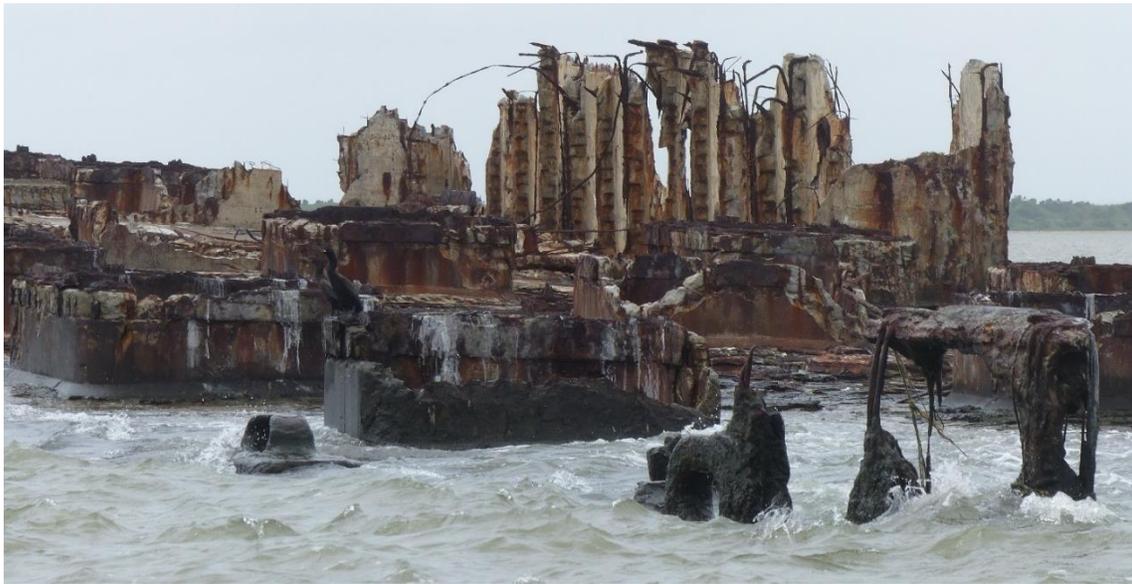
Figure 33. View of *Selma* stern to amidships from the port side, 2018.¹²²

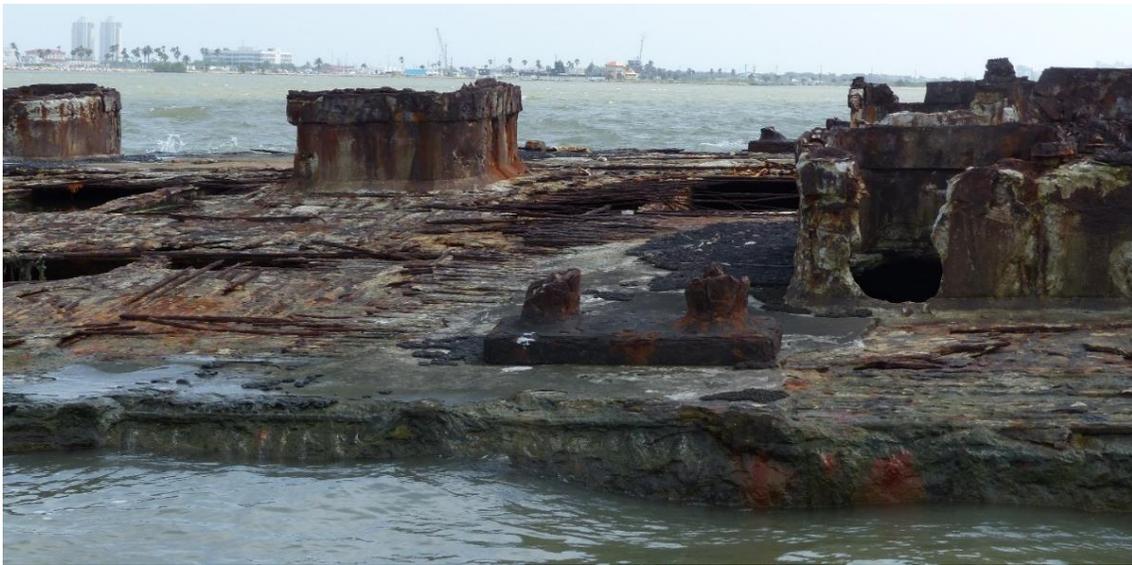
Figure 38. View of *Selma*, amidships deck, 2018.¹²⁷

Figure 38 shows the large holes in the deteriorated deck. The original surface of the concrete is gone. The metal deck fittings in this photo are also in poor condition with the bollards posts missing their upper ends.

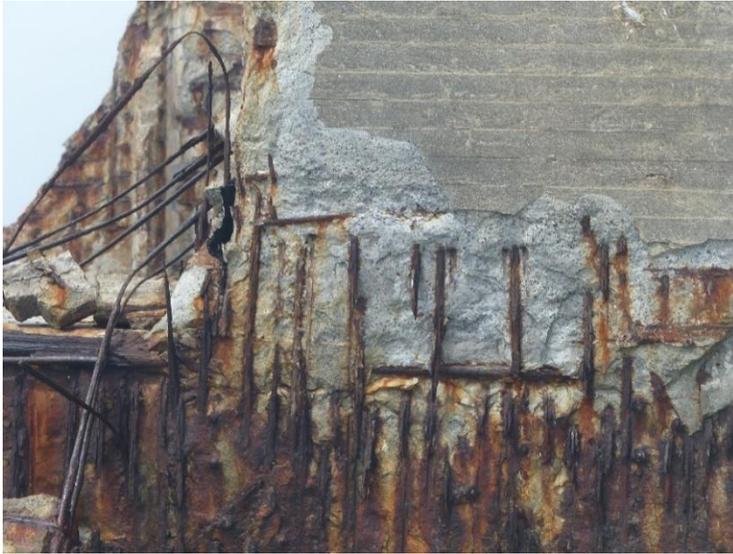
Figure 39. Close up of concrete on *Selma*, 2018.¹²⁸

Figure 39 indicates that in a few places the original surface of the concrete has survived, complete with impressions of the planks that formed the construction molds. In all of these images we can see that the deterioration of the steel inside the concrete is damaging the integrity of the hull as much or more than the actions of outside wave and currents.

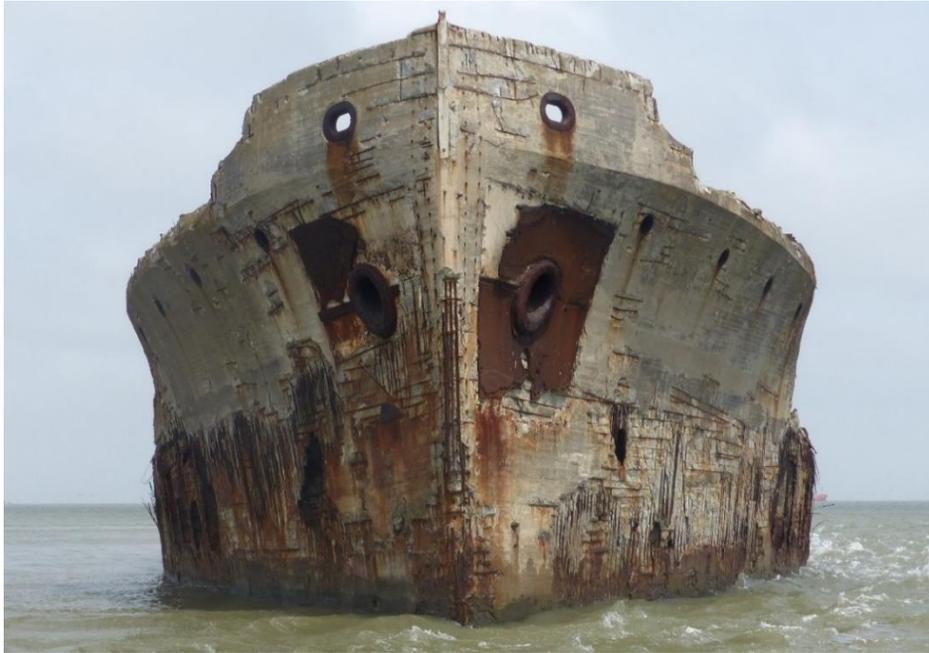
Figure 40. View of the bow of *Selma*, 2018.¹²⁹

As expected, the condition of *Selma* has deteriorated greatly over time, with the stern degrading at the fastest rate and the bow holding up longer (Figure 40). The ship has been exposed to many deteriorating factors such as storms, waves, currents, salt water, vandalism, and particularly the effects of iron corrosion causing the concrete to spall and check. The rate of degradation of *Selma* does not appear to be changing too much, but the areas with issues are only increasing. It is a large mass of concrete and steel, however, and even in its deteriorated condition, *Selma* will continue to be a landmark in Galveston Bay for many years to come.
