47TH TURBOMACHINERY & 34TH PUMP SYMPOSIA
HOUSTON, TEXAS | SEPTEMBER 17-20, 2018
GEORGE R. BROWN CONVENTION CENTER

MULTIDISCIPLINARY APPROACH TO FAILURE ANALYSIS OF TURBOMACHINERY COMPONENTS

Kirill Grebinnyk, P.E.

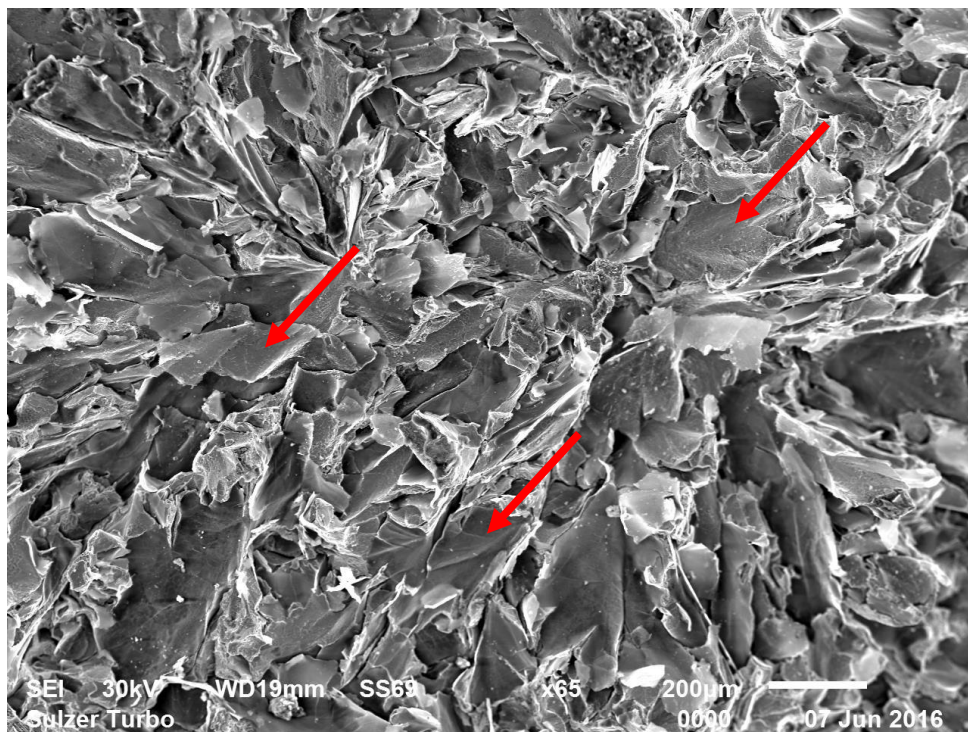
Brittle fracture may show cleavage features when examined with a scanning electron microscope. Figure 5 shows a sample SEM image of a cast part that failed in a brittle manner. The arrows in the figure point to some of the cleavage facets on the fracture surface.

Figure 5: SEM image showing cleavage fracture in a cast part used in a steam turbine.

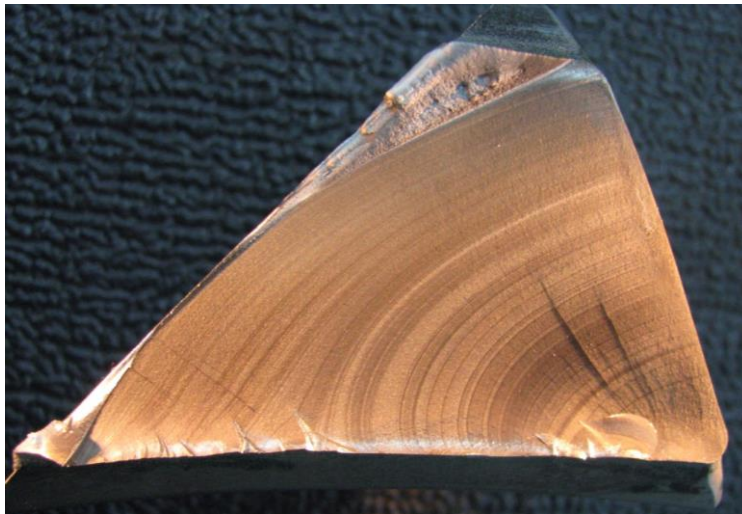
Typical fracture surface due to fatigue would be flat and featureless. It may exhibit “beach marking” as example shown in Figure 8. Beach markings can provide a good indication of where the fatigue initiated and propagated.

Figure 8: Fracture Surface of Blade Root Section Failed in Fatigue

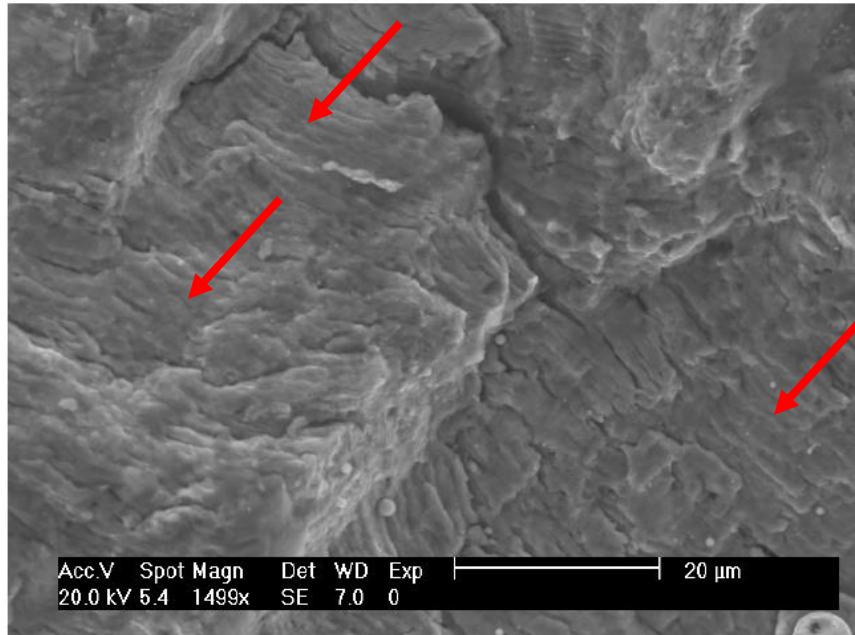
In some cases, SEM evaluation may show striations which are also evidence of fatigue mode of failure. Striations on a fracture surface of a failed compressor blade are shown as an example in Figure 9.

Figure 9: SEM Image of a Failed Compressor Blade Fracture Surface. Arrows point to some of the striations.

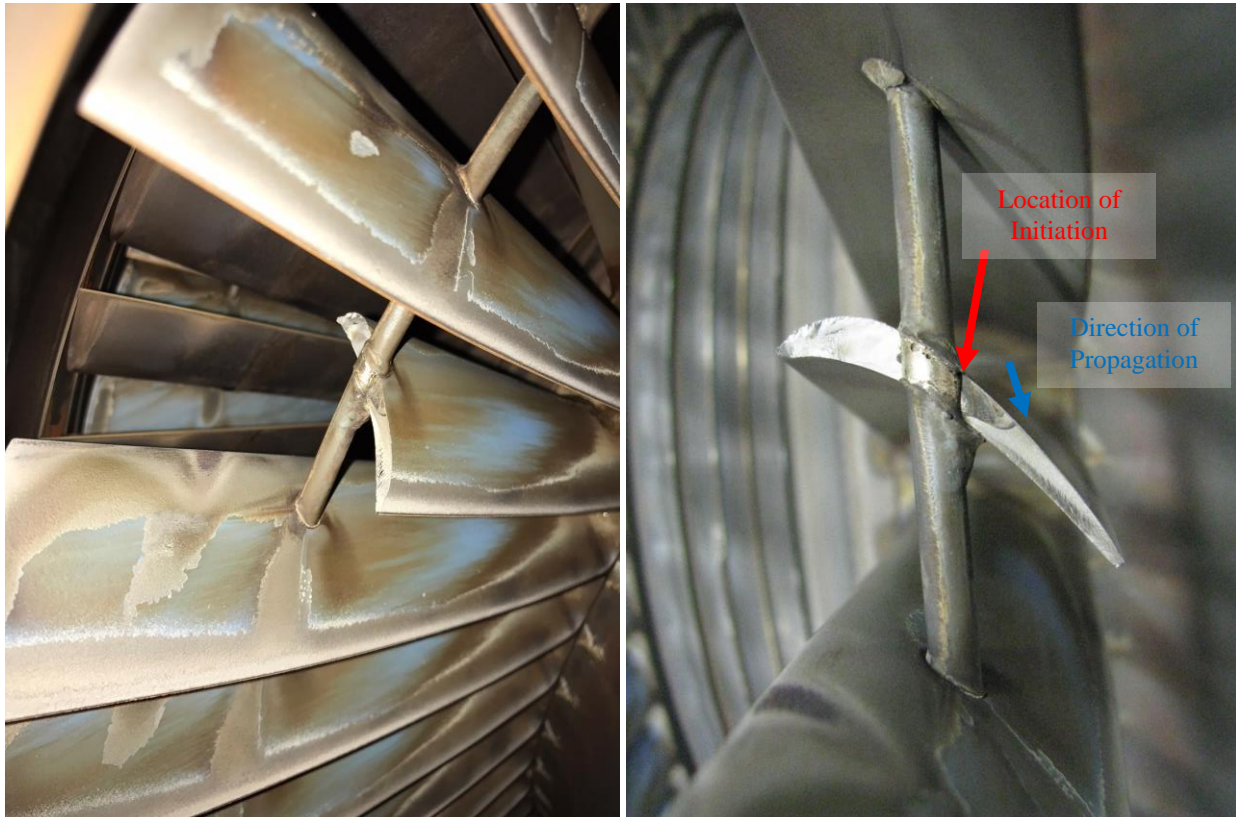
In addition to the design features, which may serve as stress concentrators (holes, fillets, notches), material conditions have an influence on the fatigue properties of a component. This includes the grain size, surface finish of the part, etc. An example of a steam turbine blade failure due to fatigue is shown in Figure 10. In this case, tie-wire hole in the last stage airfoil served as a stress concentrator (pointed by red arrow) and became the initiation location for the fatigue fracture. The crack propagated from the convex (suction) side towards trailing edge and concave (pressure) side of the airfoil, parallel to the direction indicated by the blue arrow.

Figure 10: Fatigue Failure of Steam Turbine Blade

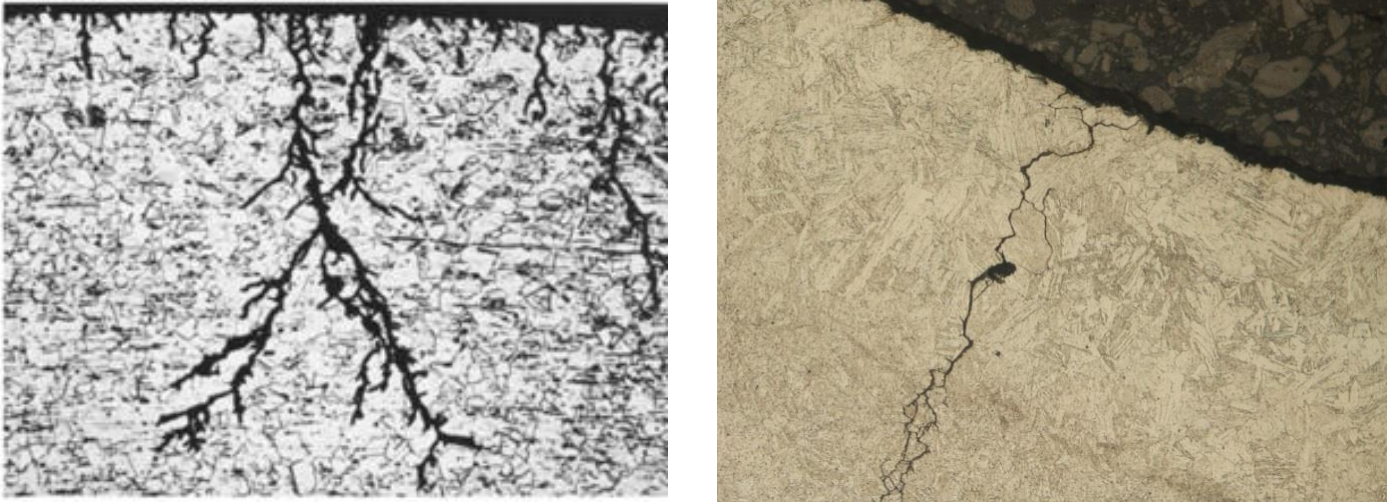
Stress corrosion cracking can occur in intergranular or transgranular fashion. Optical metallography through the crack would help to determine if the crack is transgranular or intergranular. Figure 12 shows examples of transgranular and intergranular cracks. In the figure on left, cracks are going through the interior of the grains in the micrograph, which is called transgranular cracking. In the figure on right, cracks are going along the grain boundaries in the micrograph, which is defined as intergranular cracking

Figure 12: Transgranular (left, Balan (2018)) and Intergranular (right, failed impeller studied by the authors) Stress Corrosion Cracking

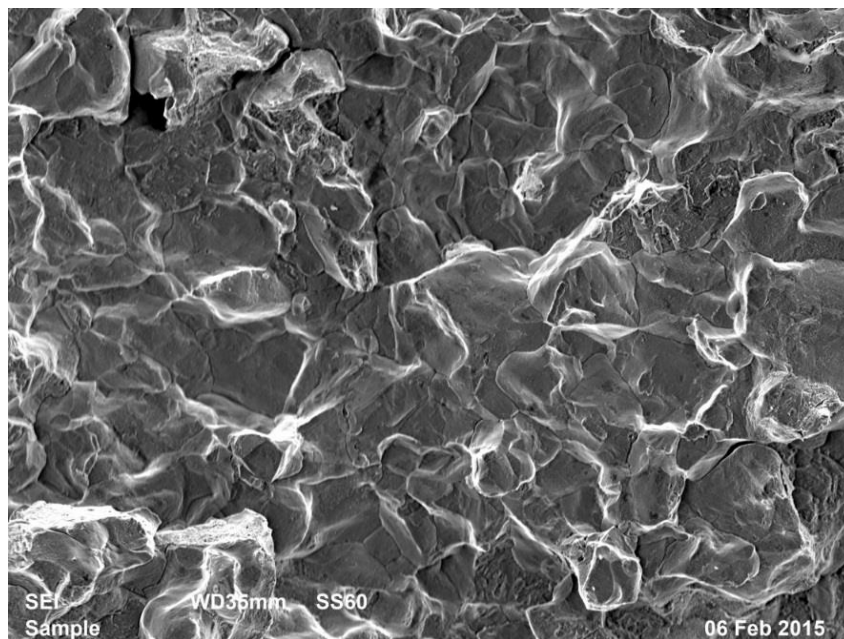
A surface with intergranular fracture would show different facets of grains as shown in Figure 13, which is an SEM fractograph of a cracked rotor. Facets of different grains can be seen. The failure had occurred along these facets of the grains.

Figure 13: Intergranular Cracking in Steam Turbine Rotor (Gowreesan and Grebinnyk (2017))

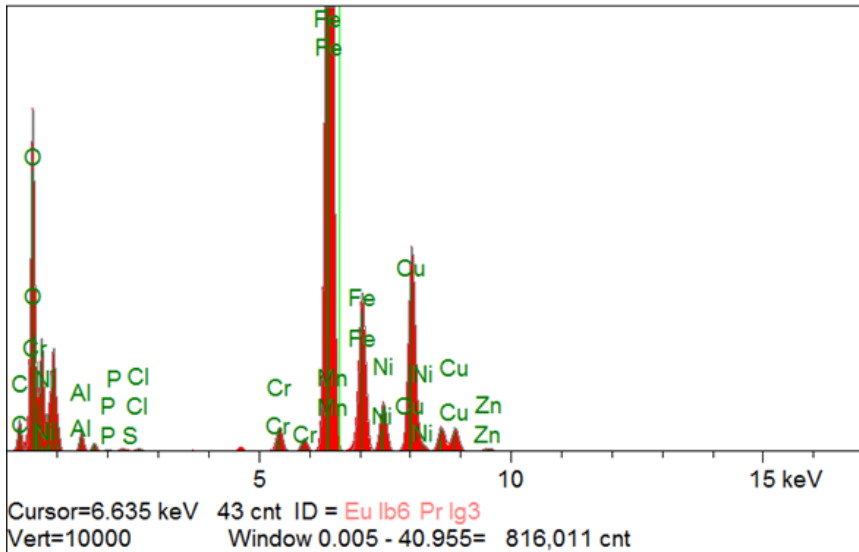
An additional confirmation of corrosion-related nature of a failure can be obtained by examining the fracture surface using Energy-Dispersive Spectroscopy (EDS). Presence of oxygen, chlorine or sulfur on the fracture surface is an indication of the part being subjected to corrosive environment during service. Figure 14 shows results of EDS performed on the fracture surface of a steam turbine shroud (base material 17-4PH). The fracture surface had all the evidence of SCC and EDS confirmed the presence of corrosion products. Excessive amount of oxygen (20%) in combination with chlorine indicates highly corrosive environment and unsatisfactory water treatment at the steam turbine's facility. Abnormally high copper content (15%) was explained by the end-user as being carried over with steam from the turbine condenser piping.

Element	Intensity (c/s)	Concentration	Units
C	7,054.0	7.530	wt.%
O	69,463.8	20.775	wt.%
Al	4,754.4	0.955	wt.%
Si	2,154.6	0.313	wt.%
P	667.6	0.080	wt.%
S	761.4	0.073	wt.%
Cl	1,012.6	0.089	wt.%
Cr	8,385.5	0.652	wt.%
Mn	3,693.4	0.368	wt.%
Fe	441,386.6	48.538	wt.%
Ni	18,849.8	3.083	wt.%
Cu	80,674.0	15.417	wt.%
Zn	9,768.5	2.127	wt.%
		100.000	wt.%

Figure 14: EDS Analysis of the Deposits on the Fracture Surface of a Steam Turbine Shroud

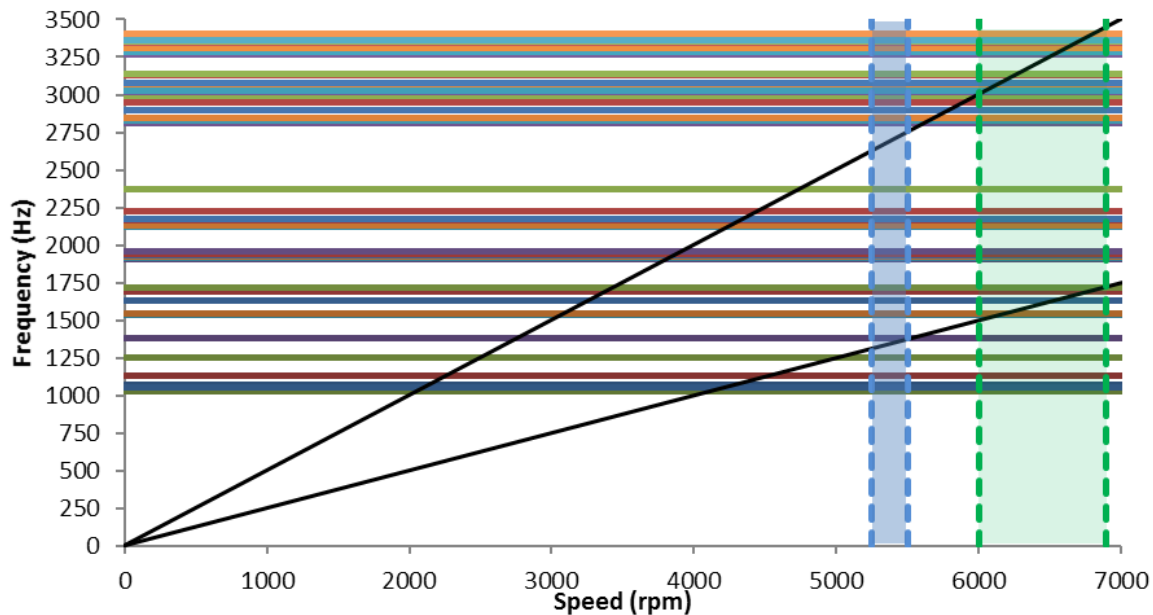
Figure 30: Campbell Diagram for the Impeller (Modified Design)

cost/time efficient for the constraints given. Instead, the solution was to machine cut-outs to the backplate of the existing impeller, typically referred as “scallops” (Figure 29). This allowed to change the impeller’s natural frequencies and to successfully move them out of the interference range. Campbell and SAFE diagrams for the redesigned impeller are shown in Figure 30 and Figure 31 respectively. Additionally, two safe operating speed ranges were defined within which the blower could operate at lower and higher speeds depending on the plant’s air demand. It was advised to the end-user to avoid operating outside of the speed ranges defined as safe.

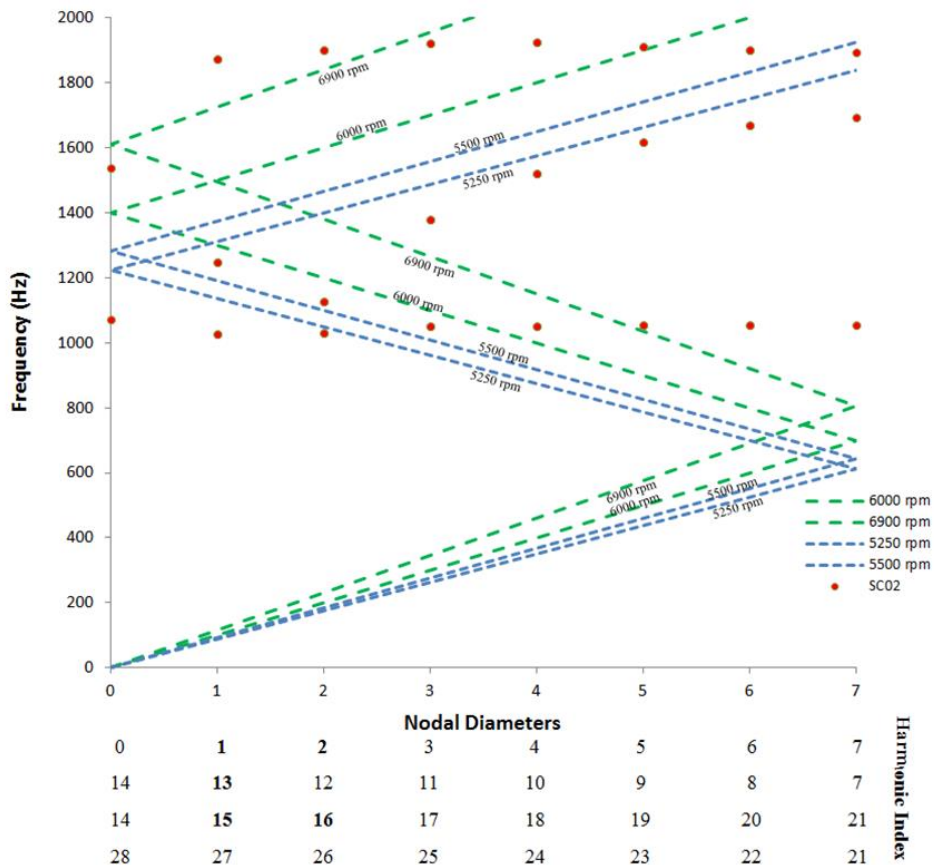
Figure 31: Interference (SAFE) Diagram for the Impeller (Modified Design)
