47TH TURBOMACHINERY & 34TH PUMP SYMPOSIA
HOUSTON, TEXAS | SEPTEMBER 17-20, 2018
GEORGE R. BROWN CONVENTION CENTER

Steam Turbine Reoccurring Rubs, Troubleshooting and Corrective Action

Patrick J. Smith
Brent M. Ziegler

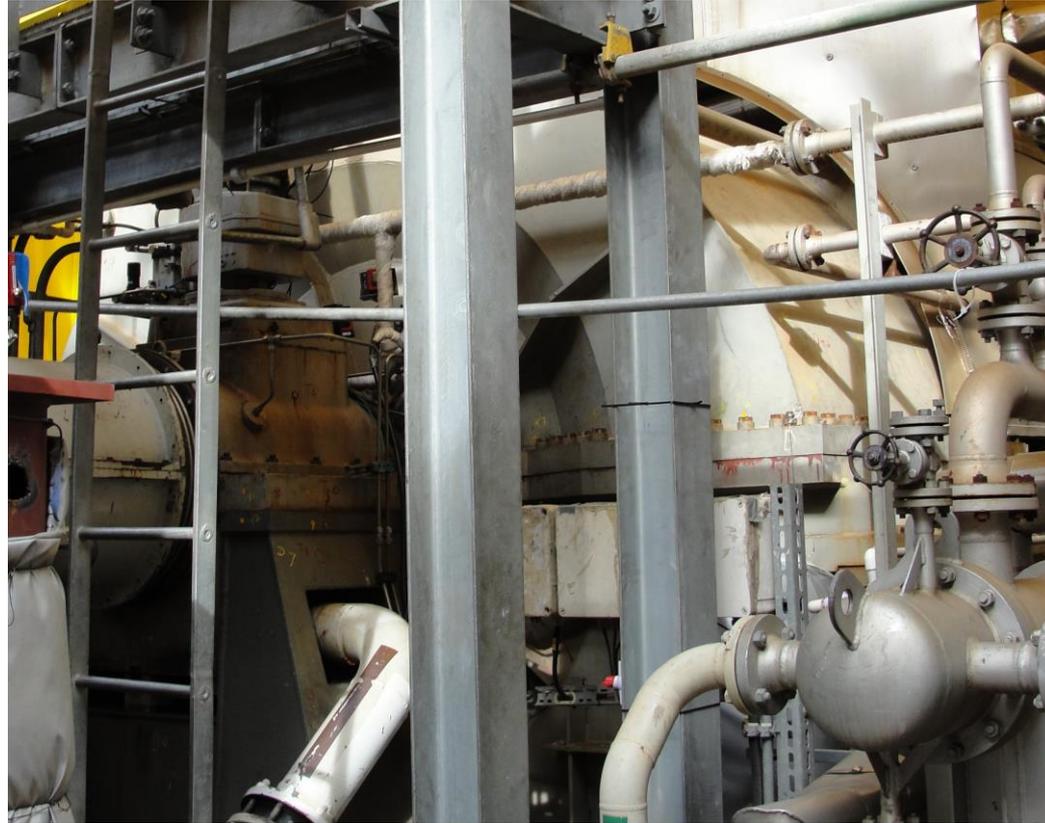
Exhaust End Bearing Housing

- Vibration increase is subsynchronous, 1x is stable.
- Significant exhaust end bearing pedestal response.
- Vibration excursions typical in the heat of the afternoon (>33C) and last several hours.
- Vibration excursions subside during infrequent rain.
- Sprinklers were rigged around the machine to create artificial rainstorms.
- Various sun shade configurations were tried.
