47TH TURBOMACHINERY & 34TH PUMP SYMPOSIA
HOUSTON, TEXAS | SEPTEMBER 17-20, 2018
GEORGE R. BROWN CONVENTION CENTER

*Preventing a Major Wreck on a New Reciprocating
Compressor: The importance of commissioning testing*

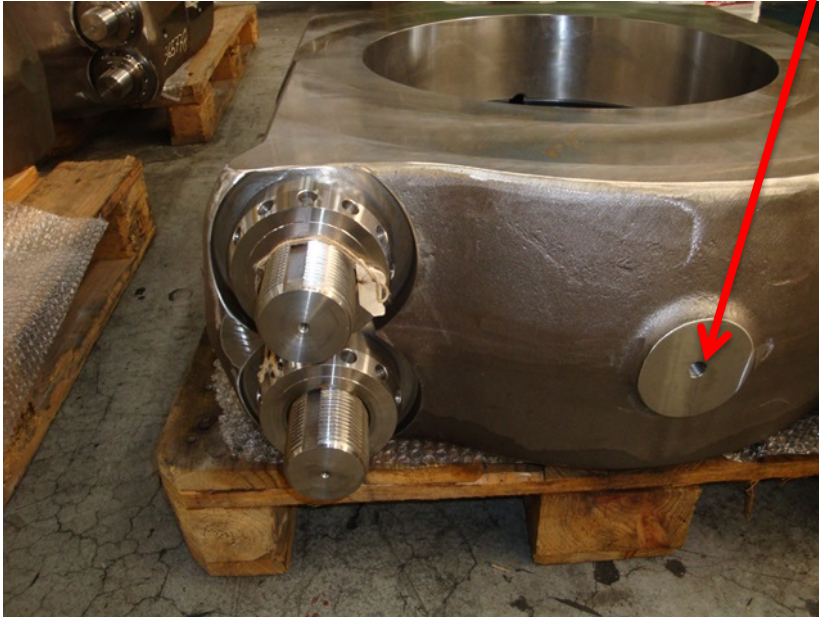
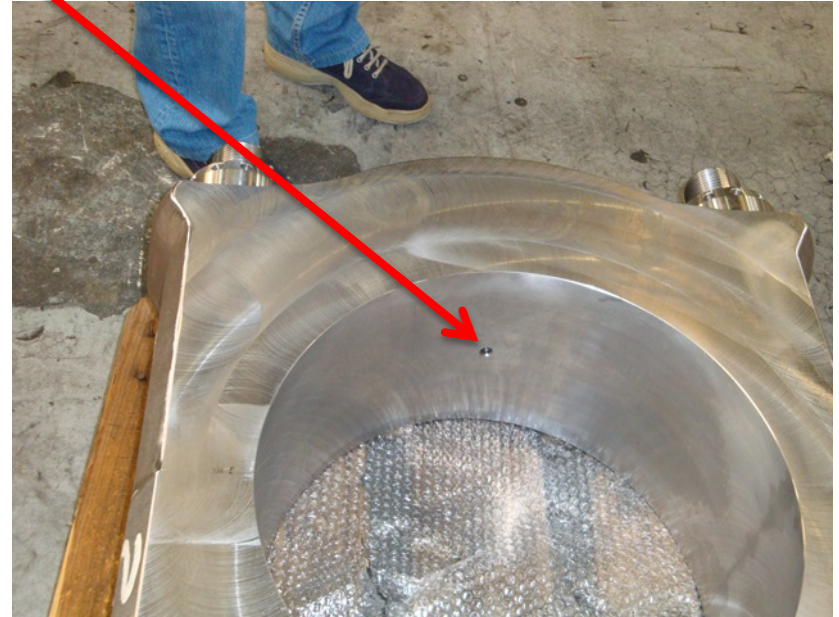
Location of Temperature in Connecting Rod Cap

Temperature Sensor Location

- Protection/Monitoring system was active and alarmed during the test
- Debris Entered the bearing and embedded into crankshaft
- Location of temperature sensor was sufficient to measure the temperature rise
- Debris was removed and bearings replaced with out a major failure

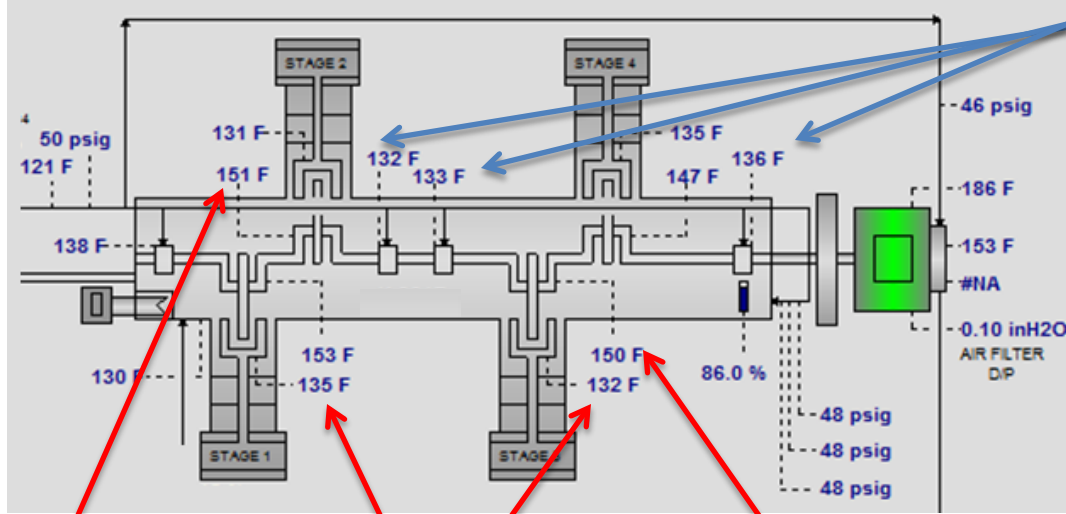
Bearing Temperature Schematic & Wrist Pin Sensor

Main Bearing Temperatures
