TURBOMACHINERY
& PUMP SYMPOSIA

Shop Run Test Failure of an API 610 Vertical Sump Pump: what it exposed, and why it was critical to solve.

Mohamed Hazem Sadek

Enppi

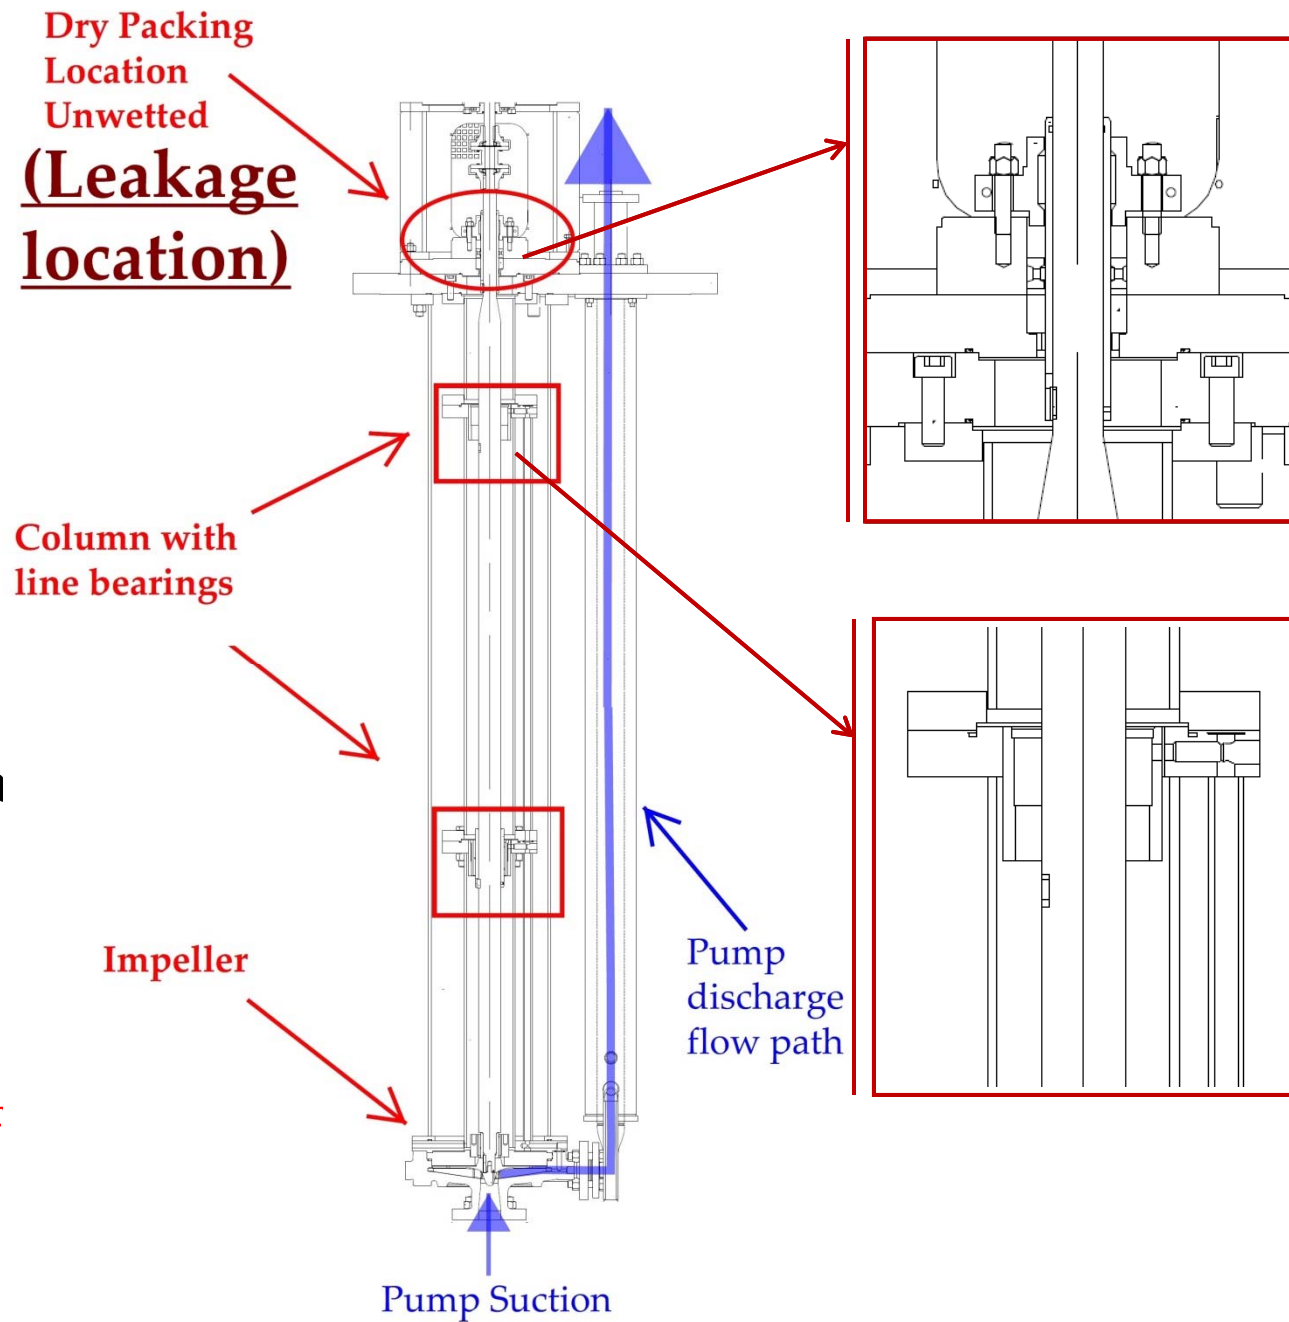
- The pump is a **Vertical Sump Pump** construction as per **API610 VS4** configuration
- The vertical Sump pump has the discharge through a separate column .
- The pump is supported by a column with line bearings , the line bearings are lubricated by the pumped fluid through a separate path.
- The packing for this pump is not in the fluid path, and accordingly is dry running, **in our case.. Test Liquid (Water at ambient conditions) was leaking out of it!!**
