TURBOMACHINERY  
& PUMP SYMPOSIA

# Extending MTBF of Seals in Boiler Feed Water Service

Case Study – Christopher “Topher” Ropp  
Principal Engineer - Flowserve AMSS, Kalamazoo MI

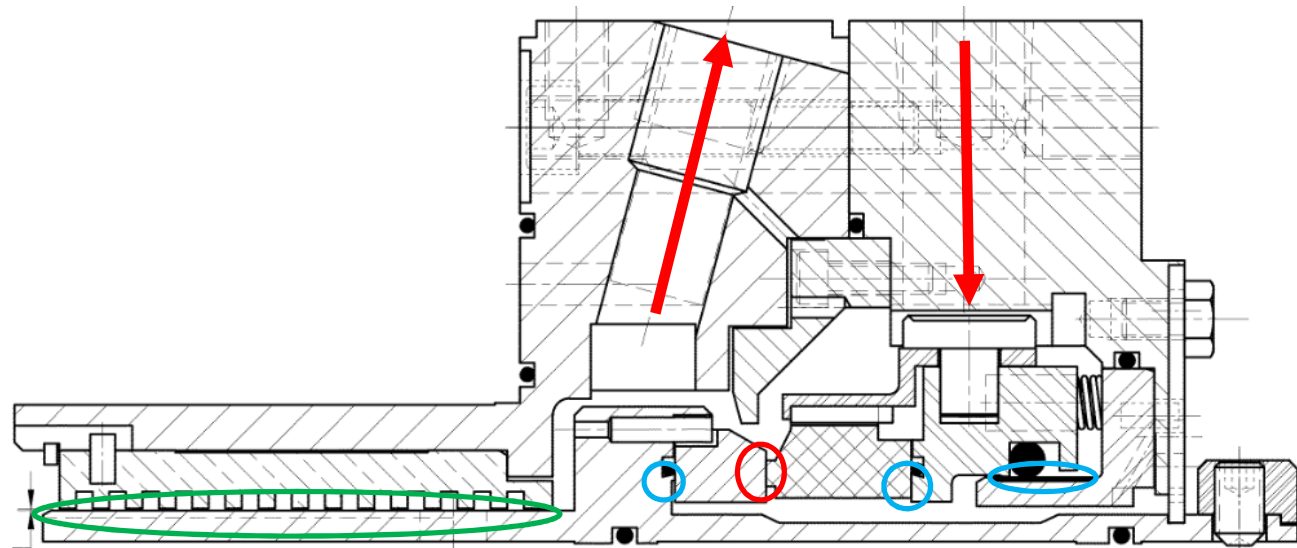
Three RCA's were performed that pointed to areas of concern:

1. Inadequate plan 23 cooling (Red)
2. Excessive Fretting (Blue)
3. Bushing Contact (Green)

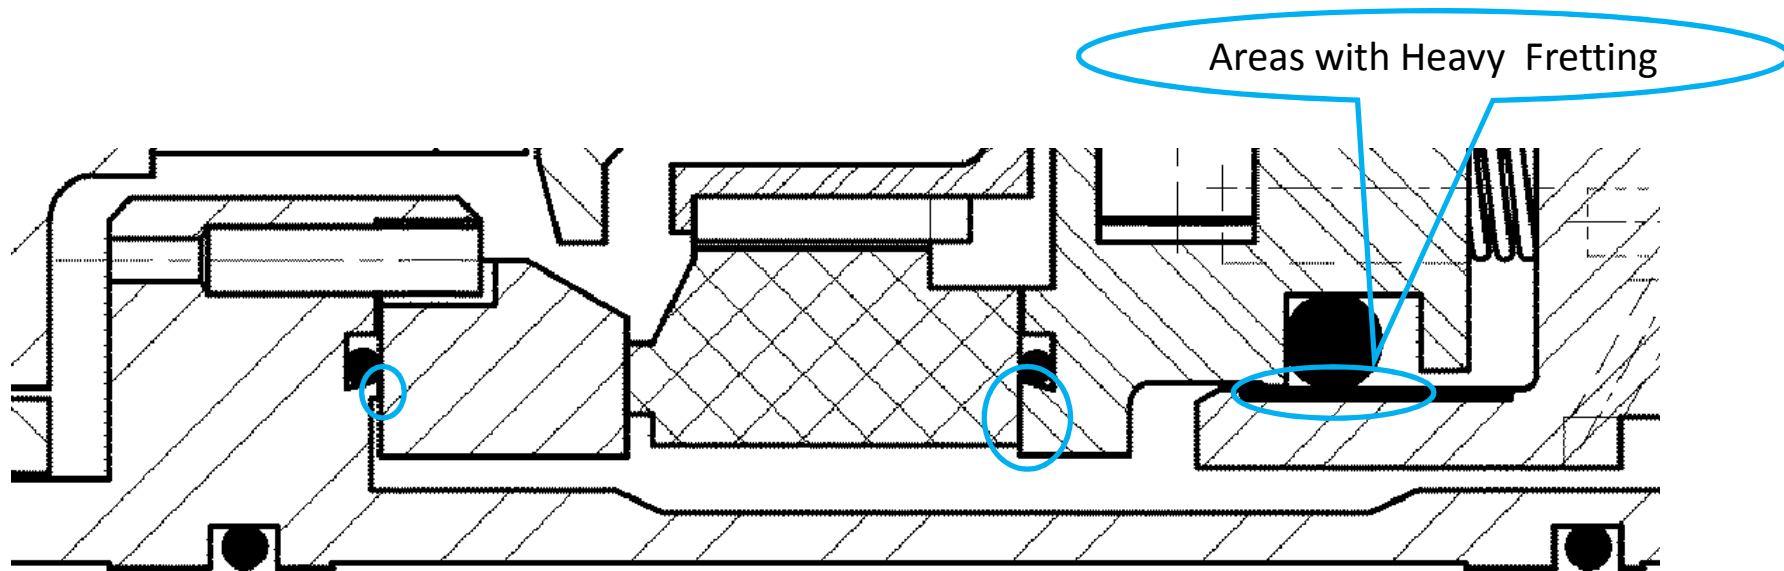
## 2. Excessive Fretting

Heavy Fretting was noticed in three (3) distinct areas

- Seal cavity temperatures above 160°F can cause flashing and instability within the seal
- Reduced sleeve to shaft clearance to API 682 fits of **F7/h6** will reduce seal wobble
- Added 2<sup>nd</sup> key slot to the sleeve ID for higher speed mechanical stability at 5500 rpm

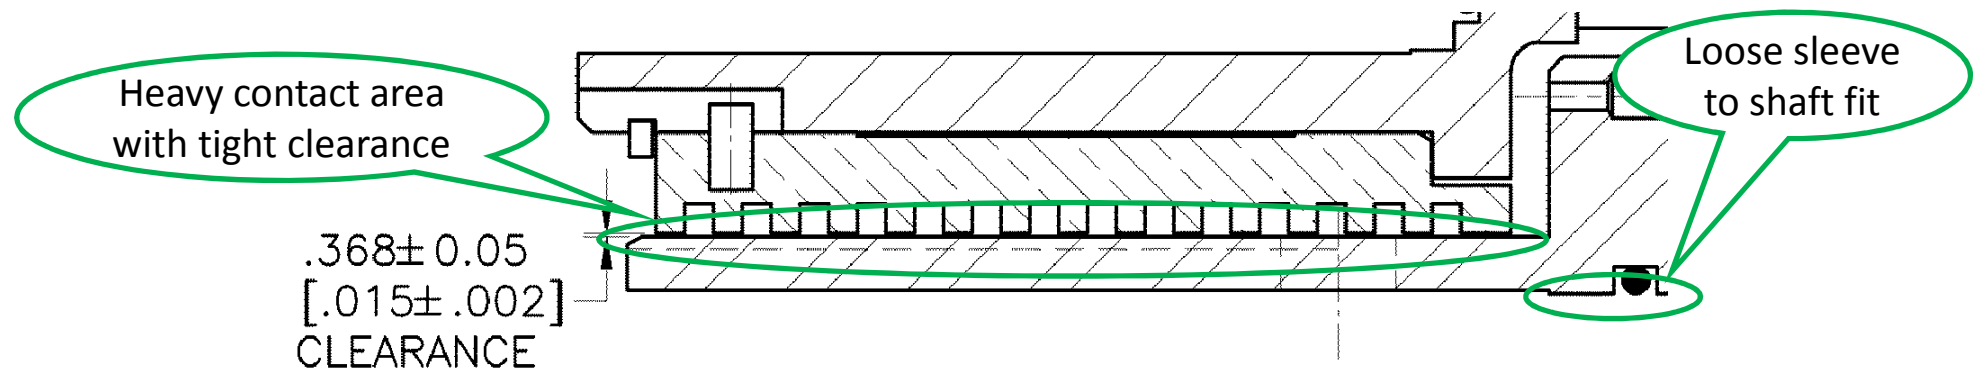
### 3. Heavy Bushing Contact

#### Heavy contact between the Sleeve OD and Bushing ID

- The Long Metal Bushing was designed for Pressure Breakdown
- Tight 0.015" radial clearance
- Loose sleeve ID to shaft OD clearance
- One key slot was in the bottom of the sleeve

- Redesign bushing to a shorter Carbon thermal break design vs. Metal pressure breakdown design
- Increased Bushing clearances to ensure no contact between the Bushing and Sleeve
- Changed sleeve to 17-4 material that is stronger and lower thermal expansion rate
