The Effects of a Water Plant Structural Foundation on Non-Clog Pump Vibration

Maki M. Onari

Sept. 12, 2019

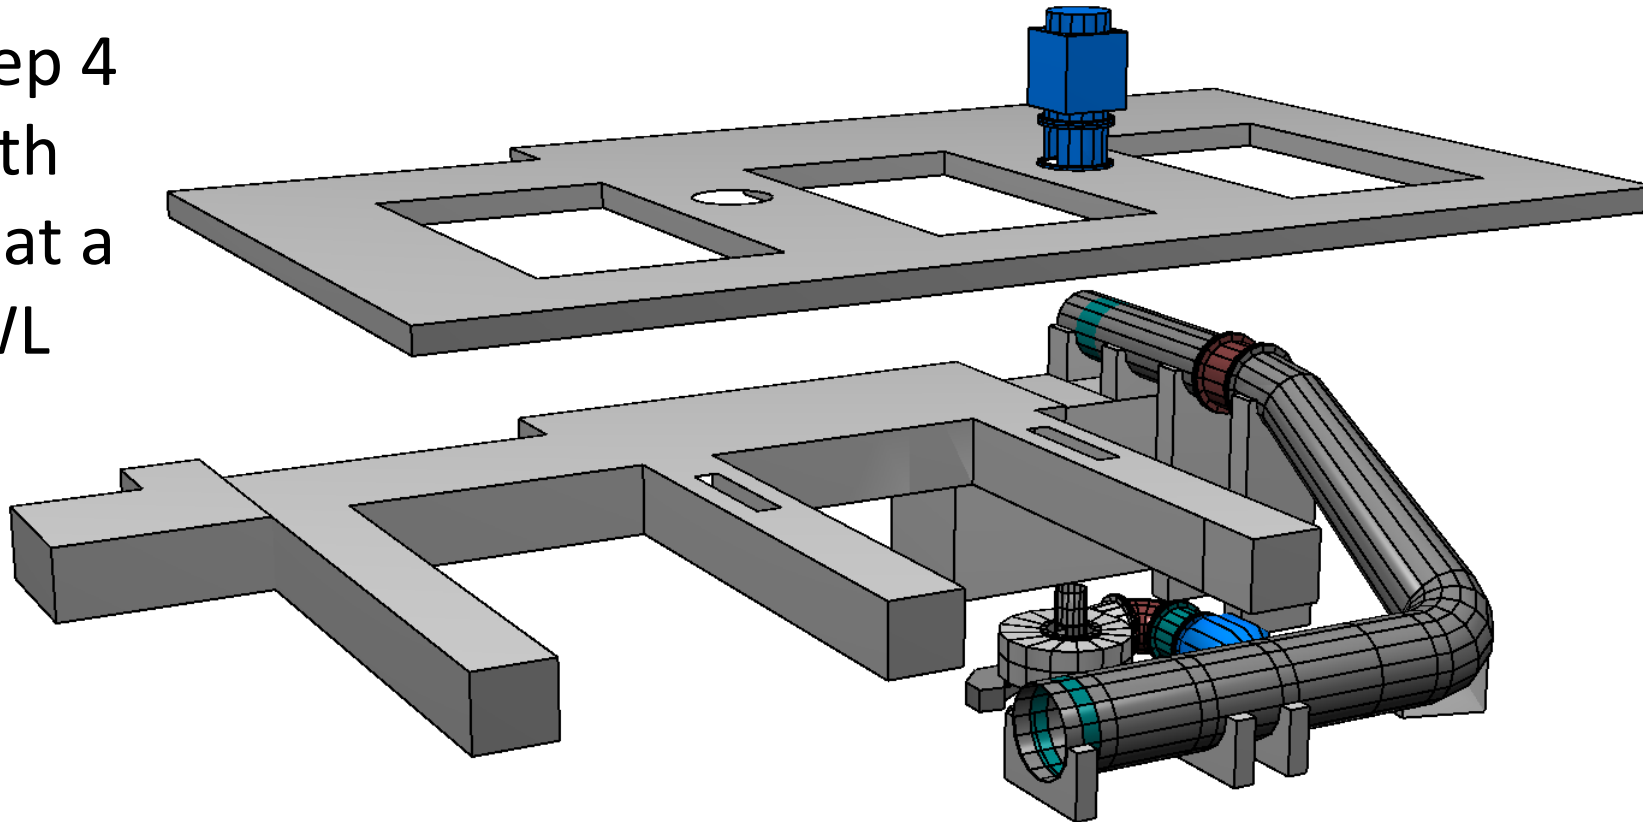
Operating Deflection Shape (ODS) Detailed Computer Model

Data taken over
4 hours at Step 4
(360 rpm) with
VPF at 18 Hz at a
constant WWL

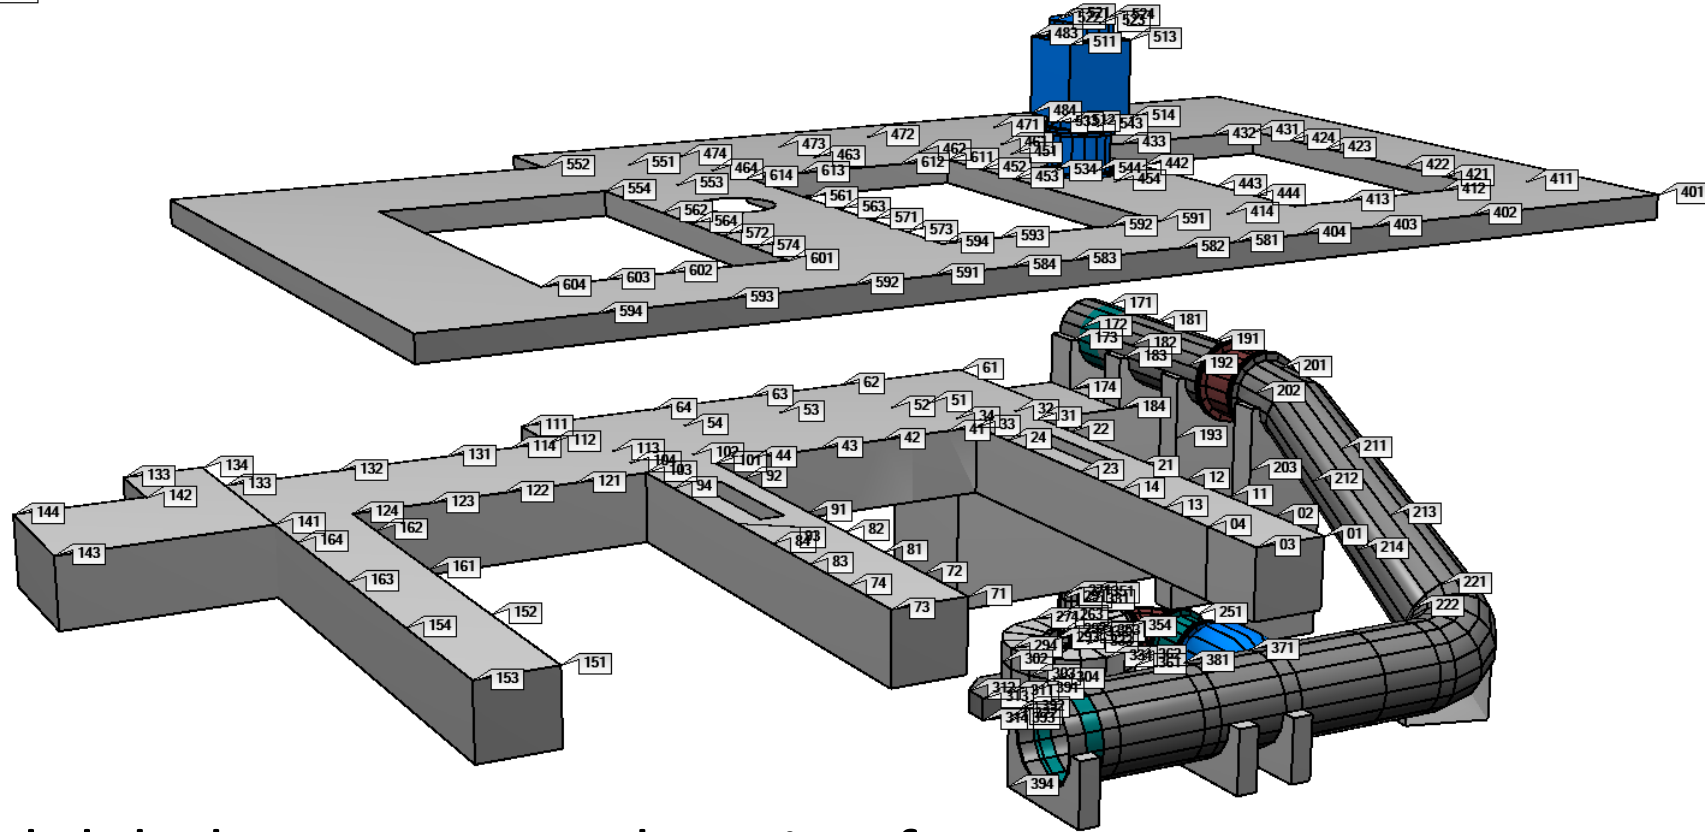
Operating Deflection Shape (ODS) Over 720 vibration locations / directions

Each label represents a location for a tri-axial accelerometer
