TURBOMACHINERY
& PUMP SYMPOSIA

Identifying the cause of a plunger pump shutdown

Data logging to the rescue

Kelly Eberle, Michal Gaca

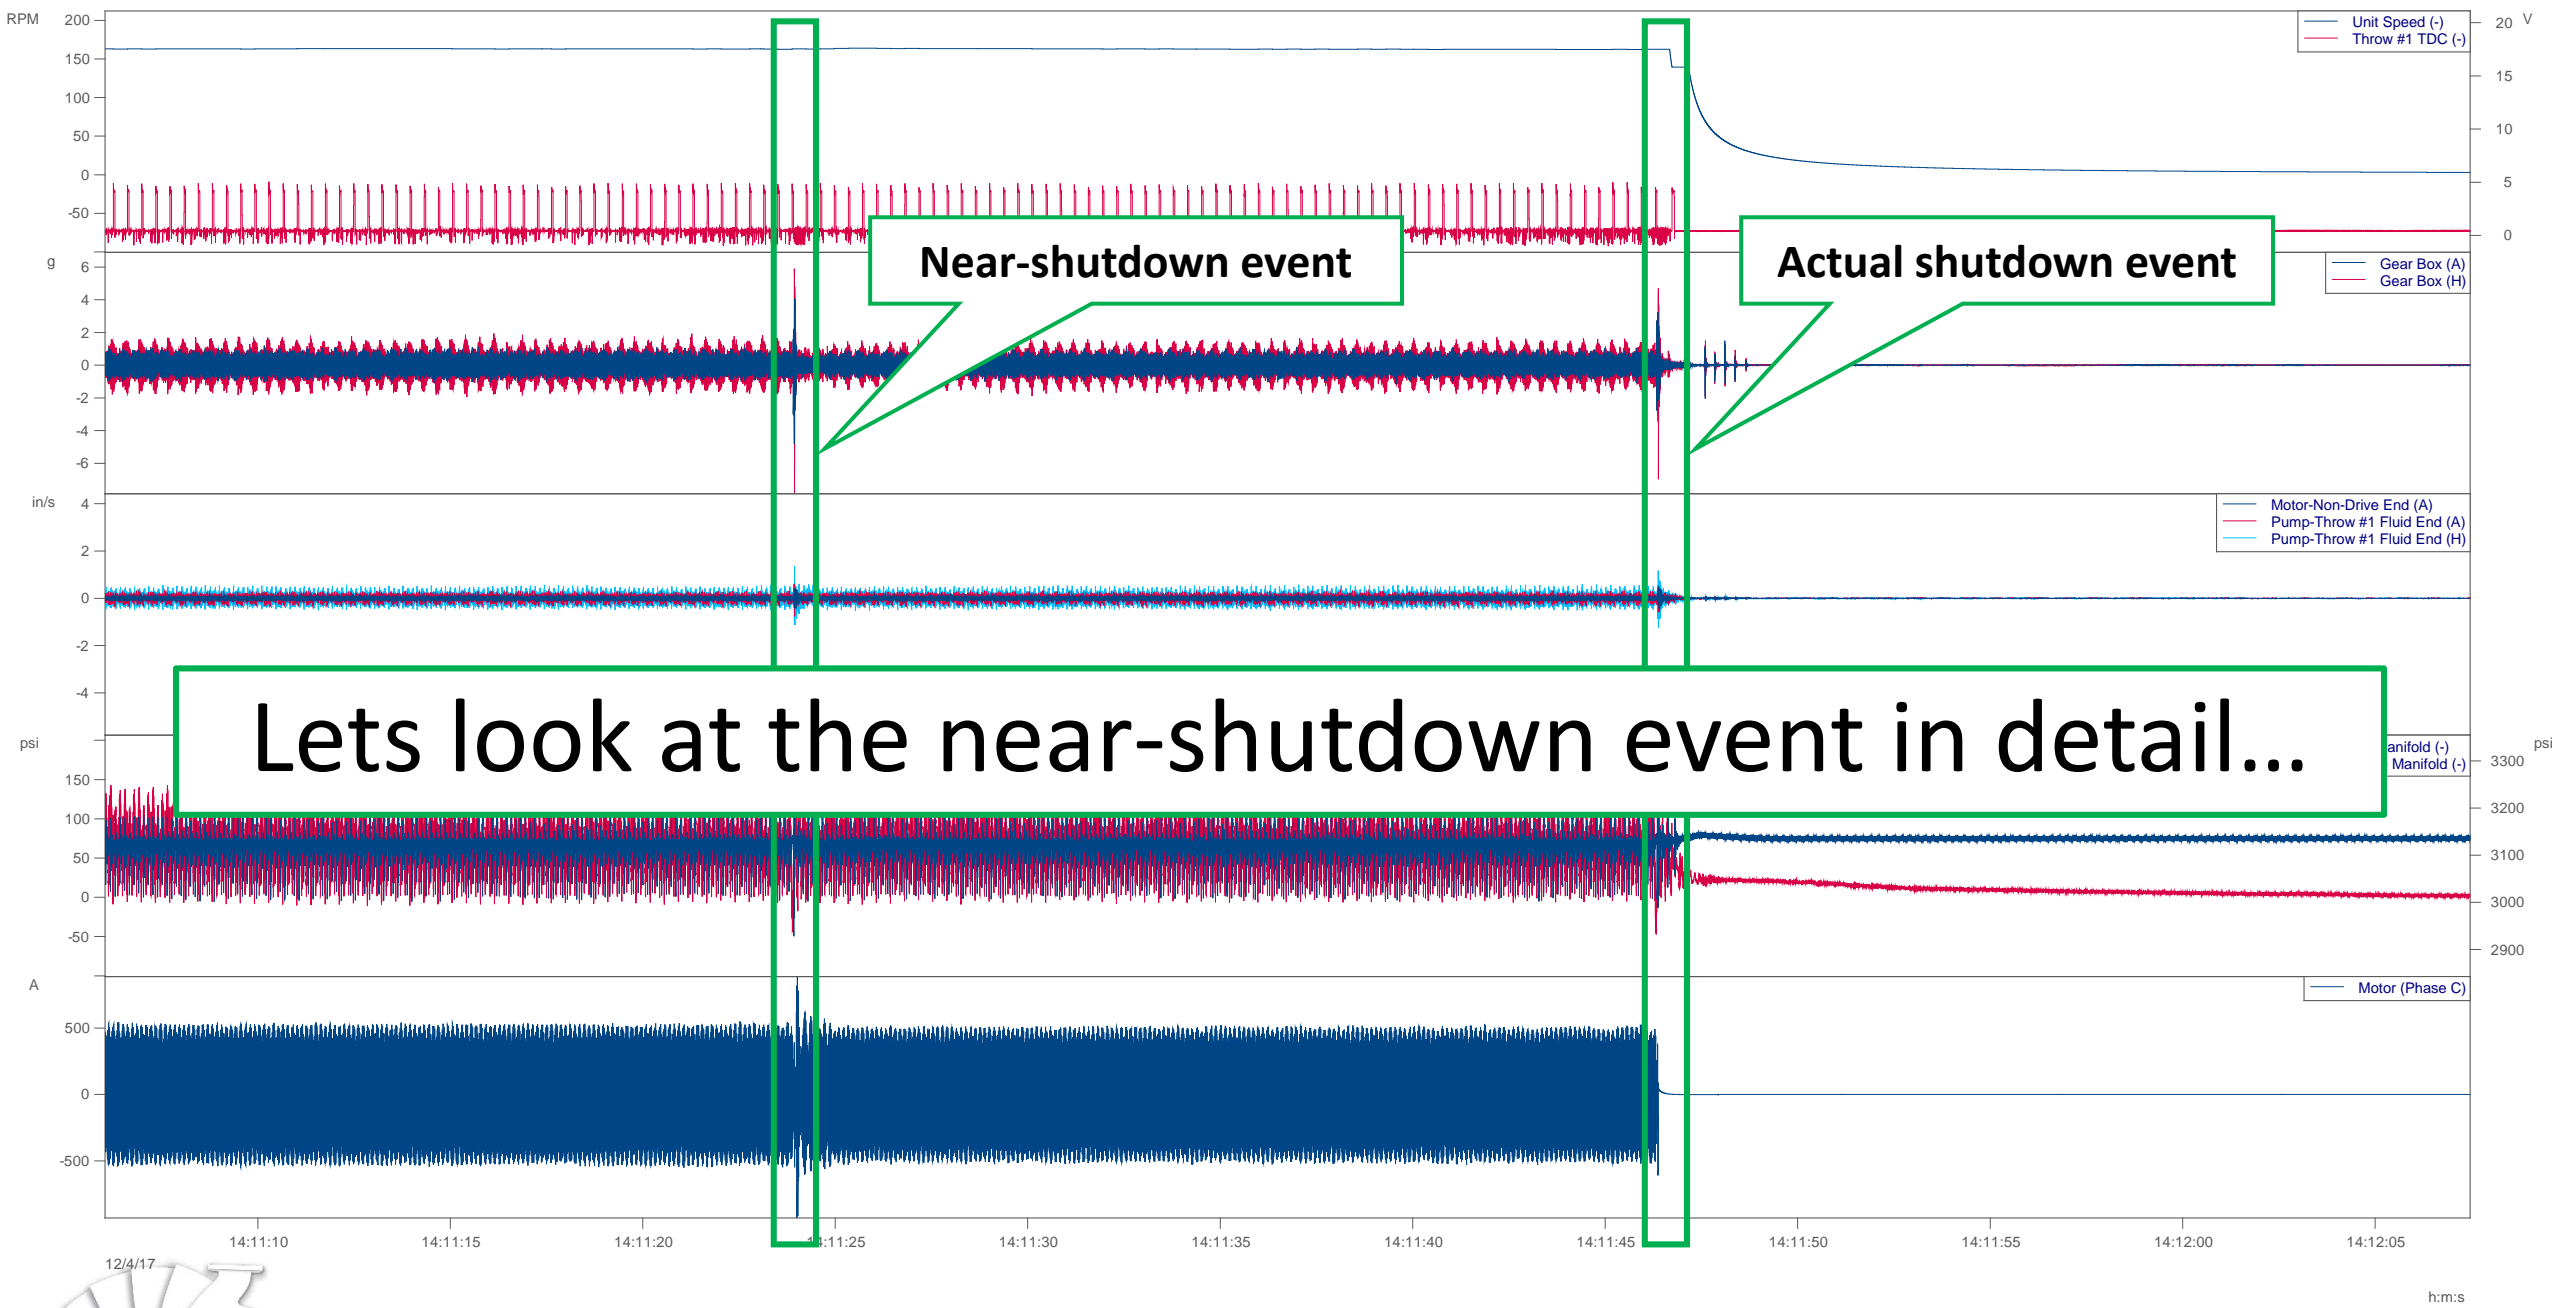
12/4/17

1. Discharge pressure drops below normal. Throw 2 discharge valve should be open. Low pressure indicates discharge valve is closed.

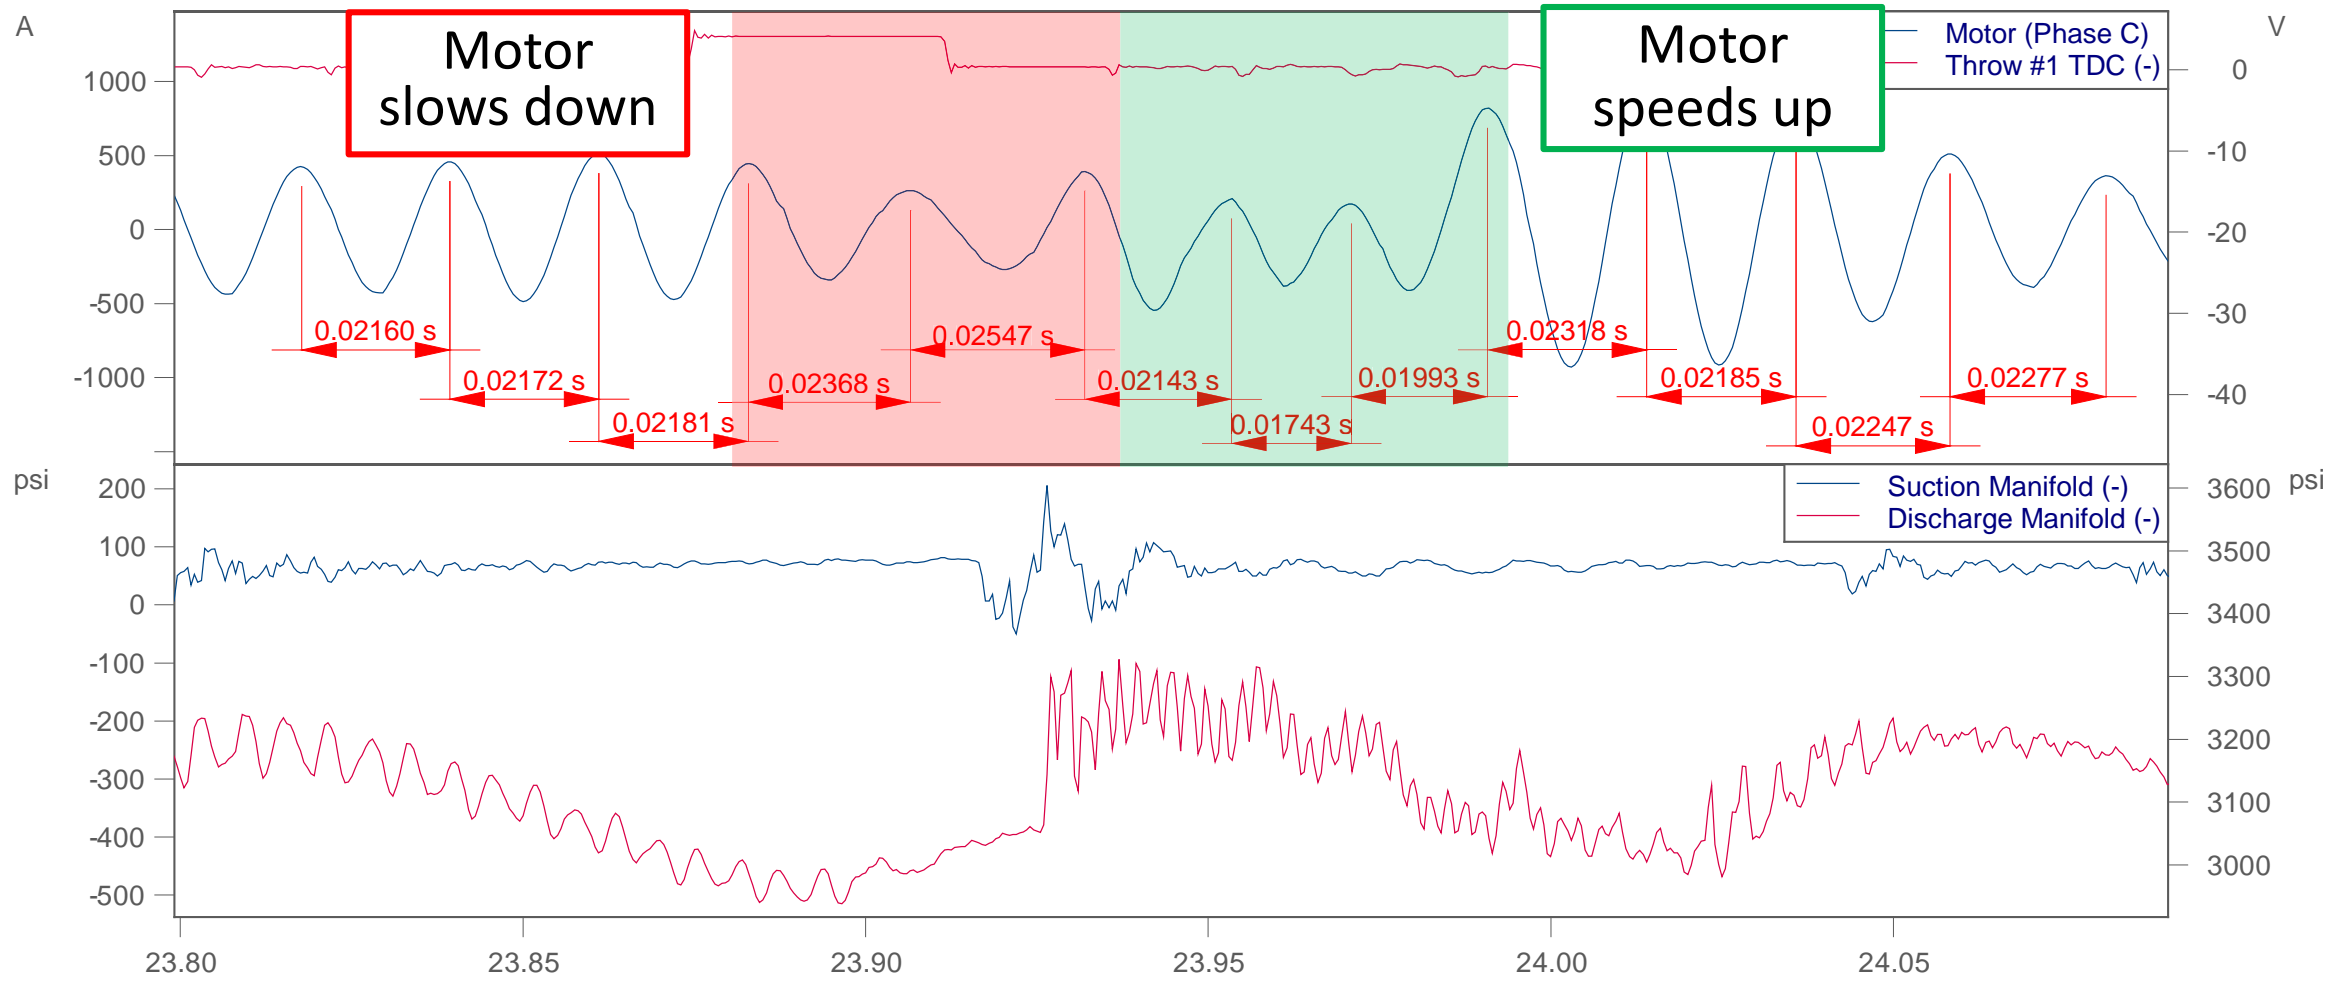
Motor current during near-shutdown event

6. The sudden increase in pressure causes higher excitation of the drivetrain, appears as high vibration. The motor current fluctuation increases in amplitude which likely causes the VFD to alarm.

- Change stiffer springs to more flexible springs
- Pumps have operated for several months without tripping with the more flexible springs
- Unsolved mystery: Why did the throw #2 discharge valve stick?
 - Only one of two pumps had problems
 - Problems appeared only on throw #2
 - Stiffer valve springs should have improved the performance
- Additional site testing and simulations proposed to determine root cause
- Pumps running OK with more flexible springs. No further work done.
