RCA report on governing valve seat failure for ERC Turbine

48th Turbomachinery & 35th Pump
Symposia | Sept. 9-12, 2019

1. Site observation of valve seat failure in Governing valve

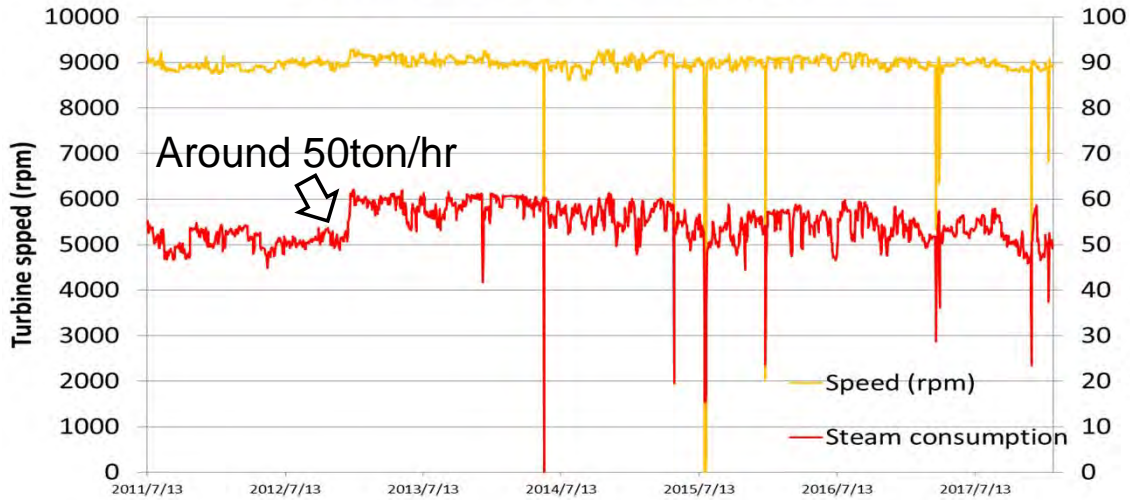
Fig Operation data

According to operation data from customer, the valve lift for 2nd valve was almost fully opened.

Abnormal operation is not confirmed.

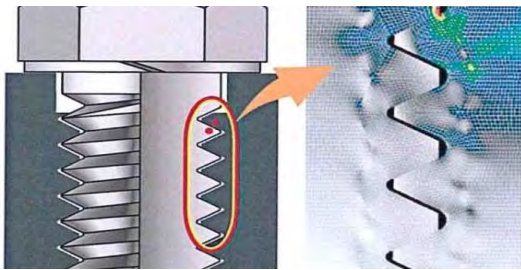
2nd valve

Looseness of screw

Wear on contact surface

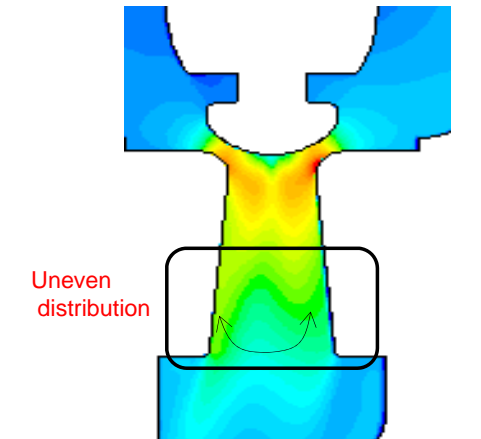
Worn out the contact surface by uneven steam pressure distribution

Uneven distribution

Worn out

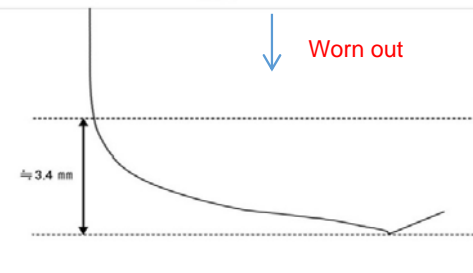
Crack origin is well matched with peak stress portion.

Dynamic stress of valve seat 1st bending mode exceeded to material fatigue limit through reduction of contact area by heavy wear
