**TURBOMACHINERY  
& PUMP SYMPOSIA**

# **RESOLUTION of HIGH VIBRATION on a GENERATOR**

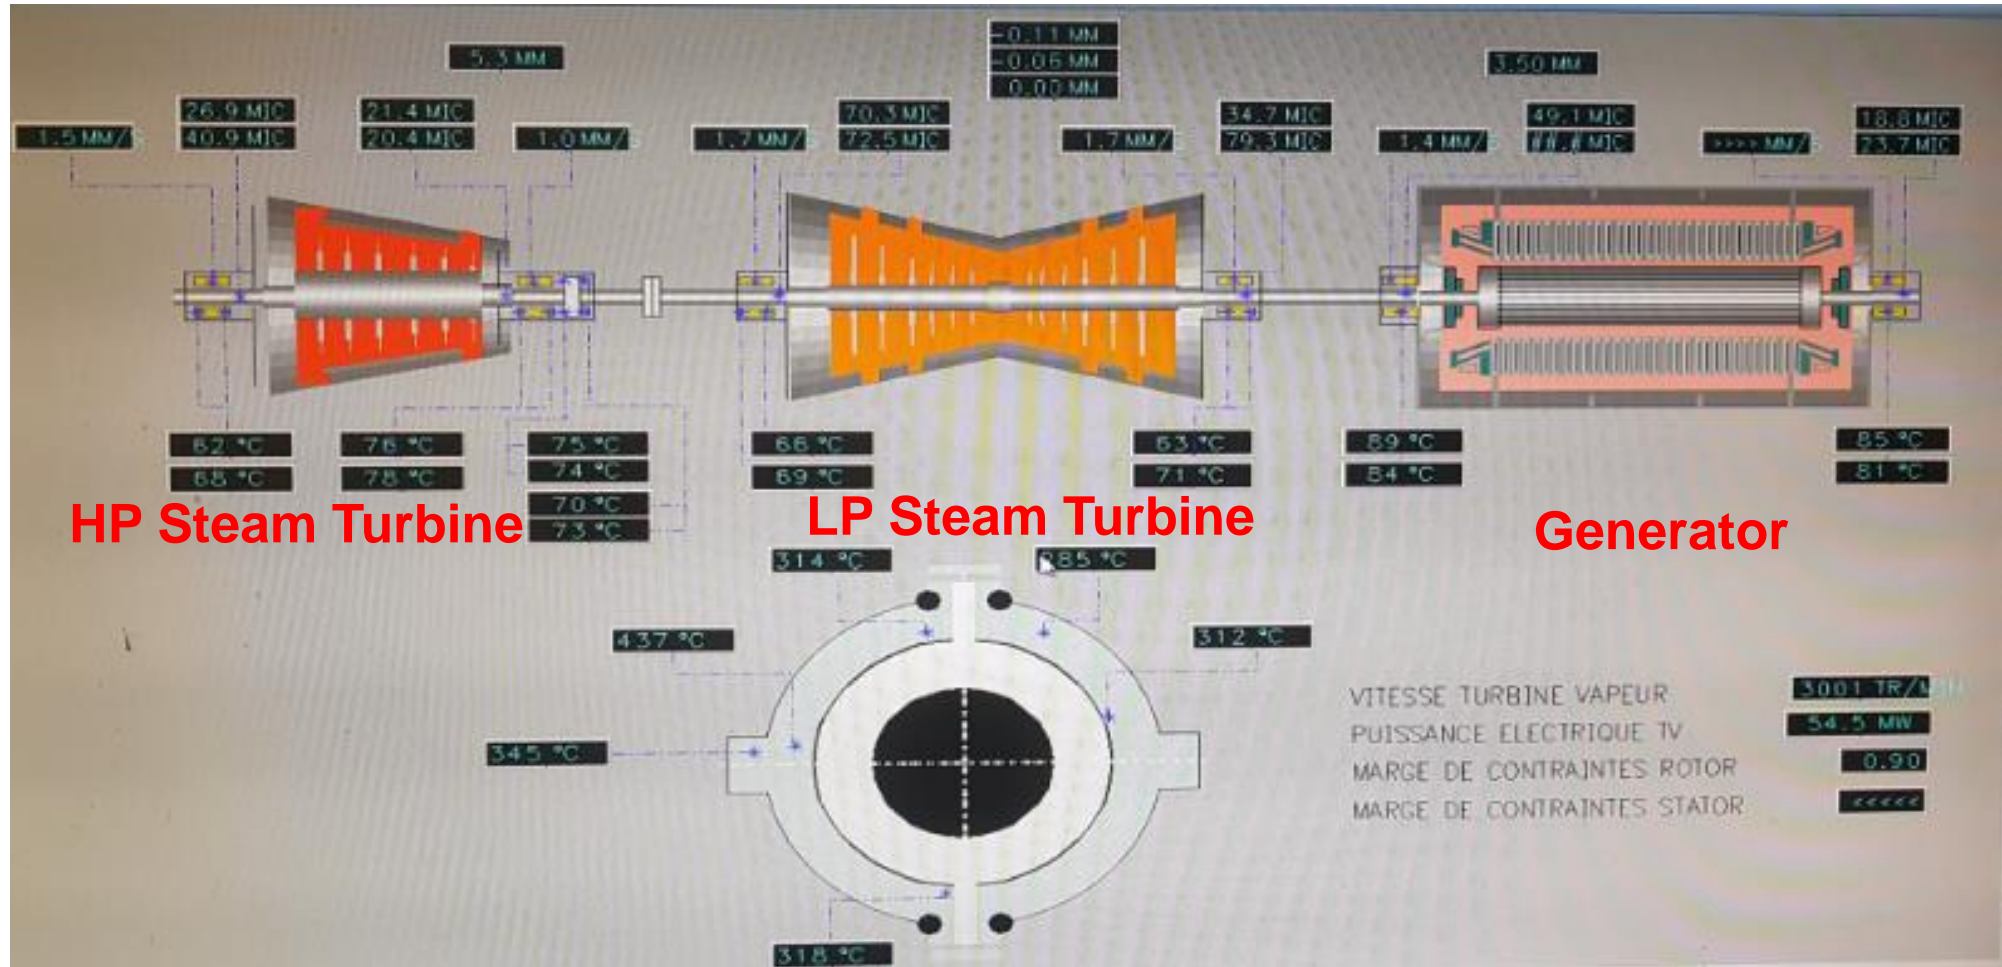
# MACHINE DETAILS

Machine Train consists of a HP/LP Steam turbine driving a Generator of 118 MW, Equipped with online protection system.

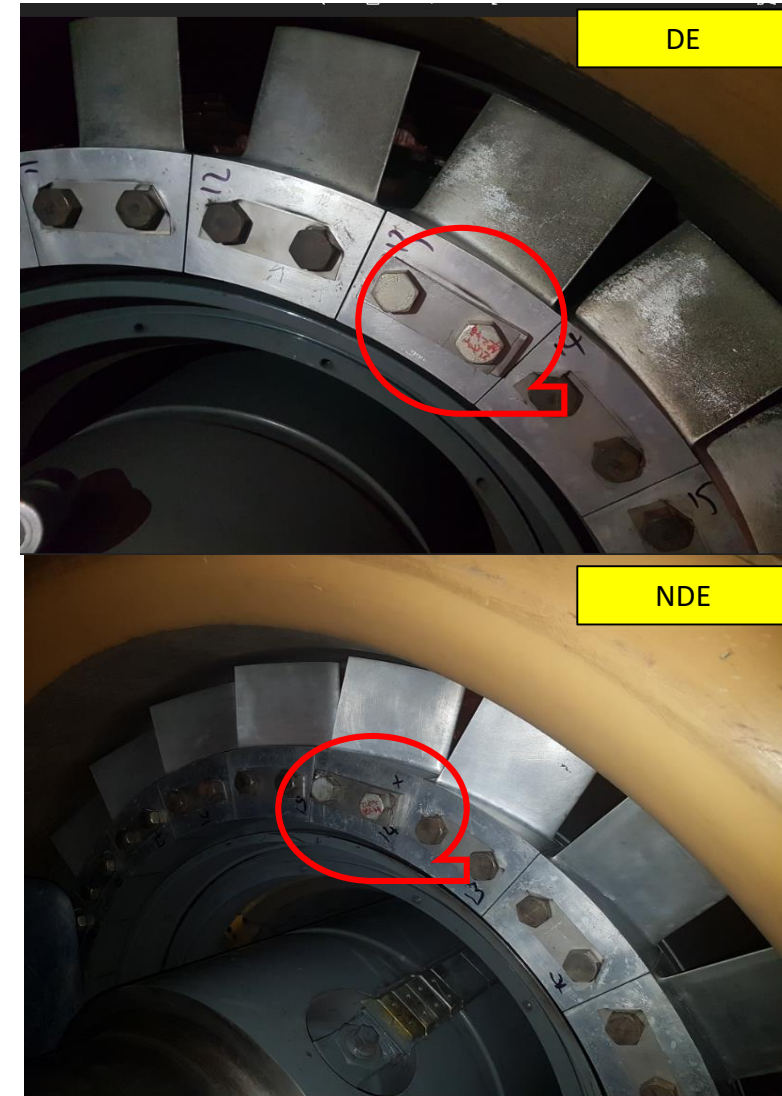
## SINGLE & TWO PLANE BALANCING EXERCISE

- A single plane balancing lowered Generator outboard bearing shaft vibration.
- No reduction in casing vibration.
- A two plane balancing lowered shaft vibration on both the bearings of generator
- High casing vibration was still observed at both bearings.
- In-situ balancing didn't resolve the high vibration on the casing.
