TURBOMACHINERY
& PUMP SYMPOSIA

Blade failure analysis for steam turbines used for driving centrifugal compressors

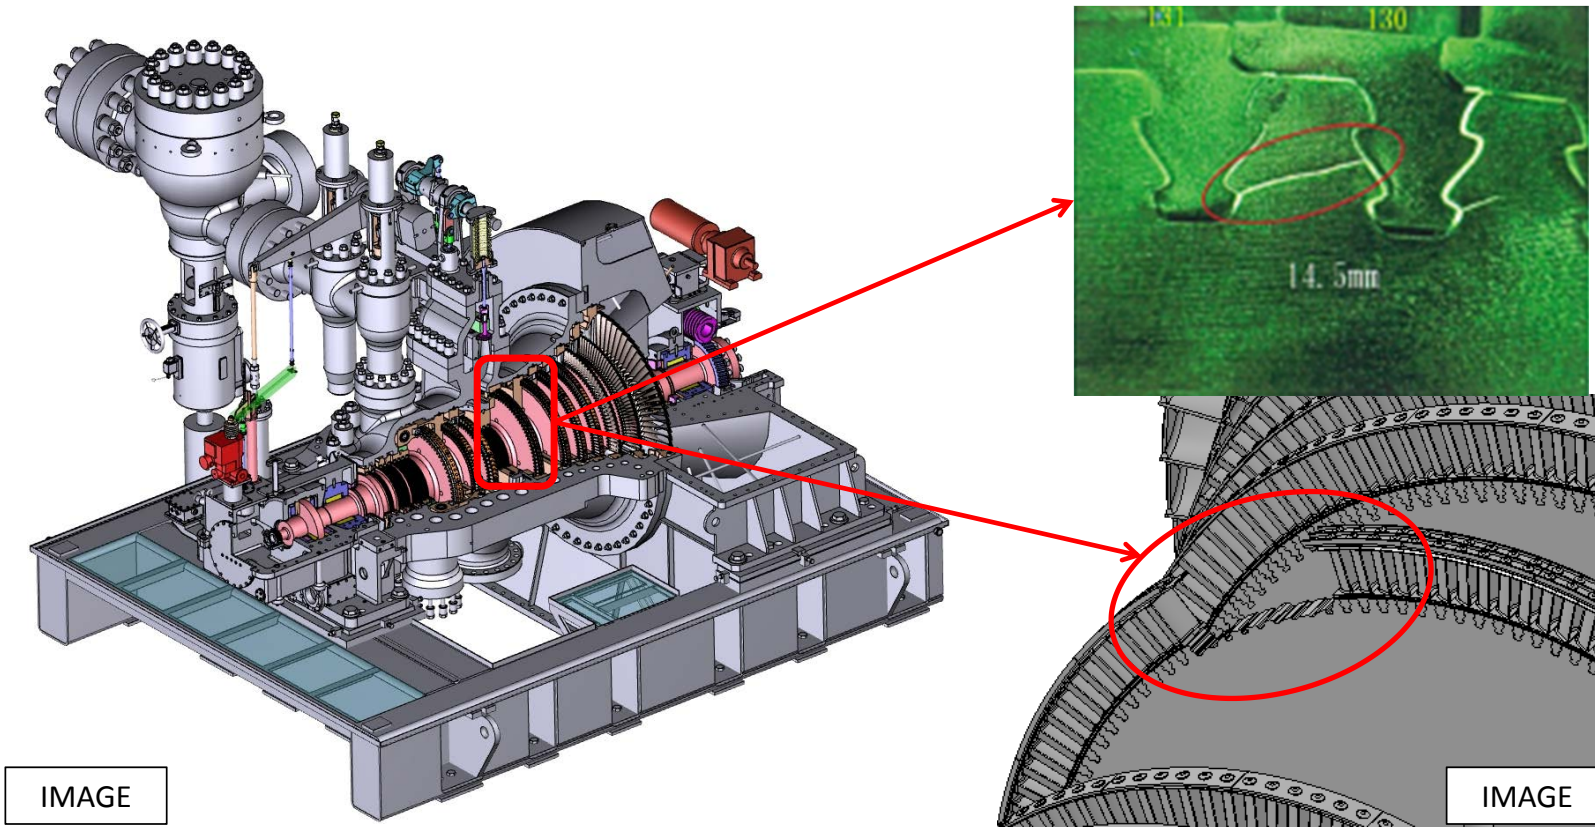
1. Background

In 2016, the compressor drive steam turbine was tripped by high radial vibration. After that, turbine casing was opened for internal parts check.

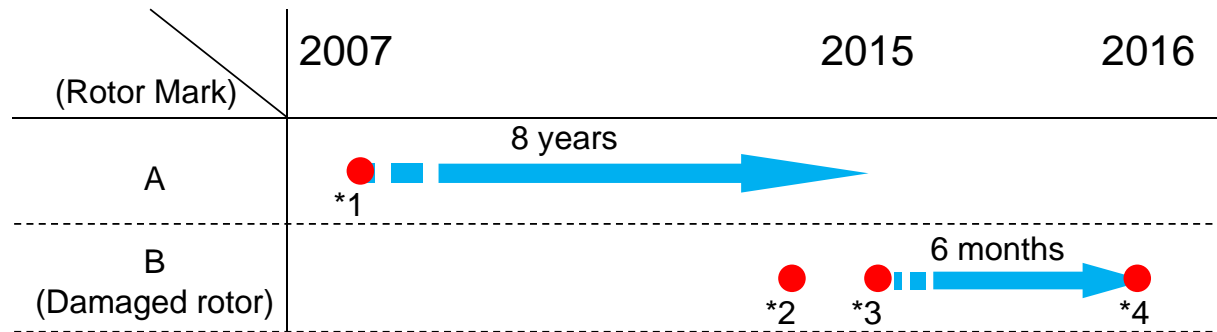
Rotor A: Original rotor
Rotor B: Revamped rotor (Damaged)

- *1 Plant started with rotor A in 2007 and 8 years of normal operation was completed.
- *2 Rotor B was modified for revamped turbine to increase the plant capacity.
Only HP stages design was changed but 4th stage (LP stage) was not changed.
- *3 Rotor was replaced from rotor A to rotor B.
- *4 After 6 months of operation, Turbine tripped due to high vibration. High vibration occurred due to the failure of 4th stage blade and related disk area.

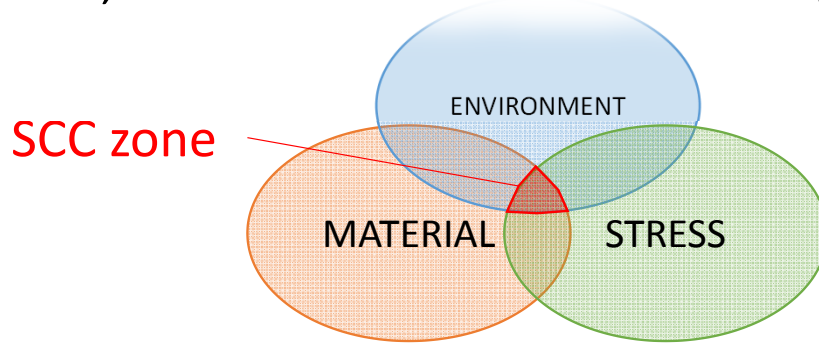
SCC will occur when these three factors occur at the same time. (Stress, Material, Environment)
Therefore, these three factors should be investigated to conclude that this failure is caused by SCC.

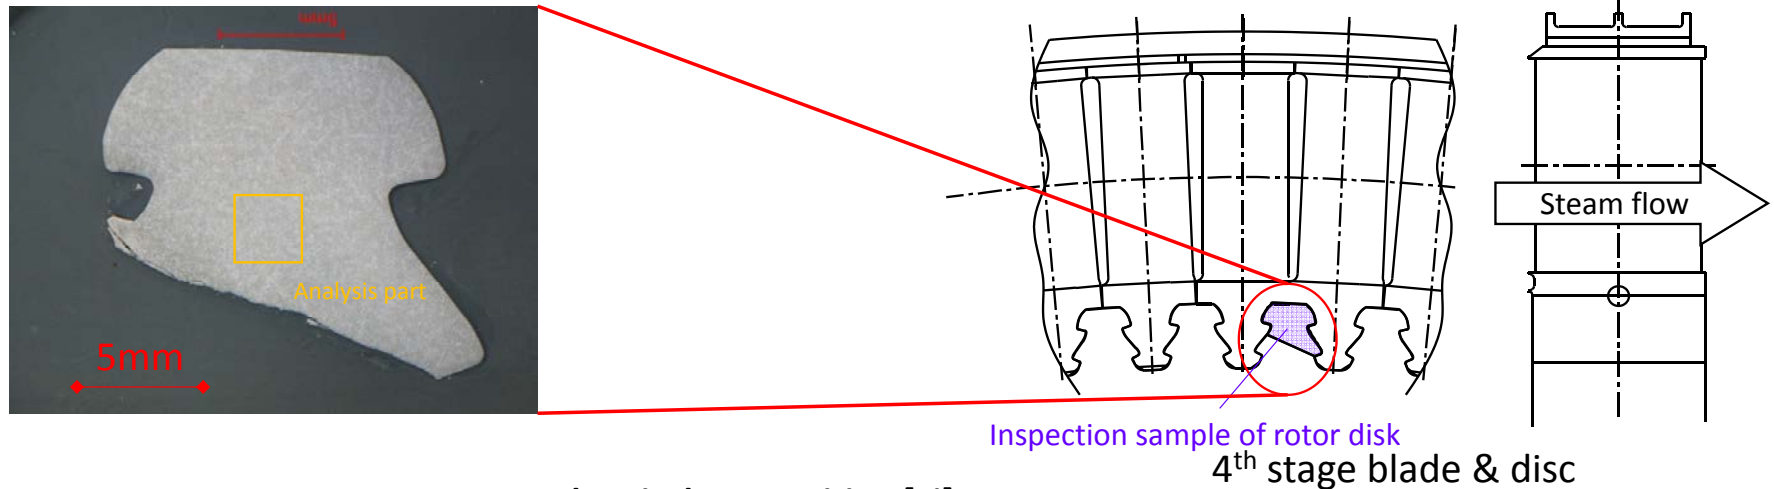
Disc material ; Low-alloy steel

- Abnormality was not observed after chemical composition check.
- Mechanical properties are satisfied by material specification.
- Result : Proper material selection was carried out and there was no problem with the design.

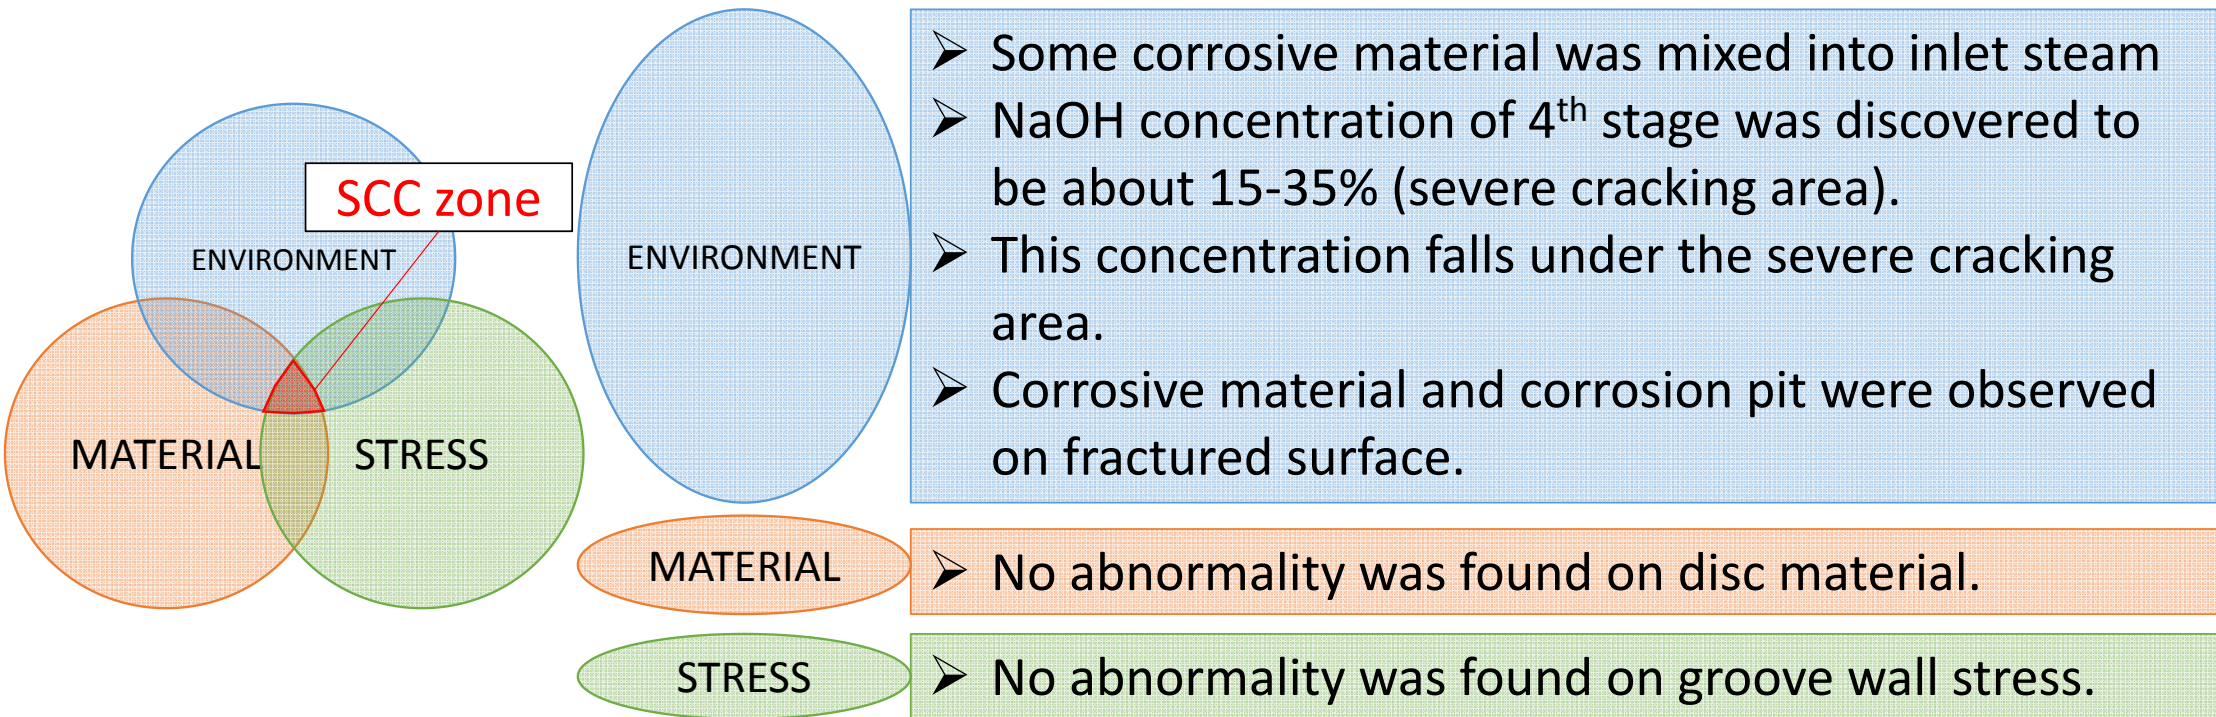
Some corrosive material was mixed into inlet steam.

However, SCC occurred only for 4th stage disc. This is because NaOH concentration of 4th stage fell under the severe cracking area.

Factors	OEM	User
ENVIRONMENT	<ul style="list-style-type: none"> ▪ Online monitoring system of user's steam inlet condition and operation data should be developed. 	
	<ul style="list-style-type: none"> ▪ Discussion about user's steam condition should be carried out before manufacturing the machine at OEM. 	
	-	<ul style="list-style-type: none"> ▪ If there is any possibility of some corrosive material getting mixed into steam or steam water, user should inform this to OEM. *1)
