48<sup>TH</sup> TURBOMACHINERY & 35<sup>TH</sup> PUMP SYMPOSIA  
HOUSTON, TEXAS | SEPTEMBER 9-12, 2019  
GEORGE R. BROWN CONVENTION CENTER

## INTRODUCTION TO SCC FAILURES IN STEAM TURBINES AND SOLUTIONS

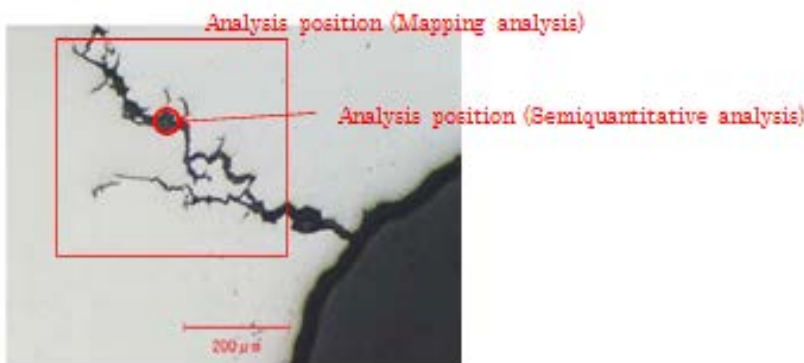
Fig.9 Section A-A on part B

- The crack was found on the corner R of the disc groove where it is likely to be highest stress point. (See Fig.7)
- The crack had a jagged appearance, and exhibited crack branching, and scale within the crack. (See Fig 8.)
- Microhardness examination revealed no significant deviation in hardness (267 ~ 287HV) on adjacent to the crack compared to other areas (>248HV).
- The micro structure of this material was normal, tempered martensite.

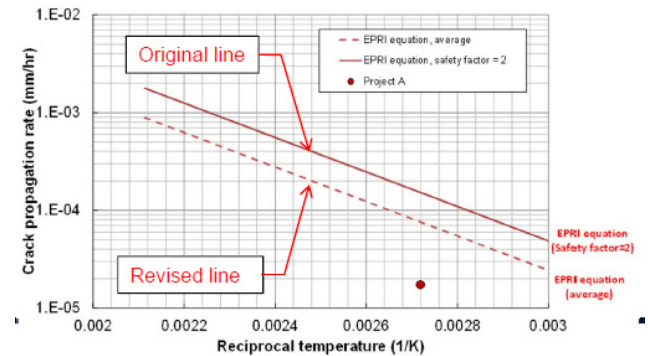
Fig.14 Comparison between MCO Experience and Evaluation by EPRI Equation

However, it has been often observed that the calculated crack growth rates are higher than the actual growth rates. For example, Table III shows the results of a previously-conducted evaluation.

A crack was detected after eight years of continuous operation, and remaining turbine life was estimated from the length of a detected crack. The remaining turbine life, which was limited from the maximum allowable crack depth obtained from fracture toughness and the EPRI Equation, was estimated to be 2.6 years and 0.6 years, respectively and entire turbine lifetime calculated was 10.6 years and 8.6 years, respectively, for the 8<sup>th</sup> and 9<sup>th</sup> stage discs. In many cases, our steam turbine rotors have operated without troubles for more than 15 years. Moreover, there are many examples in which the turbine is operated in very harsh conditions. This implies that the EPRI Equation can underestimate remaining turbine life. Also, a safety factor of 2 is usually applied whenever EPRI equation is used. However, this safety factor of 2 was not applied for the above evaluation. As shown in Fig. 14, the “Original line” represents the crack growth rate calculated with a safety factor of 2. The “revised line” shows the crack growth rate calculated without a safety factor of 2. The experience marked with the red dot in Fig.14 indicates a lower crack growth rate than the revised line calculated without a safety factor. The findings imply that the EPRI Equation can underestimate remaining turbine life.

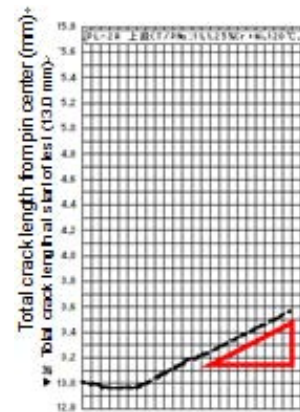
Fig.16 Result of K=90MPa√m

In this test, cracks did not grow at 30 MPa√m and 40MPa√m within the measurement time. When a stress intensity factor was increased to 50 MPa√m, cracks grew in both specimens at a constant rate. In case of 90MPa√m, Crack growth tendency was seen in two specimens approximately 700 hours after the start of the test and crack growth rate is faster than the case with 50 MPa√m . Fig.16 shows the result of K=90MPa√m case.

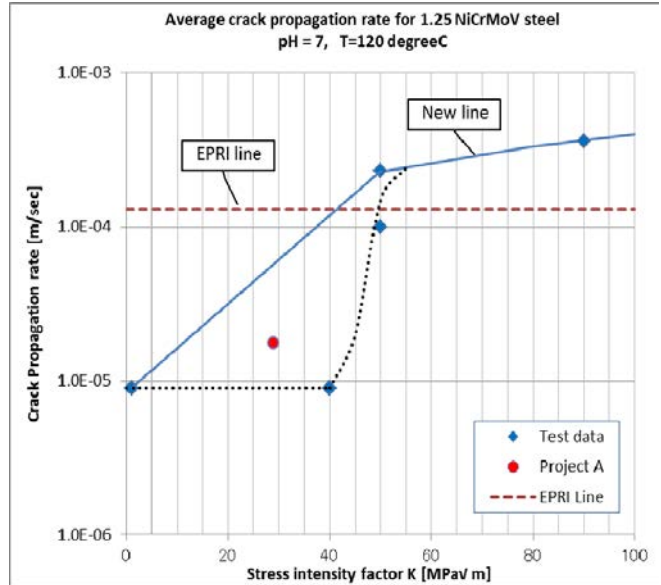
Fig.17 Summary of all test data

Test results are shown in Fig.17. As noted in Fig.17, the blue dots show the test data for each test case and black dotted line shows the actual expected crack growth rate. Also shown is the crack growth rate calculated from the EPRI equation at yield strength of 773 MPa (112 ksi) and a test temperature of 120°C as indicated by the brown dotted line. Within the test duration, there was no crack growth in K=30 and 40MPa√m. Technically, the crack growth rate for these conditions can be measured if the test continues longer. However, a limit rates mechanically obtained from the detection limit of PDM within test operation time in order to assume the limit rate.

In this Figure, it is evident that crack growth rates depend on stress intensity factors. Crack growth rate is very slow in the low stress intensity range. On the other hand, for K≥50 MPa√m, a crack growth rates increase by more than one order of magnitude compared to the low K values. Furthermore, the crack growth rate on actual data is faster than that obtained from the EPRI Equation in the range of high stress intensity over 50MPa√m.

For K≤40MPa√m, the crack grow rate on project “A” which was measured at site is relatively close to the test data. The blue solid line in Figure 17 shows the test data with a safety factor of 2 in order to account for a variety of operating conditions. In this line, the crack growth rate is divided into Stage I (low stress region) and Stage II (High stress region) and it can describe as the below equation.

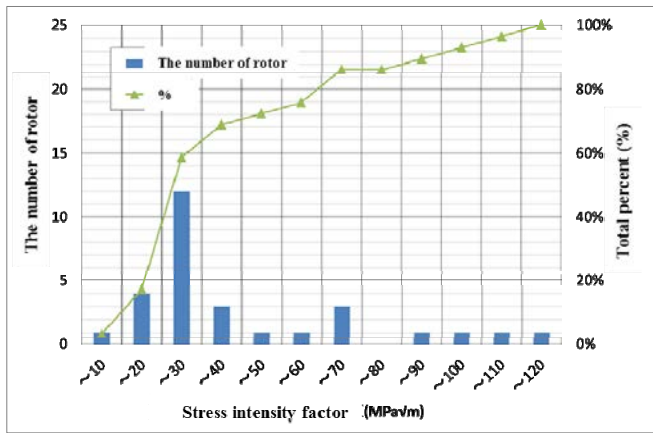
Fig.18 Statistical data for K value by PAUT inspection

In MCO statistical data shown in Fig.18, the percent of stress intensity factors less than K=40MPa√m comprises approximately 70 percent of rotors which exhibited SCC damage found by PAUT inspection. The life of many rotors can be extended because of the new method and rotor replacement can be offered at proper and precise timing with this method.

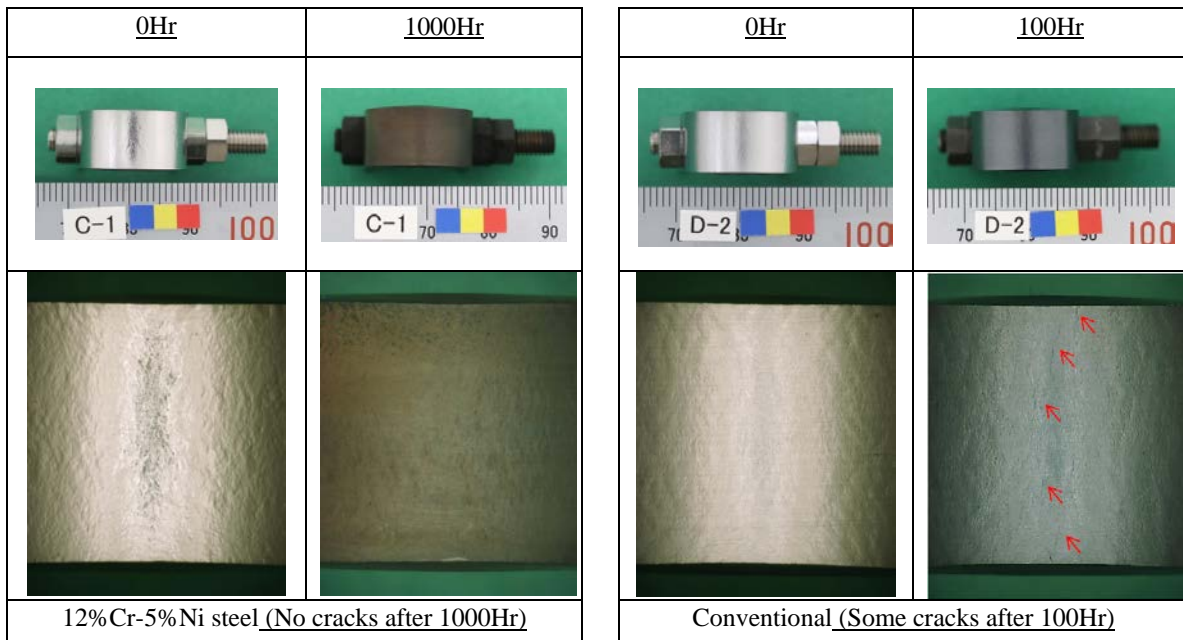
Figure 26 Test result of U bend test under 35% NaOH condition

Under this environment, cracking was first observed after occurred after 100 hours in the conventional rotor material. On the other hand, 12%Cr-5%Ni steel forging material (Test piece A & C) and weld metal made by aforementioned PQR did not crack after 1000 hours in the same environment. Therefore, the corrosion resistance for 35%NaOH for 12%Cr-5%Ni steel improved relatively ten times as long as conventional material and good performance was verified on this test.

As a result of this test, and the welding technique to apply 12%Cr-5%Ni overlay on conventional rotor discs was validated as suitable for for service in severe environments.
