Documentation and Conditions Assessment of Jacob's Ladder, St. Helena (CHC 2020-01-04)

Report prepared for the British Napoleonic Bicentenary
Trust and St. Helena Government

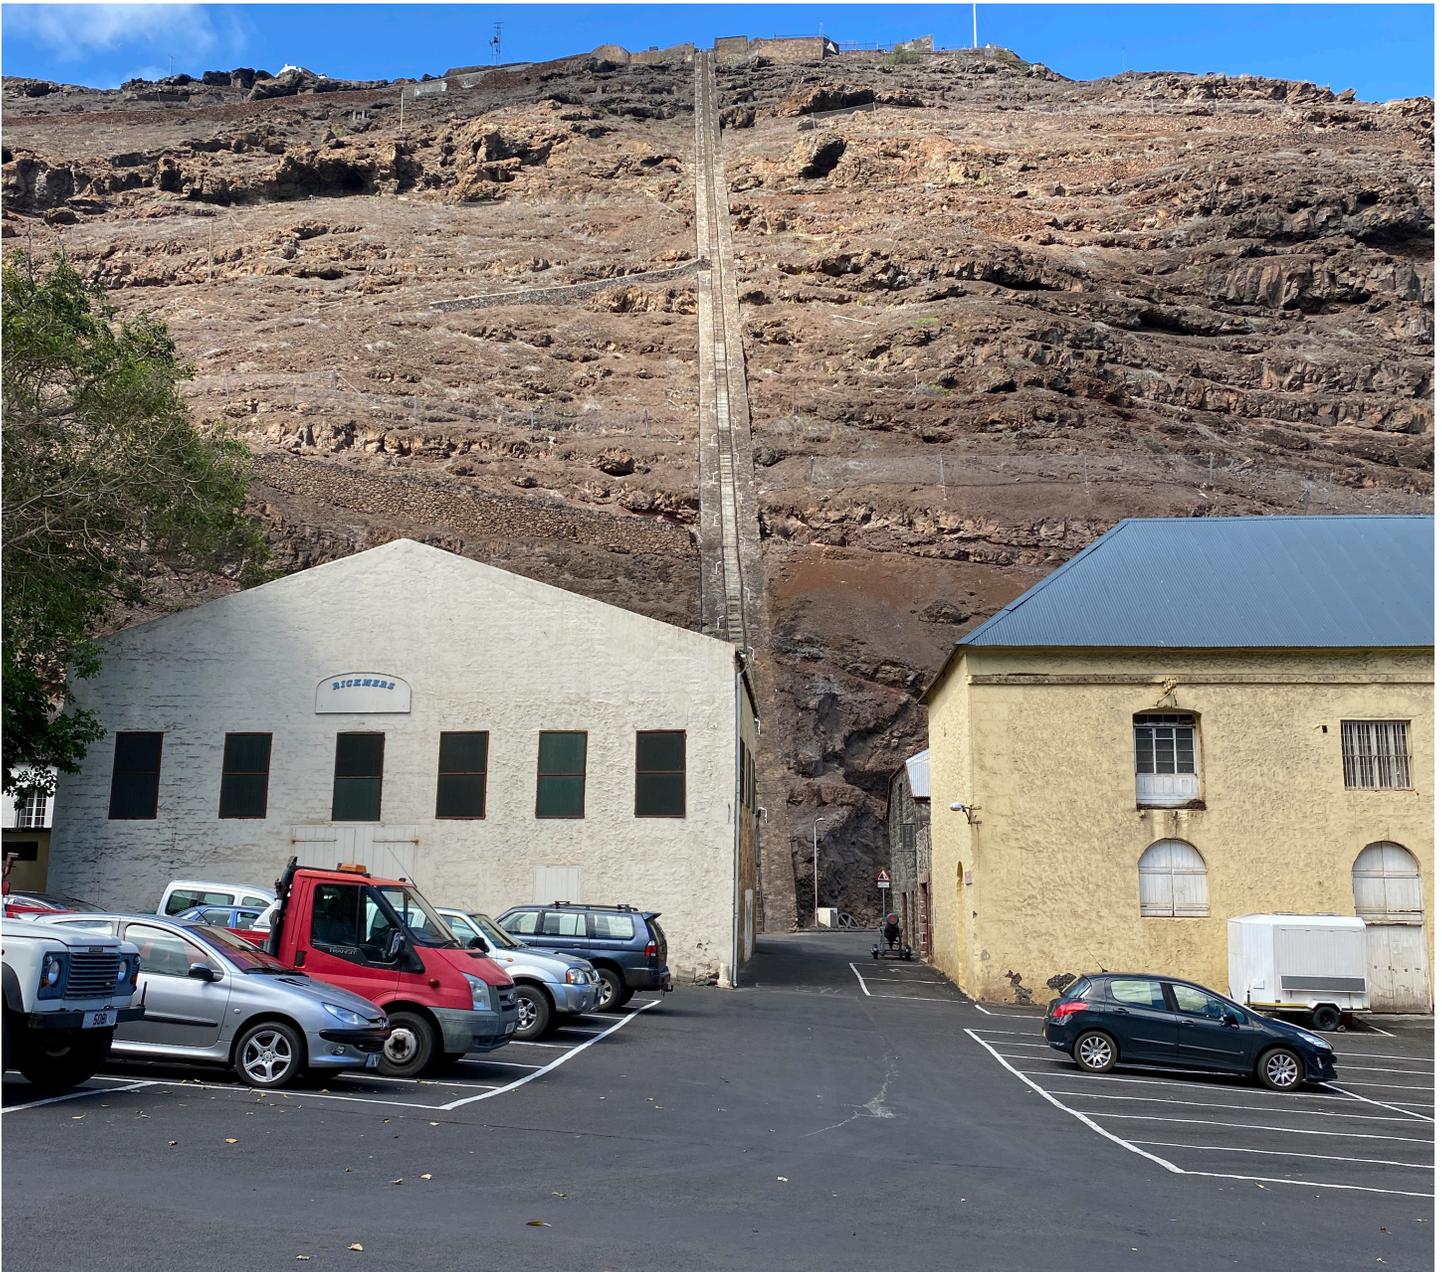
Figure 10: View of Jacob's Ladder from central Jamestown (Image: B. Fortenberry).

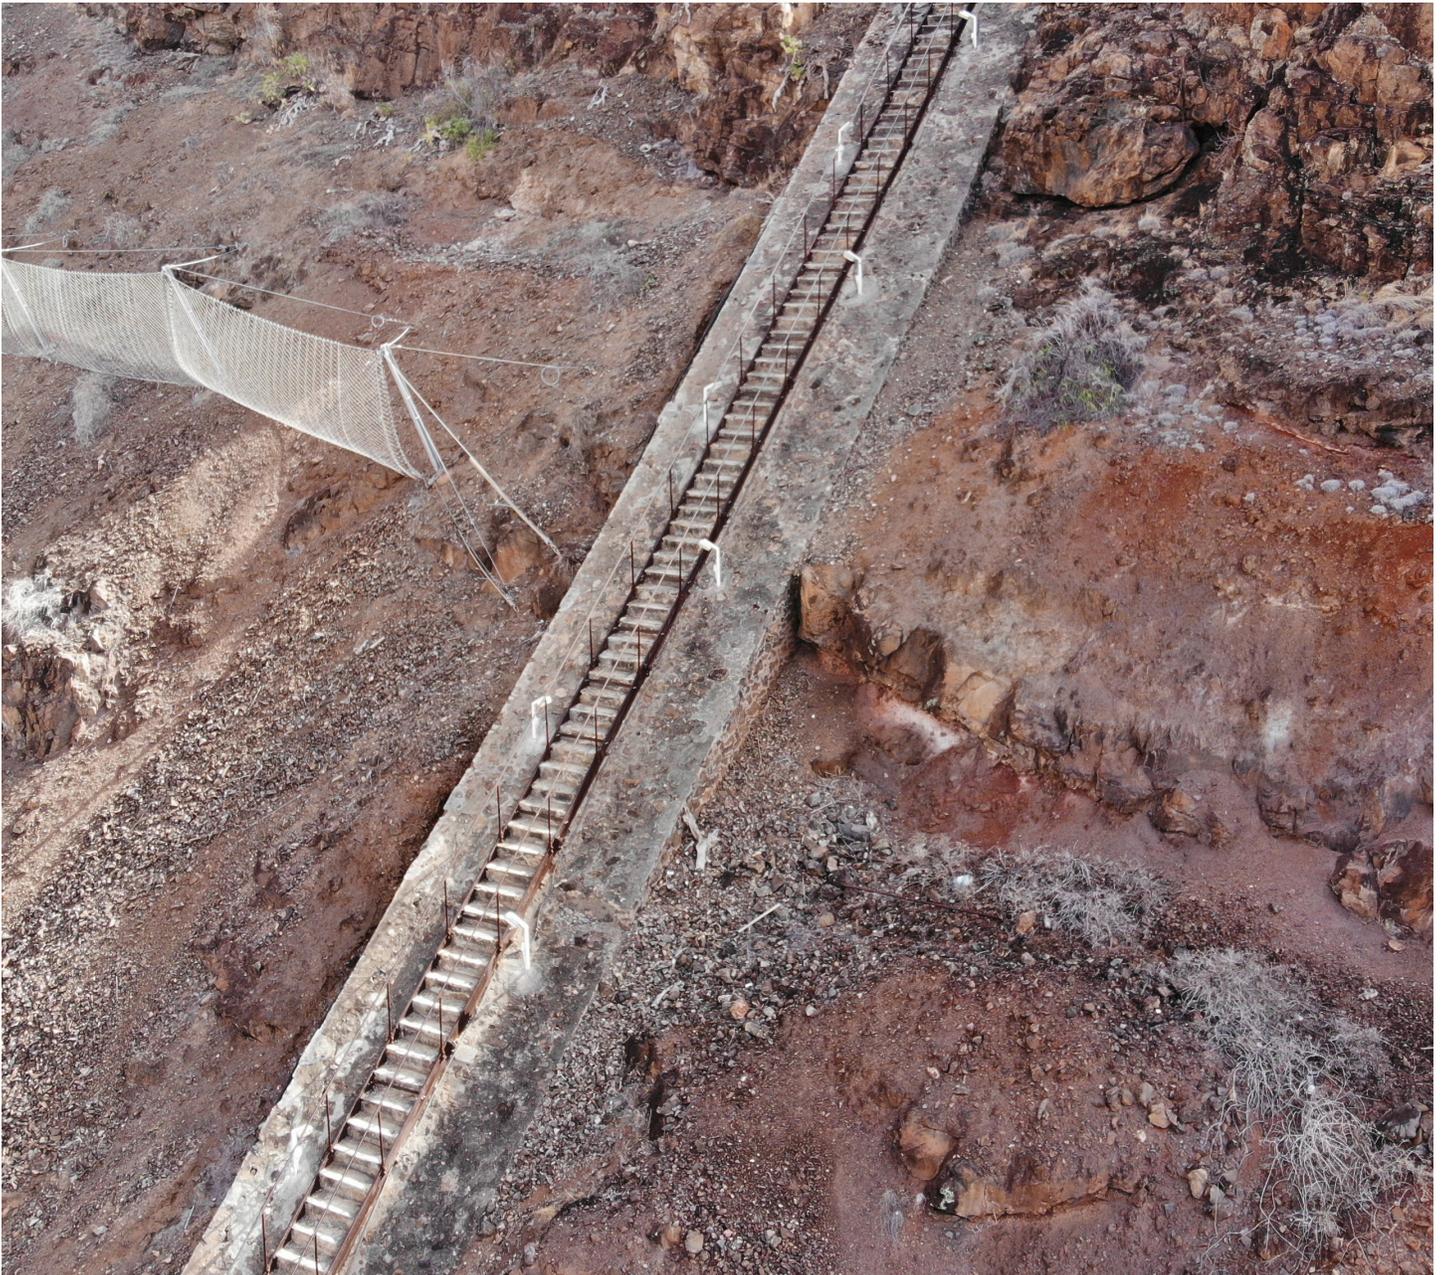
Figure 25: Ladder in context with steel netting (Image: B. Fortenberry).

1. **IMMEDIATE:** Treat for corrosion and coat all metal elements with an anti-corrosive treatment.
2. **SHORT TERM:** Re-attach and loose step elements using a structural restoration mortar.
