Documentation and Conditions Assessment of Banks' Battery, St. Helena (CHC-2020-01-03)

**Report prepared for the British Napoleonic Bicentenary
Trust and St. Helena Government**

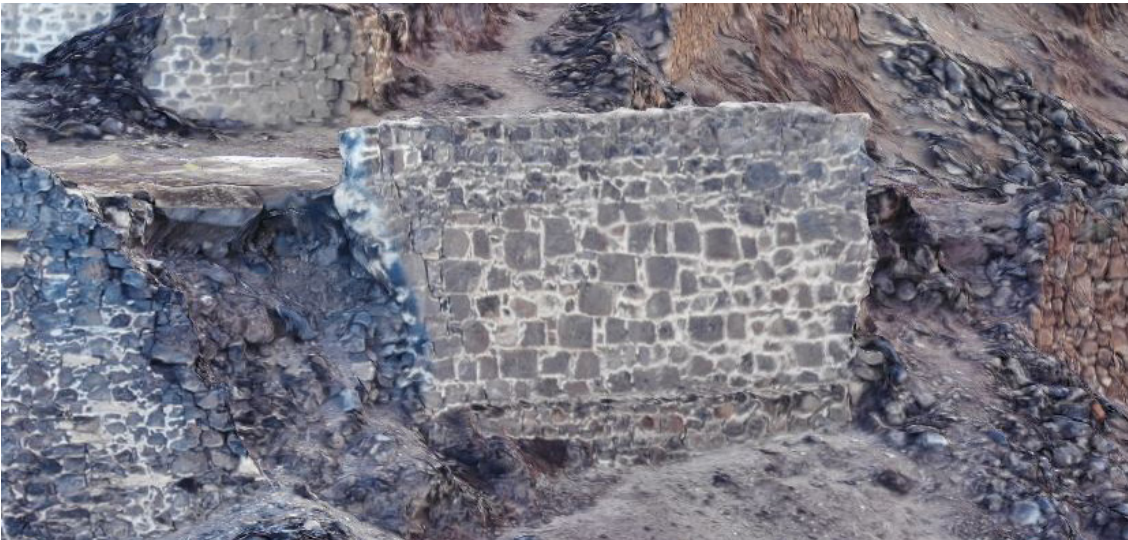
Figure 9:
Photogrammetric model,
detail of wall collapse at
Upper Banks' (Model: B.
Fortenberry).

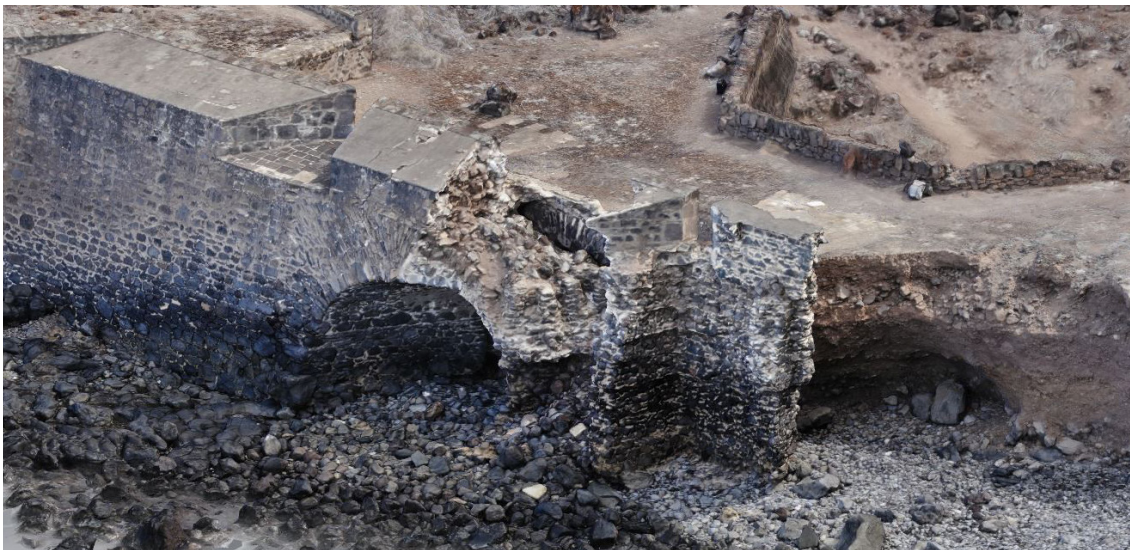
Figure 10:
Photogrammetric model,
arch collapse detail at
Lower Banks' Battery
(Model: B. Fortenberry).

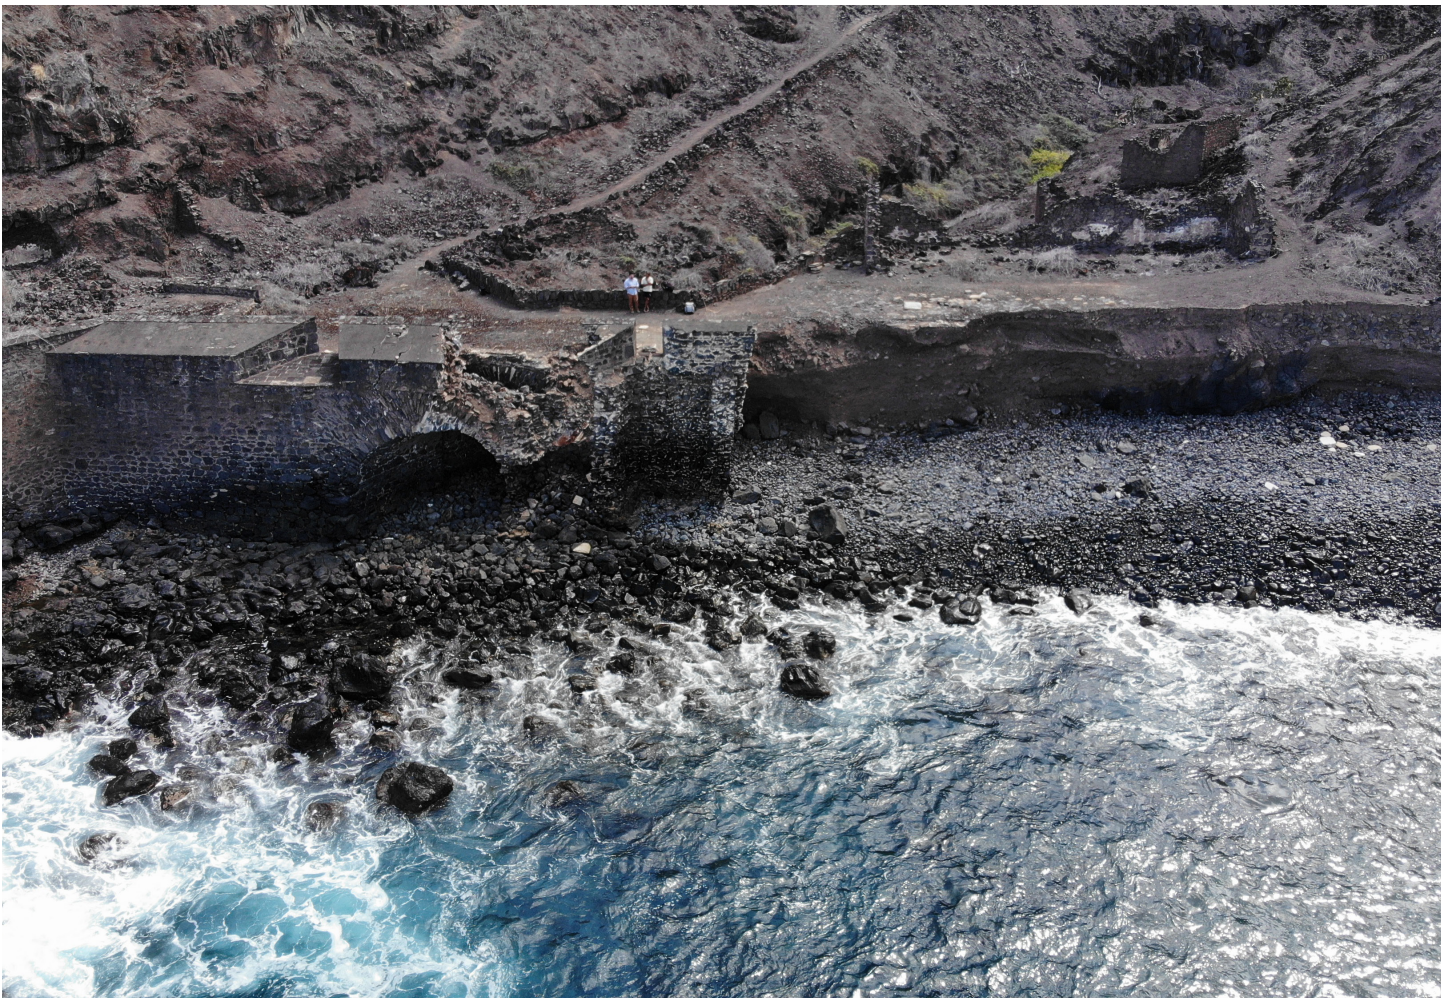
There are several areas of failure along the curtain wall at Lower Banks', all a product of the natural erosion process and deferred maintenance. On the curtain wall the failures occur primarily along the southern half of the line where the stone wall is pulling out (west) from the face. It is likely that erosional processes are pushing sediment outward and down the hill to cause this failure. A second failure to the north of this primary failure, due to the same impacts. In the storm water tunnel the arched opening is also failing as wall movement is pulling the bonding apart. The top, west side (seaward) top of the archway is failing as well.

Figure 12: Aerial image with failing Lower Bank's Battery visible (Image: B. Fortenberry).

1. The multiple wall curtain wall and arch failures at Lower Banks' Battery are the most pressing condition that needs to be addressed, and a structural engineer specializing in historic buildings should be consulted prior to any conservation work taking place. The engineer should examine the photographs, drone images, 3D models, and drawings to make preliminary determinations of the scope of rehabilitation and repair. An on-site visit is preferable for detailed inspection (The ruined buildings could best be conserved as ruins. As such, no roof structures would need to be constructed).

4. Immediate action should be taken to segregate this area from the public areas of the site. There are no barriers, permitting individuals potential access to hazardous areas in and around the collapse of the curtain wall. The area needs to be marked using health and safety guidelines.

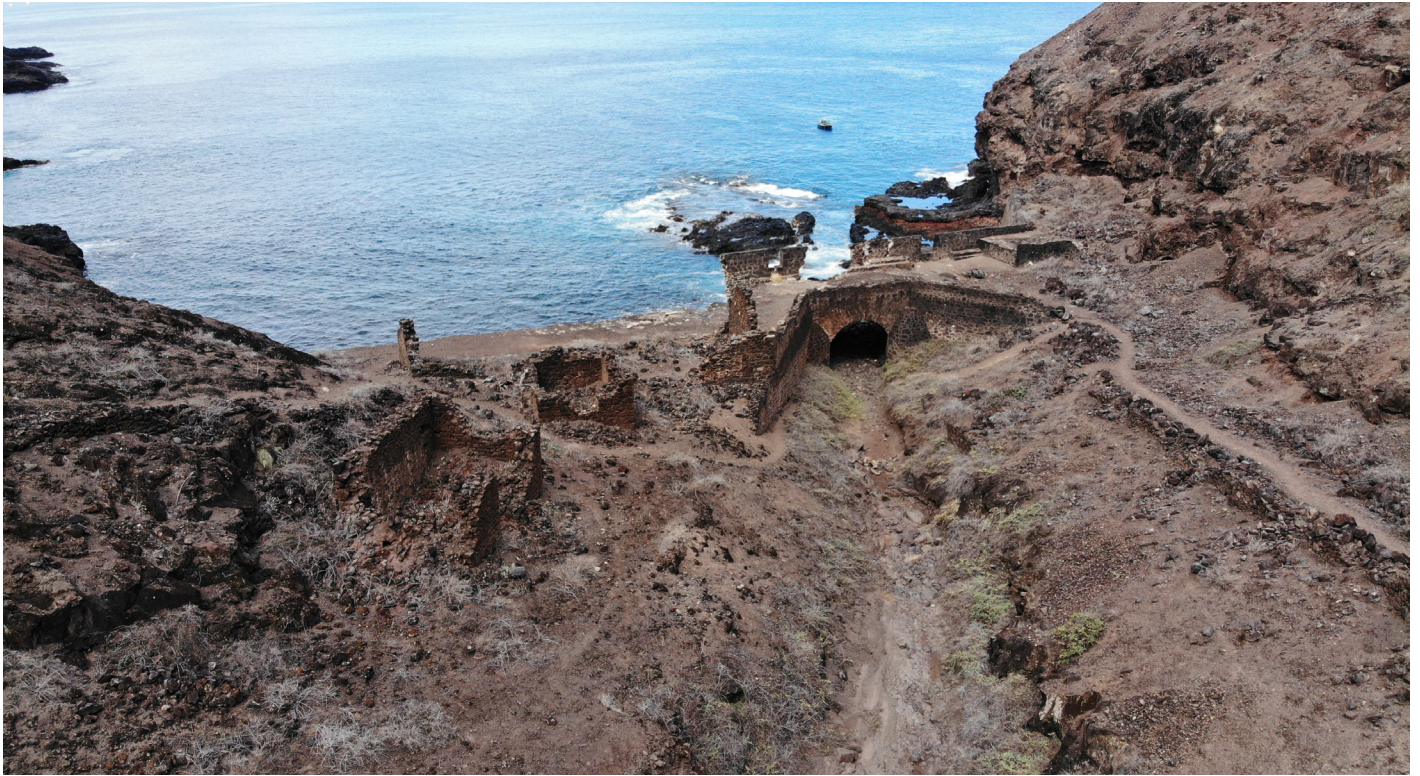
Figure 13: Lower Banks' Curtain Wall as viewed from the east (Image: B. Fortenberry).

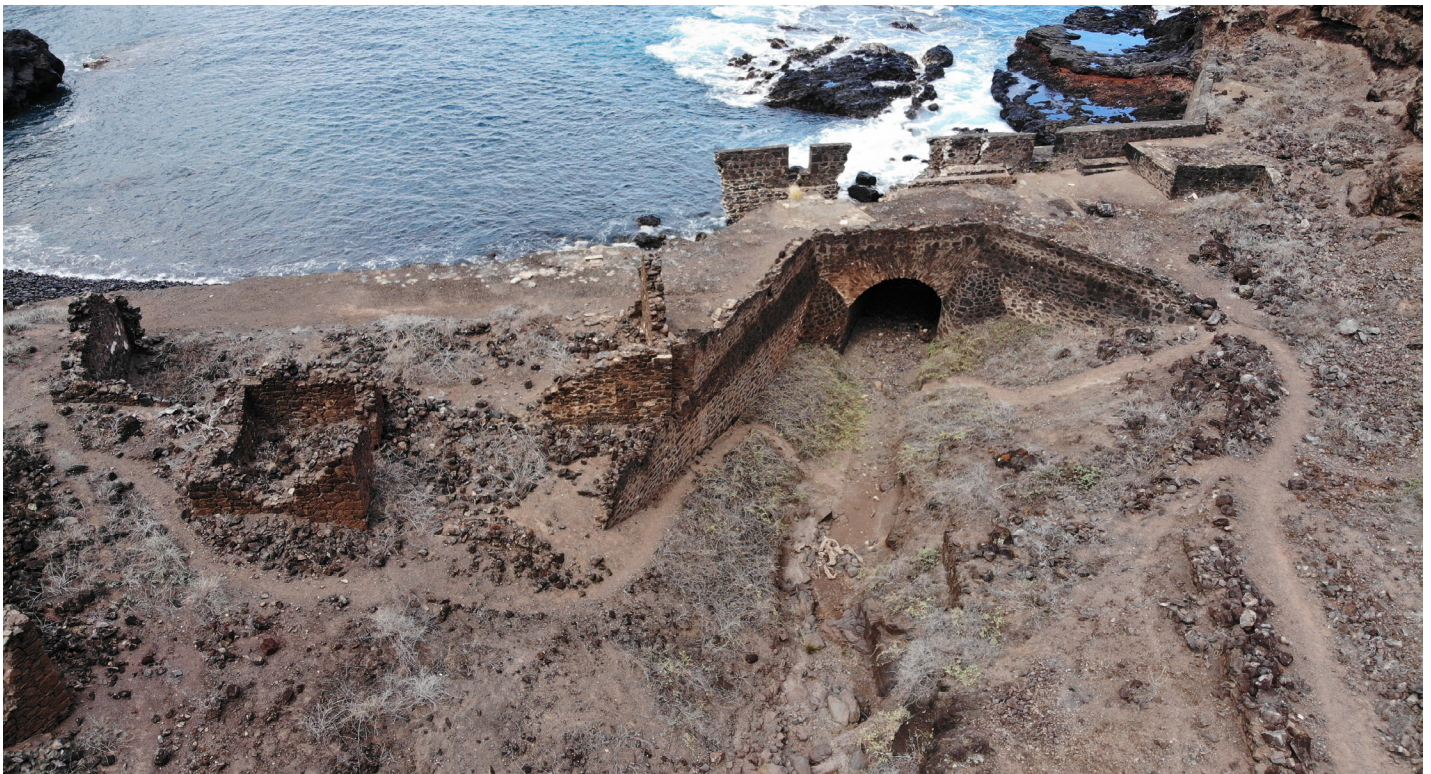
There are also several collapsed structures on Lower Banks' including a barracks building which sits parallel to the curtain wall. A smaller support building to the south, and lime kiln further to the east. These structures are all constructed of local stone and were originally bonded using lime mortars. Some cementitious mortar repairs have taken place however, not a large scale, owing to its isolation from Jamestown and accessibility only via the path from Rupert's or via watercraft.

Figure 14: Lower Banks' Curtain Wall and Ruined Support Structures (Image: B. Fortenberry).

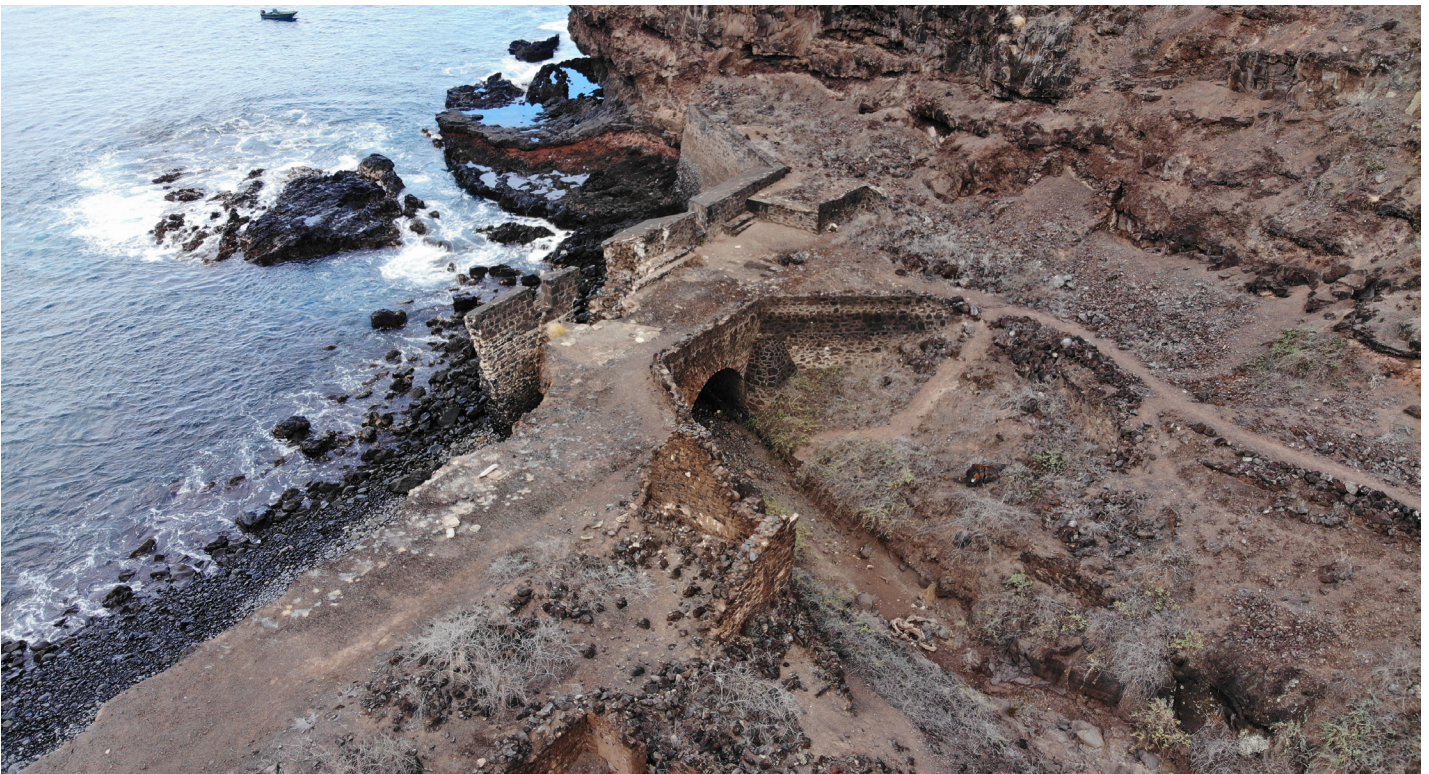
Figure 18: Aerial image of curtain wall Lower Banks' Battery (Image: B. Fortenberry).

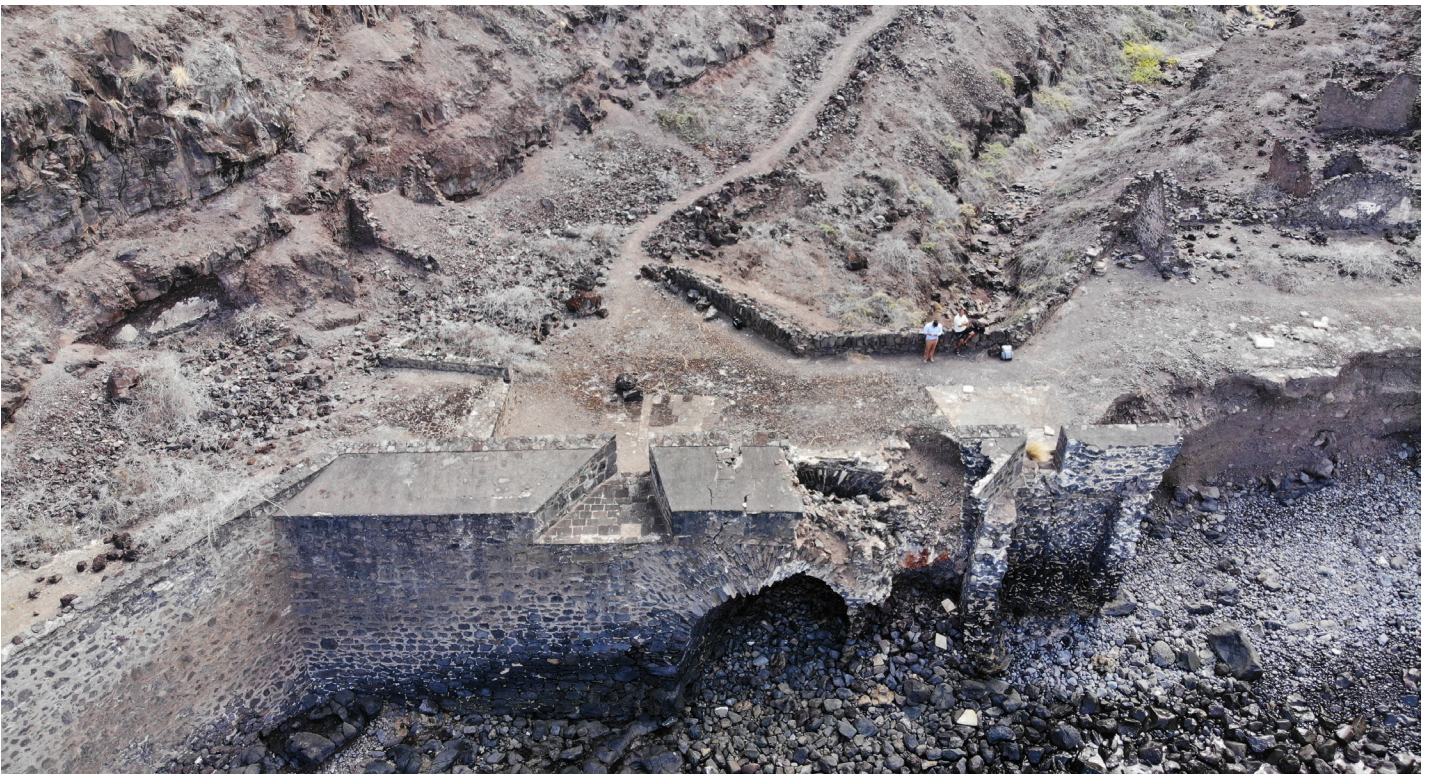
Figure 26: Aerial image of failing curtain wall and support buildings at Lower Banks' Battery (Image: B. Fortenberry).

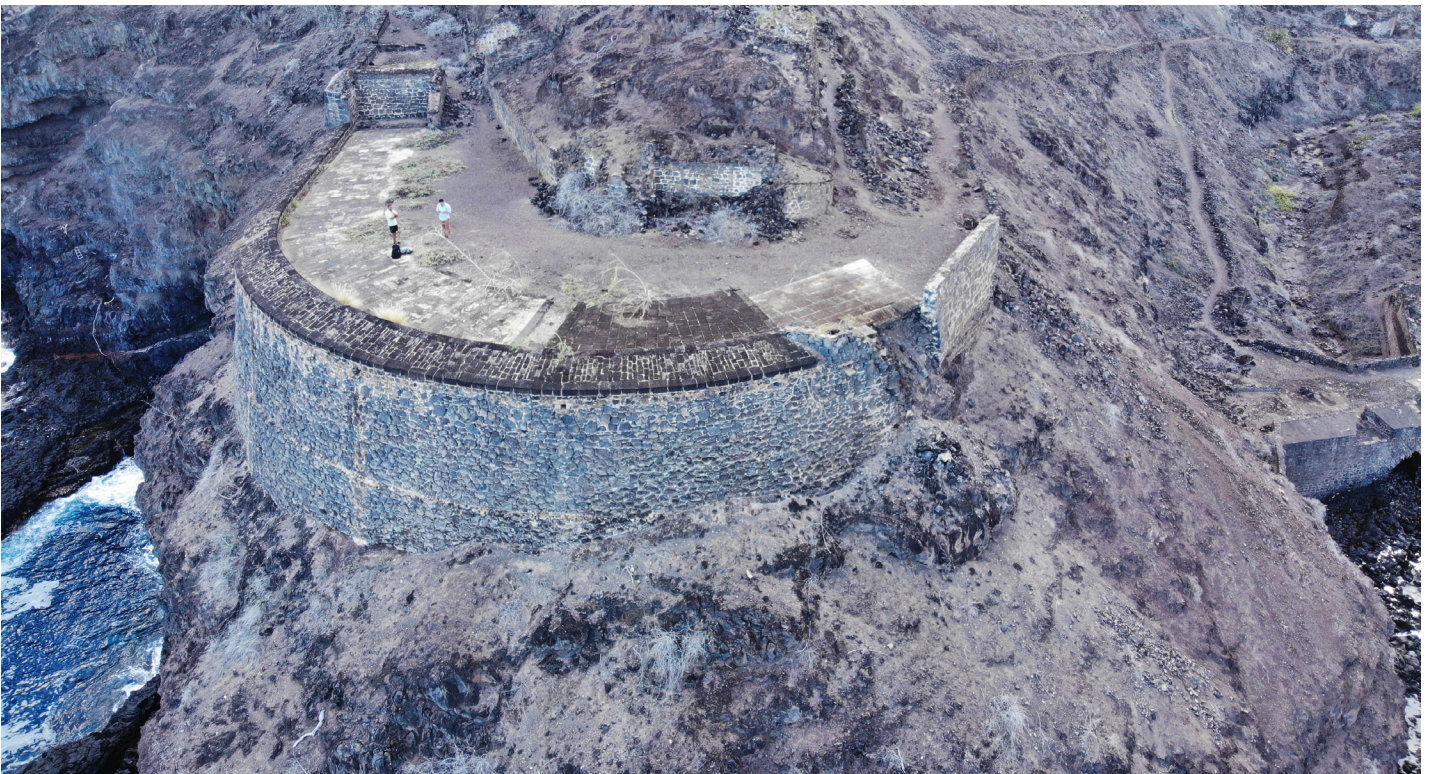
A large section of the southern battery wall has collapsed due to deferred maintenance and erosion. The section is eleven feet wide. It shows the cross section of the wall in the area to be five feet deep set directly into the hill side. The irregularly laid stones are local and are bonded together using a historic lime mortar. There does not appear to be later cementitious mortar repairs here.

Figure 39: Oblique aerial view of Half Moon Battery at Upper Banks' Battery looking east, southern wall collapse in partial view (Image: B. Fortenberry).

1. The multiple wall curtain wall and arch failures at Upper Banks' Battery are the most pressing condition that needs to be addressed, and a structural engineer specializing in historic buildings should be consulted prior to any conservation work taking place. The engineer should examine the photographs, drone images, 3D models, and drawings to make preliminary determinations of the scope of rehabilitation and repair. An on-site visit is preferable for detailed inspection (The ruined buildings could best be conserved as ruins. As such, no roof structures would need to be constructed).

4. Immediate action should be taken to segregate this area from the public areas of the site. There are no barriers, permitting individuals potential access to hazardous areas in and around the collapse of the Half Moon Battery wall. The area needs to be marked using health and safety guidelines.

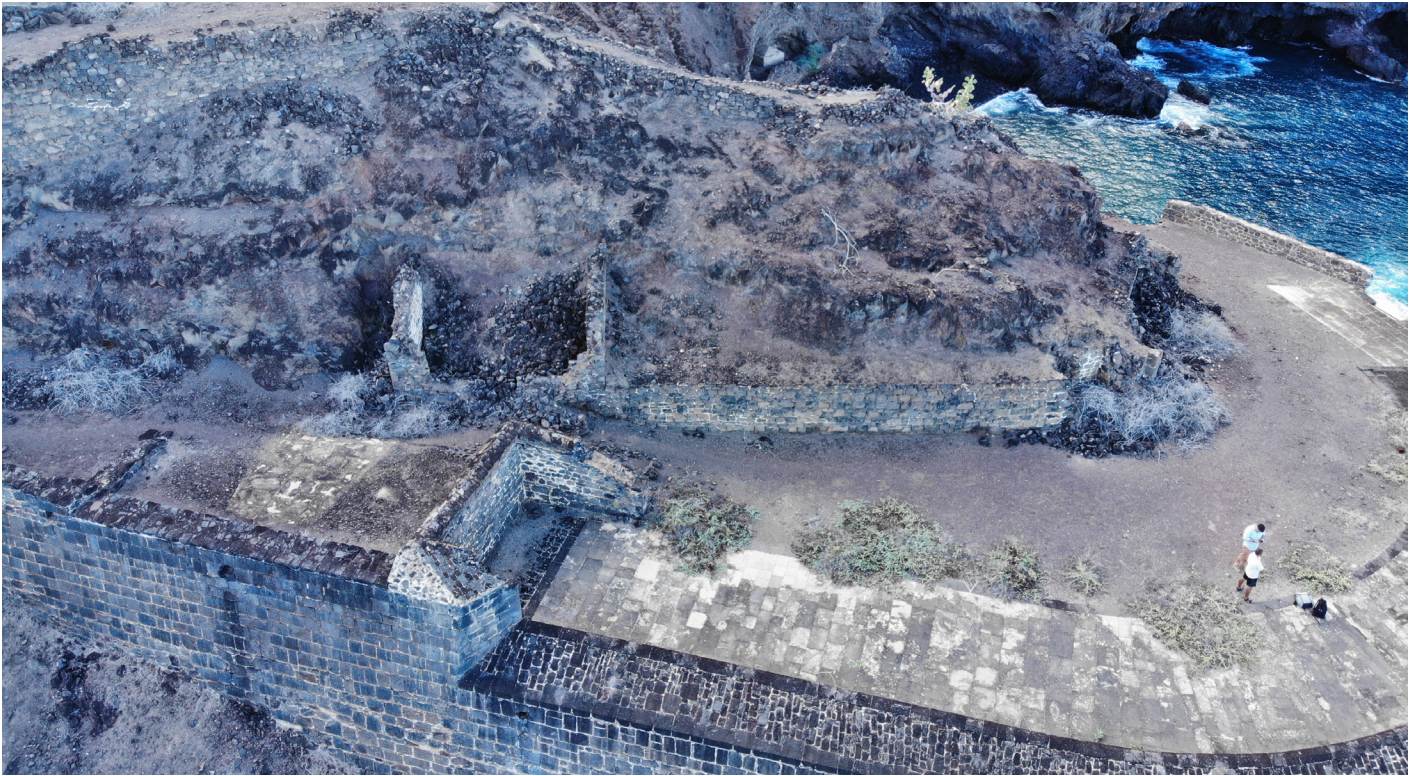
The ruined buildings are in various states of decay, however they all are constructed of worked local stone bonded by lime-based mortars. In some cases, repairs have been made with cementitious mortars. Of note is that some interior plaster survives at the officers' barracks.

Figure 44: Oblique aerial view of ruined structures at Upper Banks' (Image: B. Fortenberry).

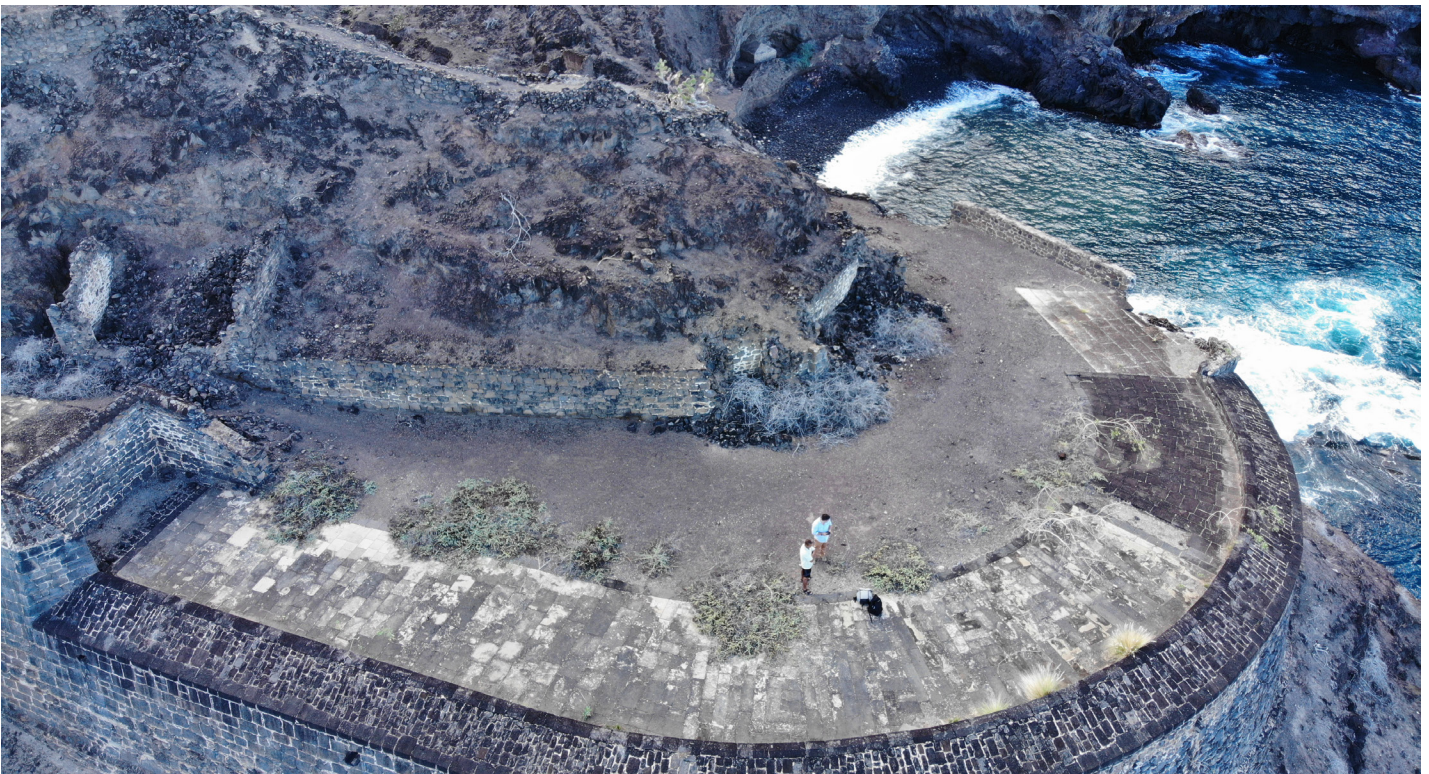
Figure 45: Oblique aerial view of ruined structures at Upper Banks' (Image: B. Fortenberry).

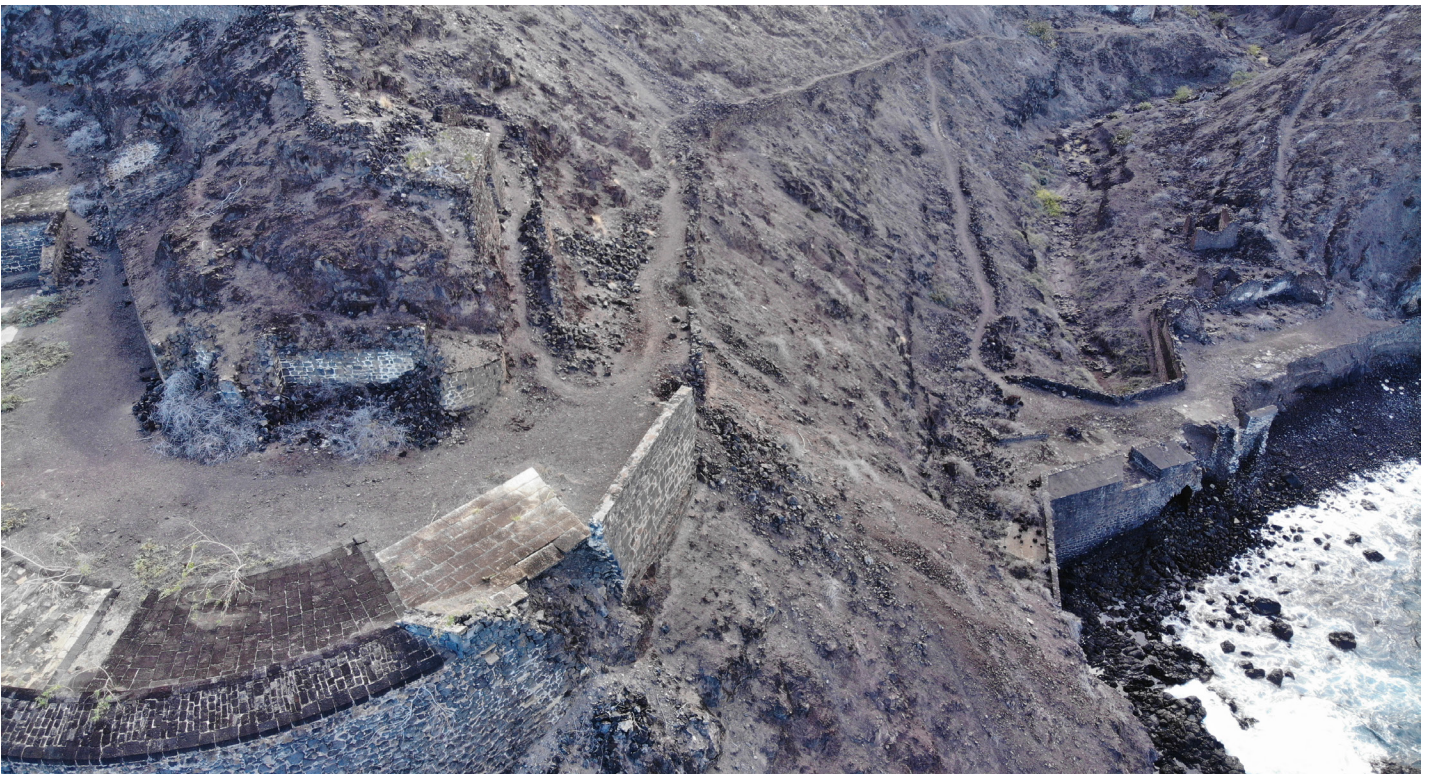
Figure 47: Oblique aerial view of ruined structures and wall collapse at Upper Banks' (Image: B. Fortenberry).

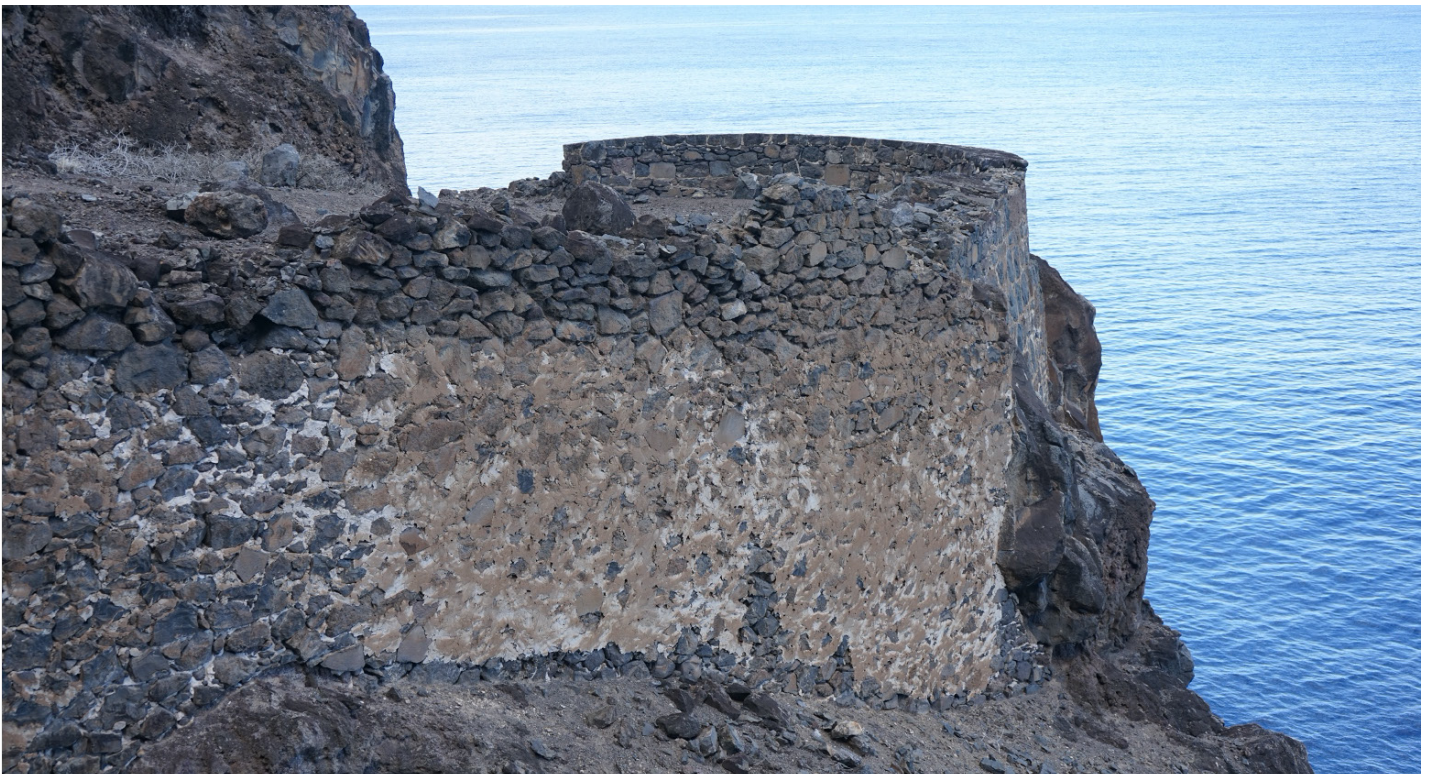
Figure 53: Historically repaired wall on the north edge of Half Moon Battery at Upper Banks' (Image: B. Fortenberry).

7. Do not remove inappropriate mortars without oversight from an architectural conservator. Monitor these areas for mortar failure and repair with historically appropriate mortar composition derived from mortar analysis (Recommendation 5). Mortar replacement should be completed in consultation with an architectural conservator.

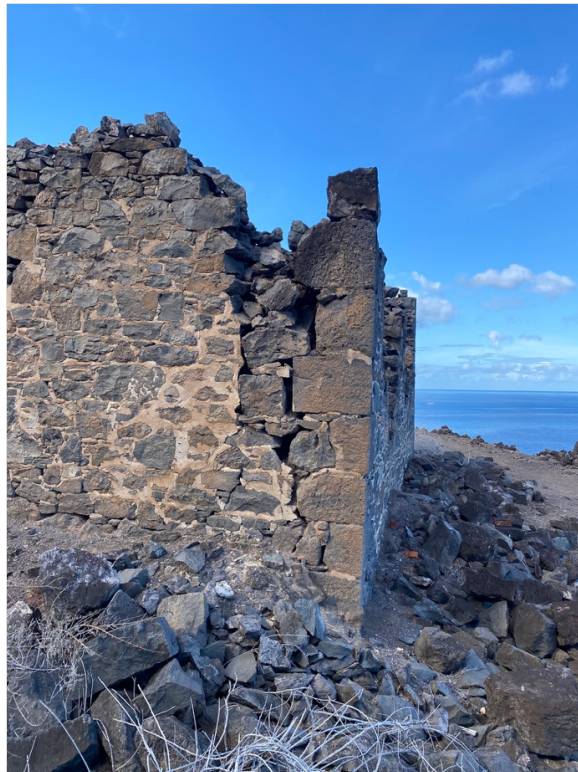
Figure 57: Wall corner collapse at support structure at Upper Banks' Battery (Image: B. Fortenberry).

6. In consultation with an architectural conservator, the dry-laid sections of the walls should be monitored to ensure their long-term integrity, consultation with a conservator and historic building contractor should a dry-laid wall collapse is recommended.

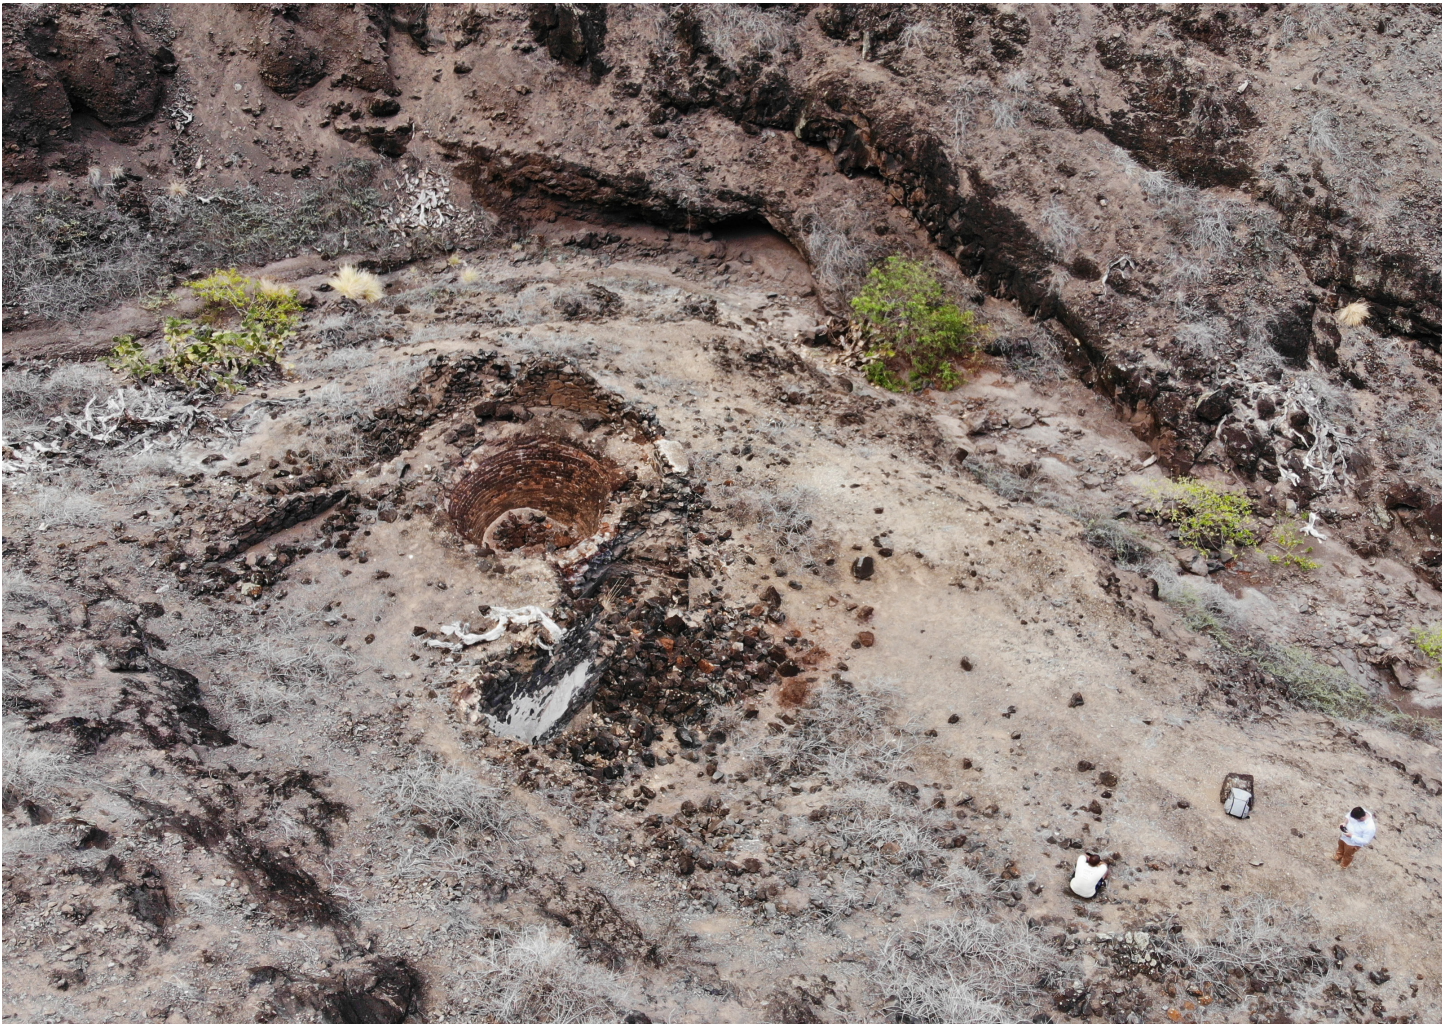
To the east of the Lower Banks' installation a 19th-century lime kiln sits in ruin. The structure was originally square with a conical interior for firing lime. Handmade fire bricks are still present in the firing hole on the east side of the structure. The lime kiln has the potential to add a non-military focus to the site's interpretation and can illustrate the elements of historic building technology to visitors. If ultimately rebuilt, lime firing demonstrations could be performed by local heritage stakeholders.

Figure 58: Oblique aerial view of the Lime Kiln at Lower Banks' Battery (Image: B. Fortenberry).

1. The collapse of the lime kiln outer walls should be addressed as a part of the site's conservation, and a structural engineer specializing in historic buildings should be consulted prior to any conservation work taking place. The engineer should examine the photographs, drone images, 3D models, and drawings to make preliminary determinations of the scope of rehabilitation and repair. An on-site visit is preferable for detailed inspection.

3. Immediate action should be taken to segregate this area from the public areas of the site. There are no barriers, permitting individuals potential access to hazardous areas in and around the collapse of the outer lime kiln walls The area needs to be marked using health and safety guidelines.

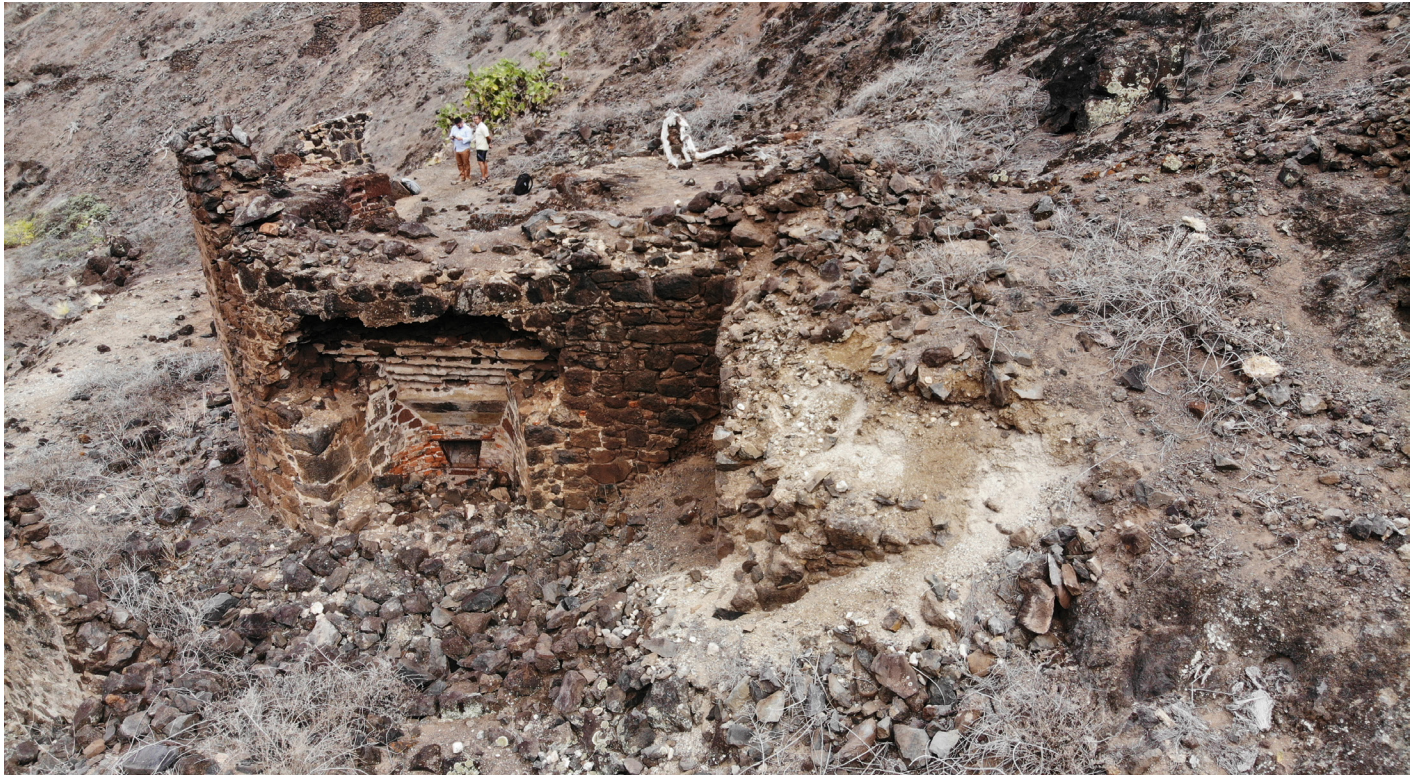
Figure 59: Oblique aerial view of east side of lime kiln with firing hole detailed (Image: B. Fortenberry).

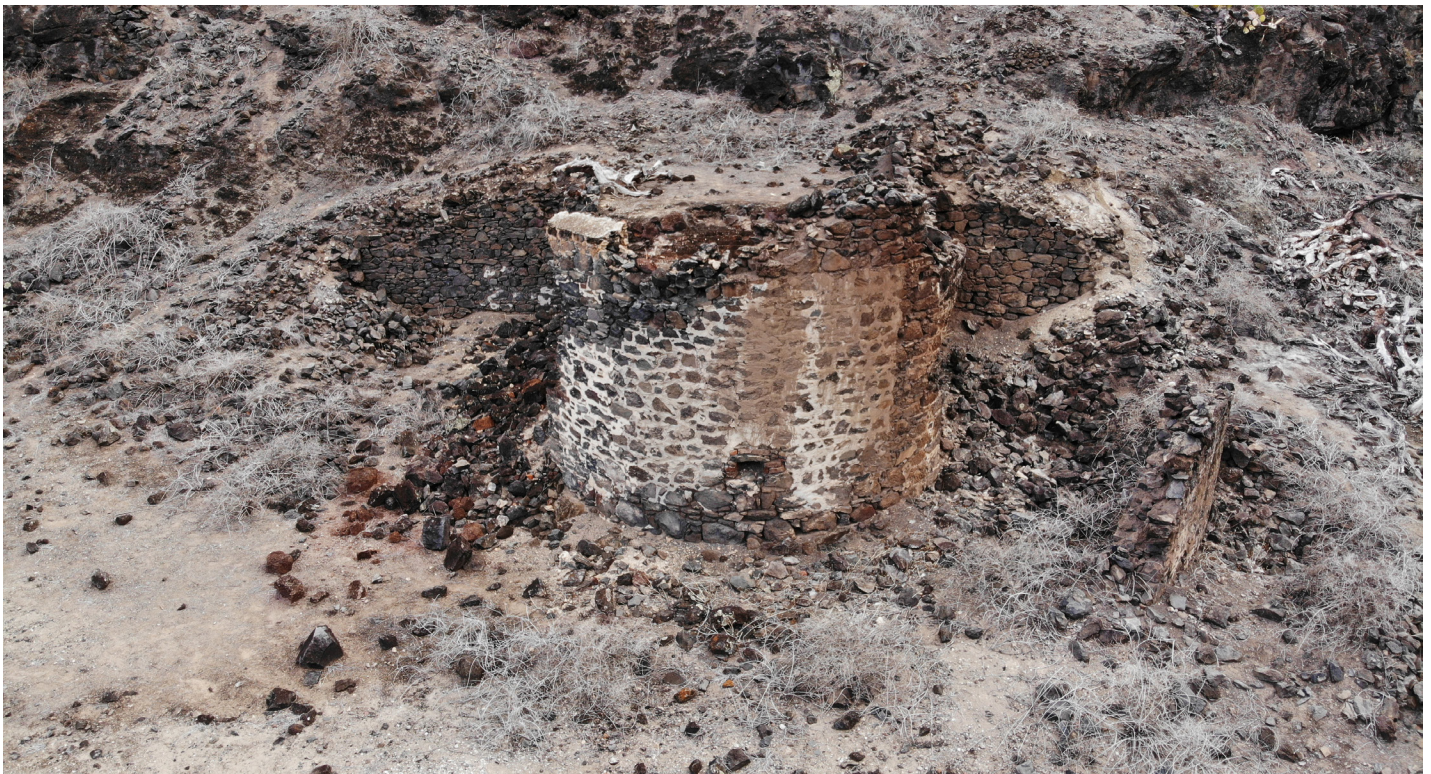
Figure 60: Oblique aerial view of north side of lime kiln with ash shoot detailed (Image: B. Fortenberry).

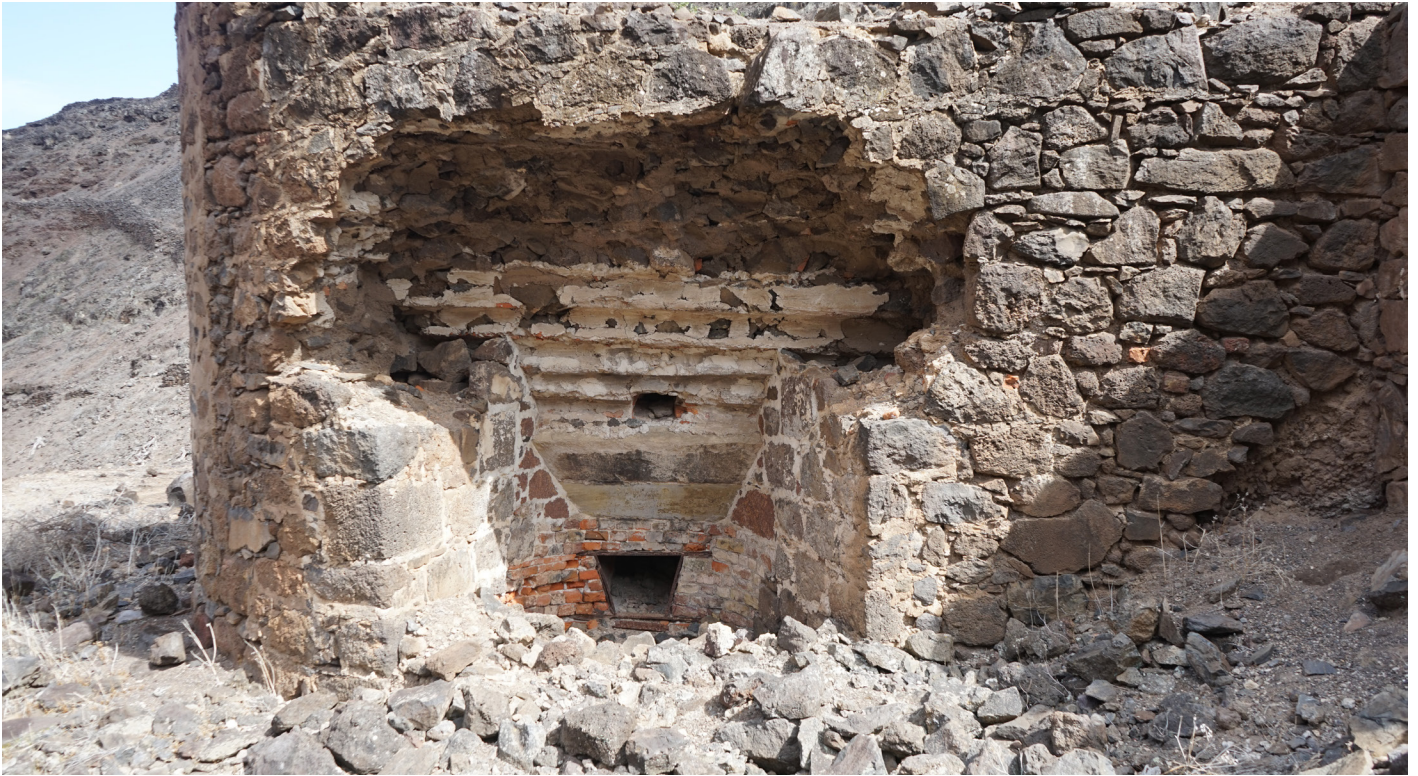
Figure 61: Detail of firing hole of lime kiln (Image: B. Fortenberry).
