Aero-Derivative Gas Turbine Vibration Troubleshooting **Comparing Traditional ODS** and Motion **Magnification Video** Techniques

Maki M. Onari President Mechanical Solutions, Inc. (MSI) maki.onari@mechsol.com

Combined Cycle Plant near Darwin, Australia

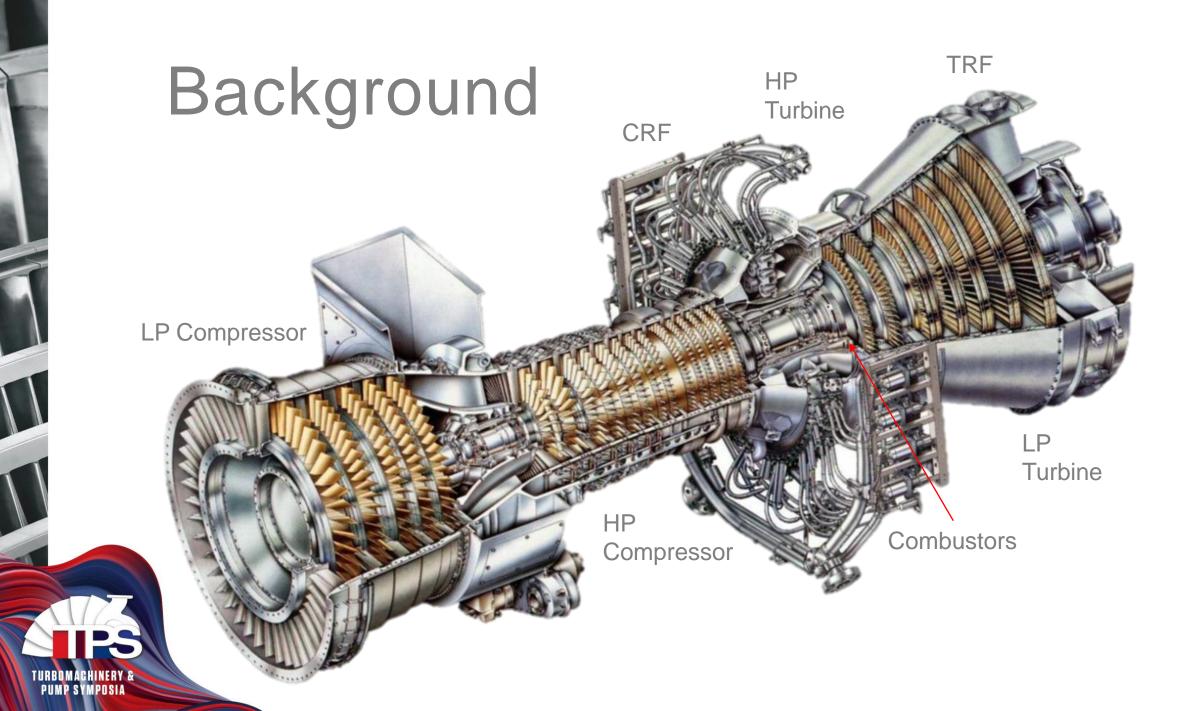
reducer

- 310 MW of installed capacity
- 33 MW Rated capacity:
- LP Rotor Speed:
- HP Rotor Speed:

~3625 rpm or 60.5 Hz 10,400 rpm or 173 Hz • Synchronous Speed: 3,500 rpm through a gear
