High Vibration of a Centrifugal Compressor Casing Caused by the Gas Leakage across a Damaged Gasket

TURBOMACHINERY & PUMP SYMPOSIA

DECEMBER 14-16, 2021

Baker Hughes

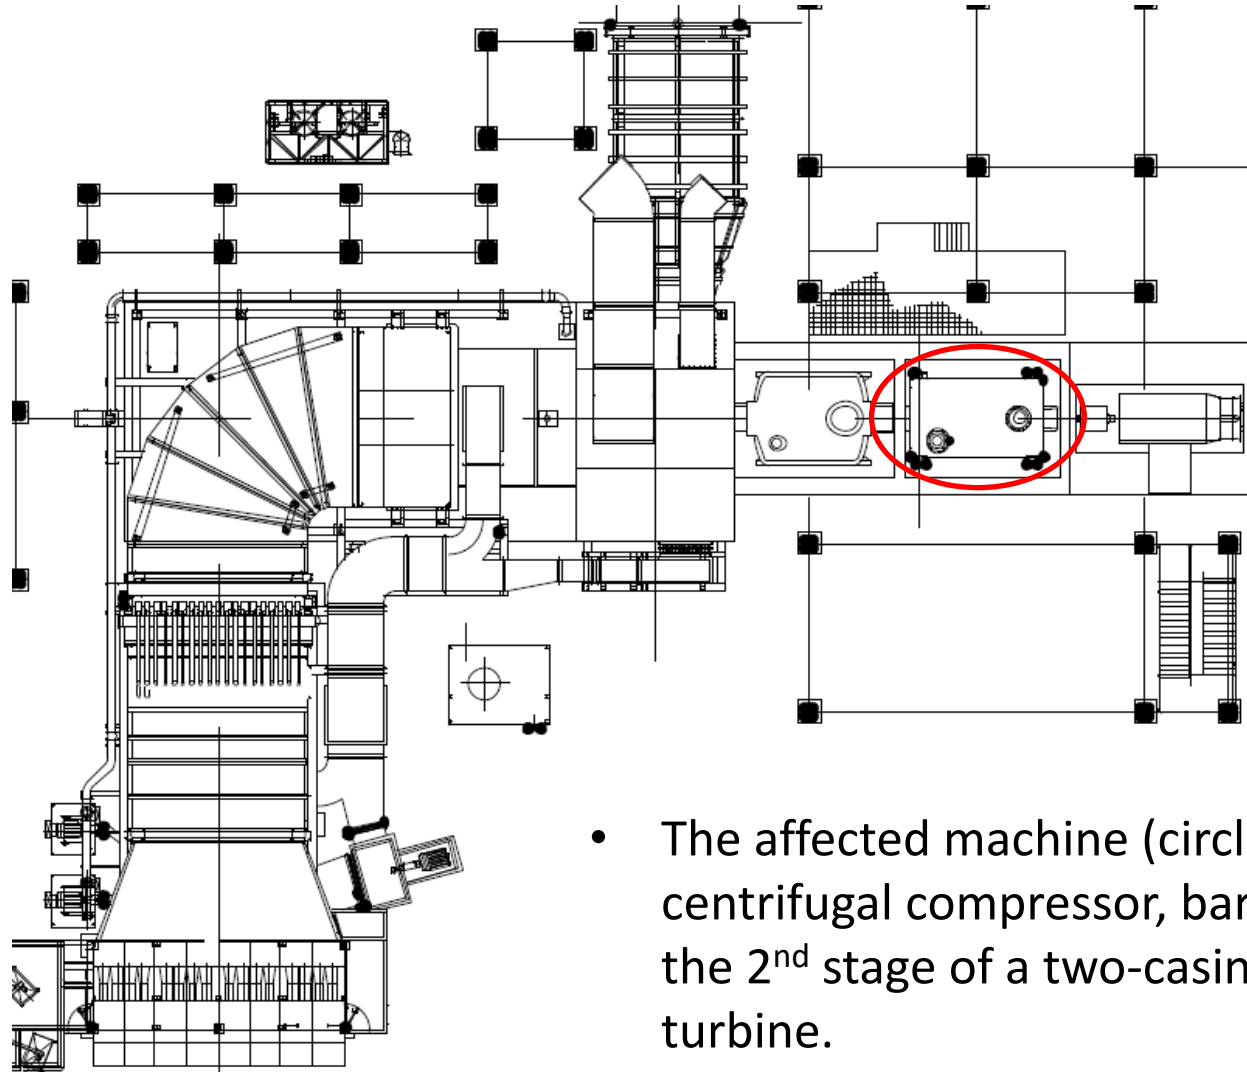
- The affected machine (circled in red) is a natural gas centrifugal compressor, barrel-type with 8 stages in line. It is the 2nd stage of a two-casing compression train, driven by gas turbine.
- The plant includes a total of 4 identical compression trains, running in parallel.

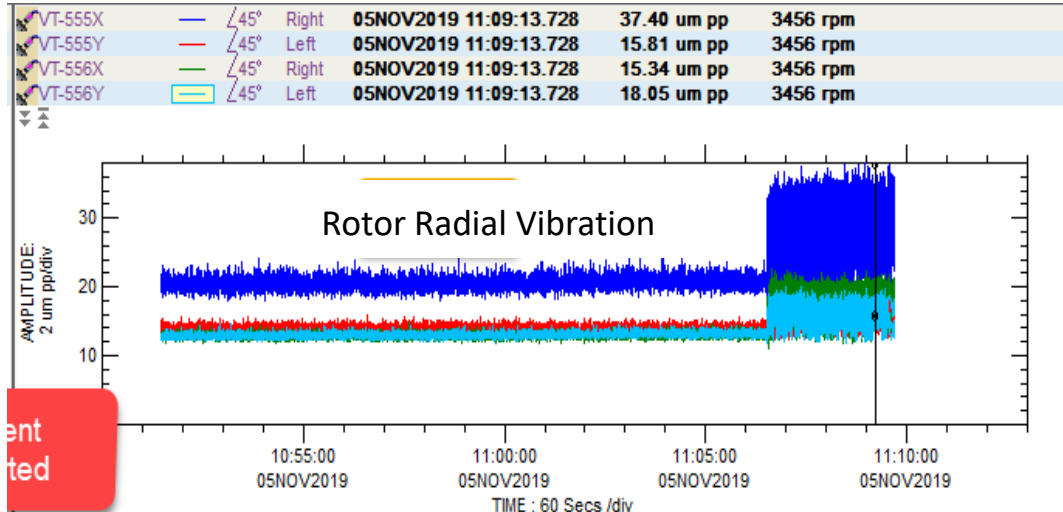
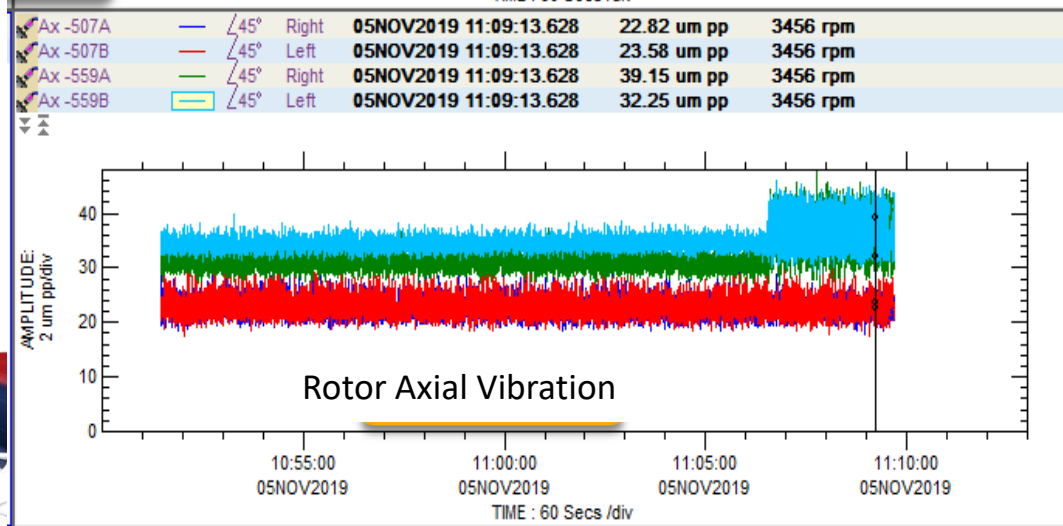
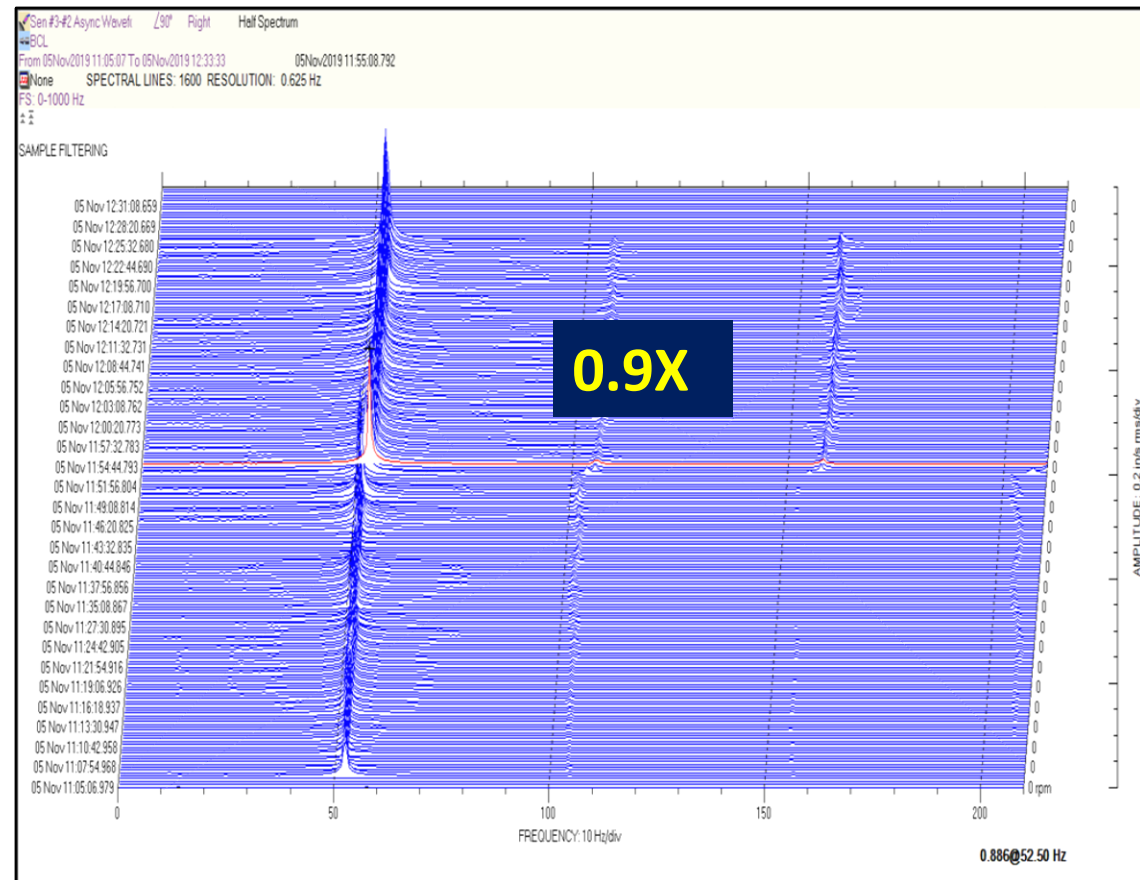
Investigation Methodology - Vibration

- The result of conventional rotor vibration analysis was not conclusive.
 - Resonance was suspected; but didn't have enough evidence to identify the source
- The decision to open the compressor for inspection has consequences
 - Must remove the motor and clutch to reach the compressors
 - Complex piping layout on top of the compressors
 - Special tools required for dismantling the compressor
 - Hence, isolating the problem was critical
- Utilize state-of-the-art technologies to identify the source of resonance
- Correlate between vibration and process

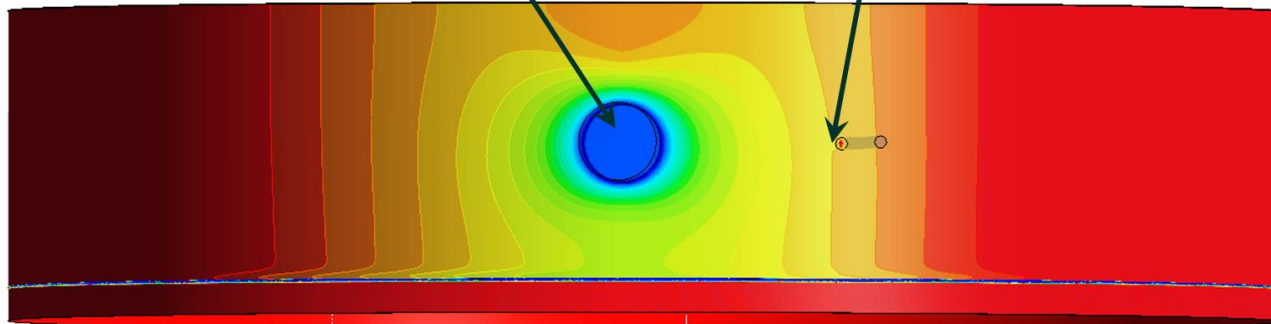
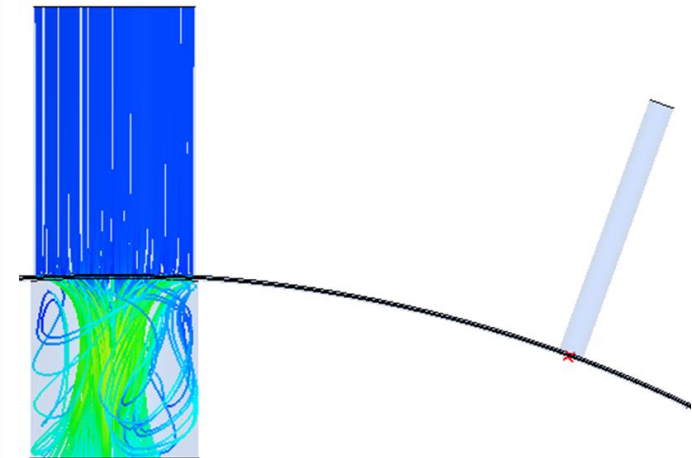
When the O-ring is working the bundle is resting on the bottom of the casing. The casing-bundle clearance at close-gap locations is $a=0.23$ mm at top, 0 mm at bottom and $a/2=0.115$ mm at sides.

Gas leakage velocity is $\cong 0$, due to the presence of the O-ring.

When the O-ring fails, the gas leakage is $G=7.1$ kg/s, limited by the sonic flow across close-gap location (area $S_c=828$ mm²).

The velocity of the gas leakage is not uniform around the bundle, since it is proportional to the local gap width:

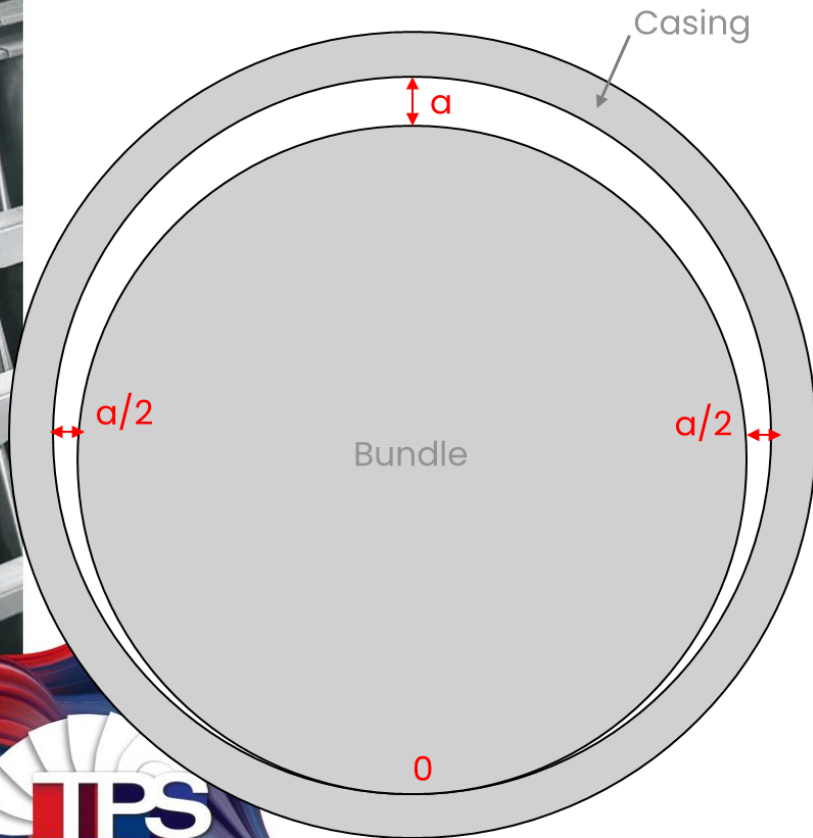
At startup the bundle is resting on the bottom of the casing due to gravity. Therefore the casing-bundle gap at locations A & C is $a=0.23$ mm at top, 0 mm at bottom and $a/2=0.115$ mm at sides.

When the O-ring is failed, the gas leakage is limited by the sonic flow across location C gap (area $S_C=828$ mm²). The gas flowrate across C gap is $G=7.1$ kg/s.

Across B gap (area $S_A=22577$ mm²) this leakage corresponds to is $Q=0.194$ m³/s and therefore to an average velocity of $Q/S_A=8.6$ m/s.

- at bundle top, $= 8.6 * 0.23 / 0.115 = 17.2$ m/s
- at bundle bottom, $8.6 * 0 / 0.115 = 0$ m/s
- at bundle sides, $8.6 * 0.115 / 0.115 = 8.6$ m/s

Therefore the average velocity along B for the top half of the bundle is $v_{TOP} = (17.2+8.6)/2 = 12.9$ m/s, while for the bottom half of the bundle it is $v_{BOTTOM} = (0+8.6)/2 = 4.3$ m/s.
