# 49<sup>TH</sup> TURBOMACHINERY & 36<sup>TH</sup> PUMP SYMPOSIA

## Analyzing and Resolving an ID Fan Failure Due to Torsional Vibration

Gary Galloway, Carmeuse Lime  
Dan Phillips, Regal Beloit America, Inc.

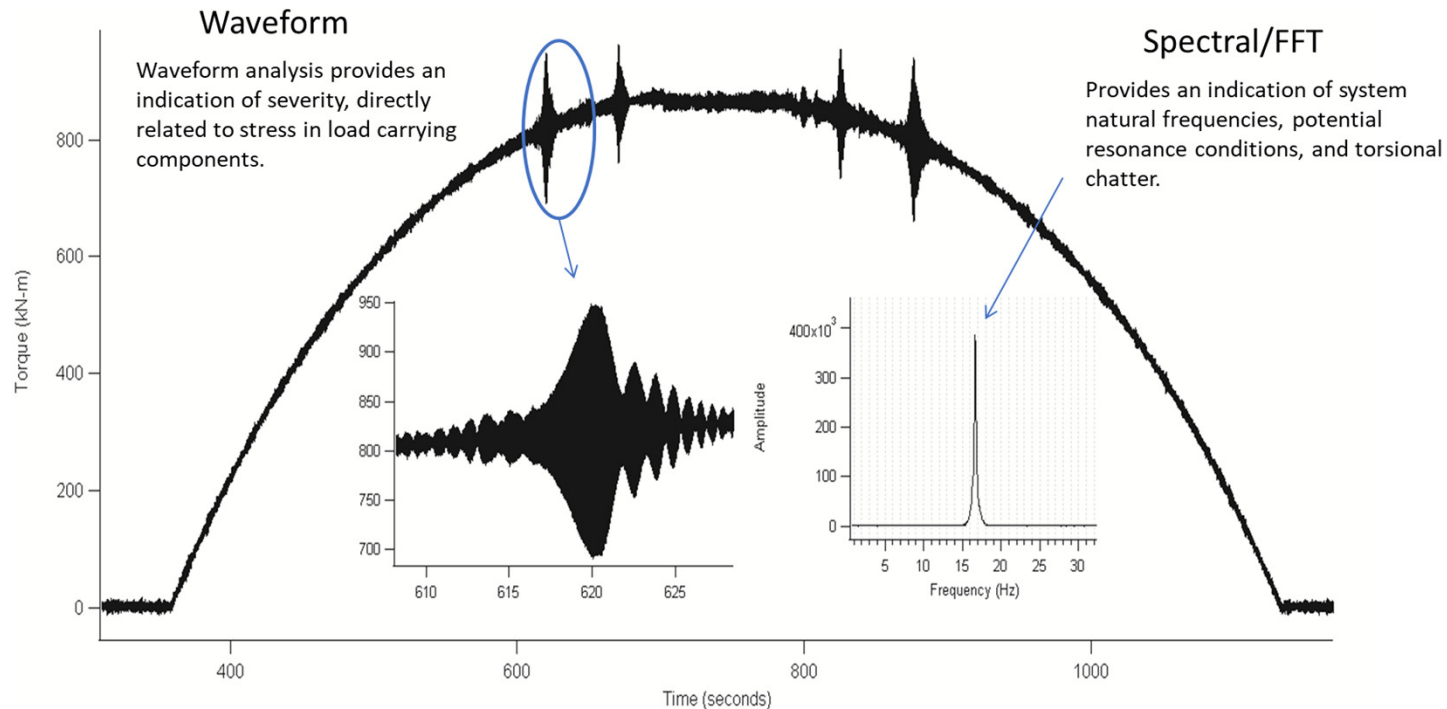
- Transient Torque
  - Strain Gage Telemetry installed on motor and fan shafts
  - Allowed for measurement redundancy and evaluation of flexible coupling effects
  - Strain data converted to torque based on geometry & shaft material
  - Recorded at 2,000 Hz (Samples/Sec)
  - Waveform and spectral analysis utilized

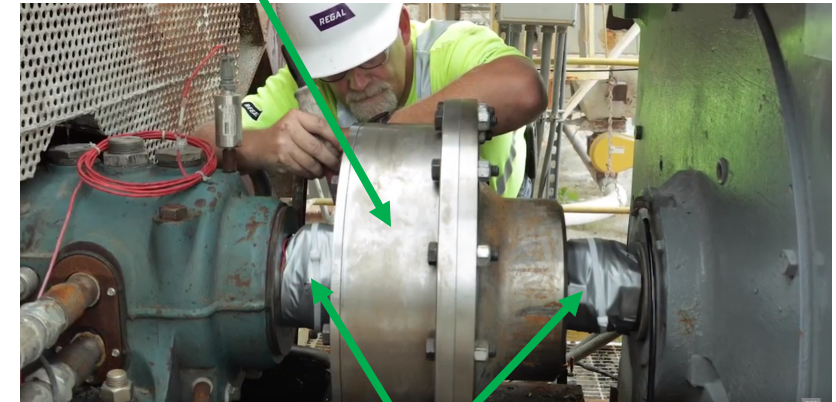
Wedge-block style Elastomeric coupling installed following torsional analysis

Subsequent tests measured torque at fan and motor shaft

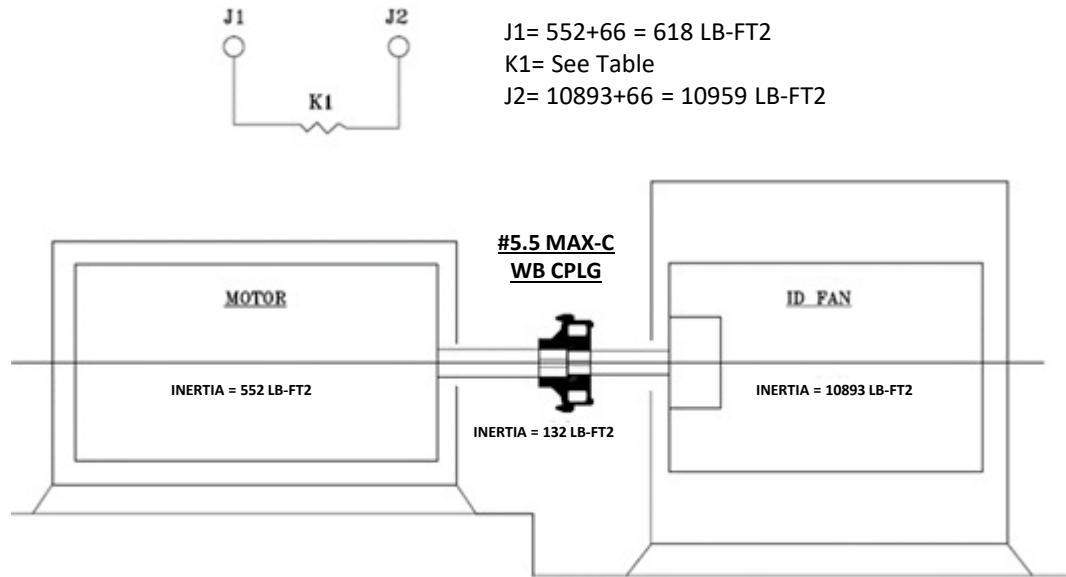
Torsional Analysis Performed on ID Fan Drivetrain

NOTE\*\* : COUPLING STIFFNESS CHANGES PER TORQUE

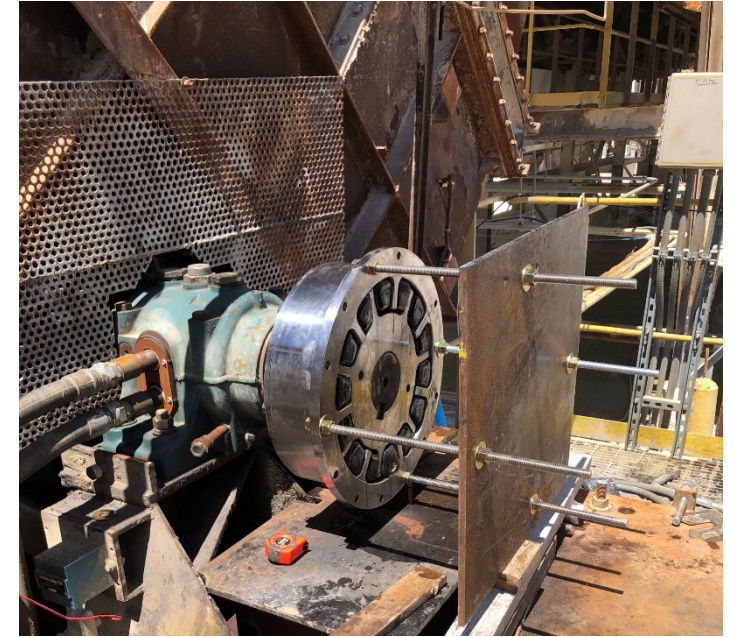
- Final testing showed a significant reduction (80%) in the torsional vibration, keeping the stress in the motor shaft below the endurance limit for the material.
- Testing was performed throughout the entire speed range with the kiln at  $\sim 600$  °F and showed no torsional oscillations of concern.
