# 49<sup>TH</sup> TURBOMACHINERY & 36<sup>TH</sup> PUMP SYMPOSIA

## Carbon Ring Seal Failure in a High Pressure CO<sub>2</sub> Compressor

Patrick J. Smith and Matthew I. Barausky

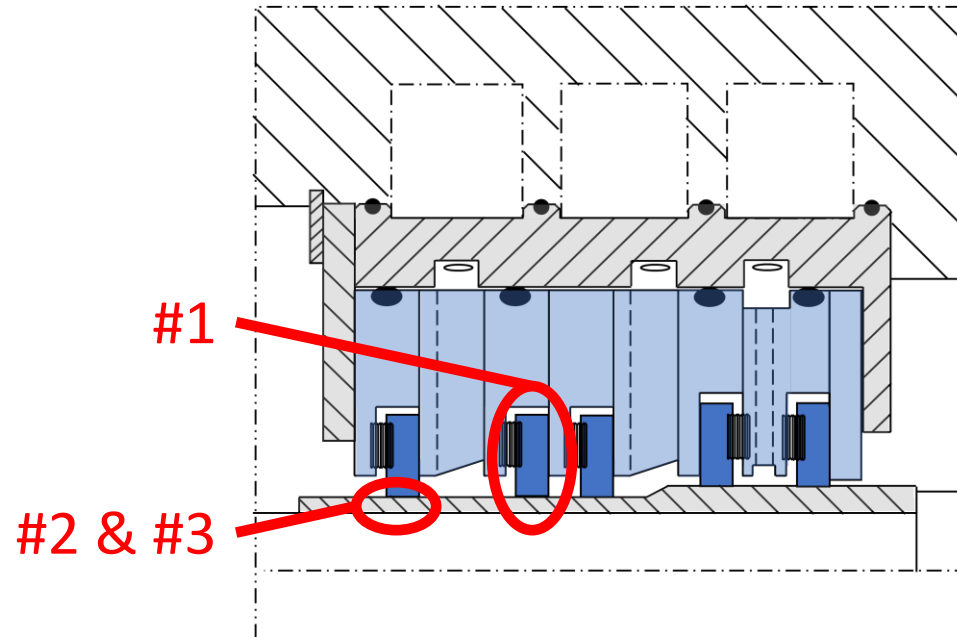
1. Excessive carbon ring clearances (parts out of tolerance)
2. Carbon ring damage from assembly / commissioning (broken rings)
3. Excessive carbon ring clearances from wear to ring and/or sleeve

- The compressor continued to operate with the high vent flows while the cause was investigated. Plants were online at this time so the machine could not be shutdown for internal inspections without causing curtailments.
- After a few months in service, the machine tripped on high vibration. While repairing the cause of the vibration, the stage 7 and 8 seal cartridges were changed out with spares.
- After the outage, the stage 7 and 8 seals were inspected with the OEM and substantial deformation of the seal support plates (lantern rings) was discovered.

- **Root Cause**: The axial force from differential pressure across the seal rings transmitted to the lantern rings and their thin sections were permanently deformed. This allowed substantial high pressure gas to leak past the carbon ring seal faces.
  - ~8,000 lbf axial force from pressure differential on 7<sup>th</sup> stage.
  - Lantern rings deformed ~0.040 inch (1 mm) at midspan between supports. Plate thickness in this area is ~0.110 inch (2.8 mm).
- **Solution**: Strengthen the thin areas of the lantern rings by increasing the number of support ribs.

- Modified lantern rings in the spare seal cartridges and took an outage in the 2<sup>nd</sup> year of plant operation to install upgraded seals.
  - Prior to the outage, HP section capacity was 11% short of design.
  - After the outage, HP section capacity was 3% short of design capacity.
  - Upgraded seals resulted in a 77% reduction in capacity shortfall.
  - Total HP vent flow is 1784 lb/hr (4.8x design flow of 372 lb/hr)
- **Currently have ~48,000 operating hours on the upgraded seals** (Spring 2020). No additional problems or degradation. HP vent flow is above original design but has been steady since seal upgrade.
