49TH TURBOMACHINERY & 36TH PUMP SYMPOSIA

Modernization of 75-year old Turbo Generator Emergency Trip System

Matthew D. Moll, Celanese

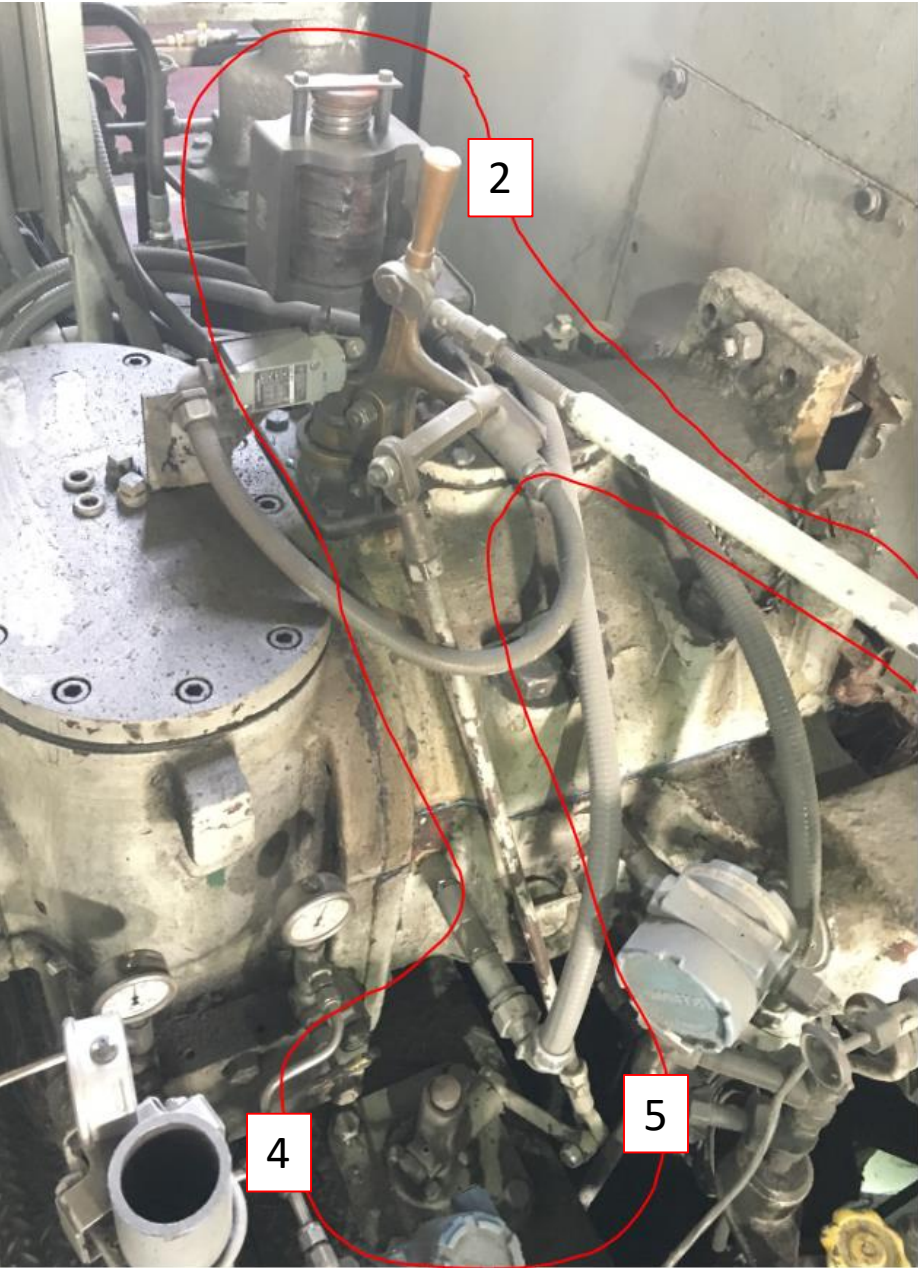
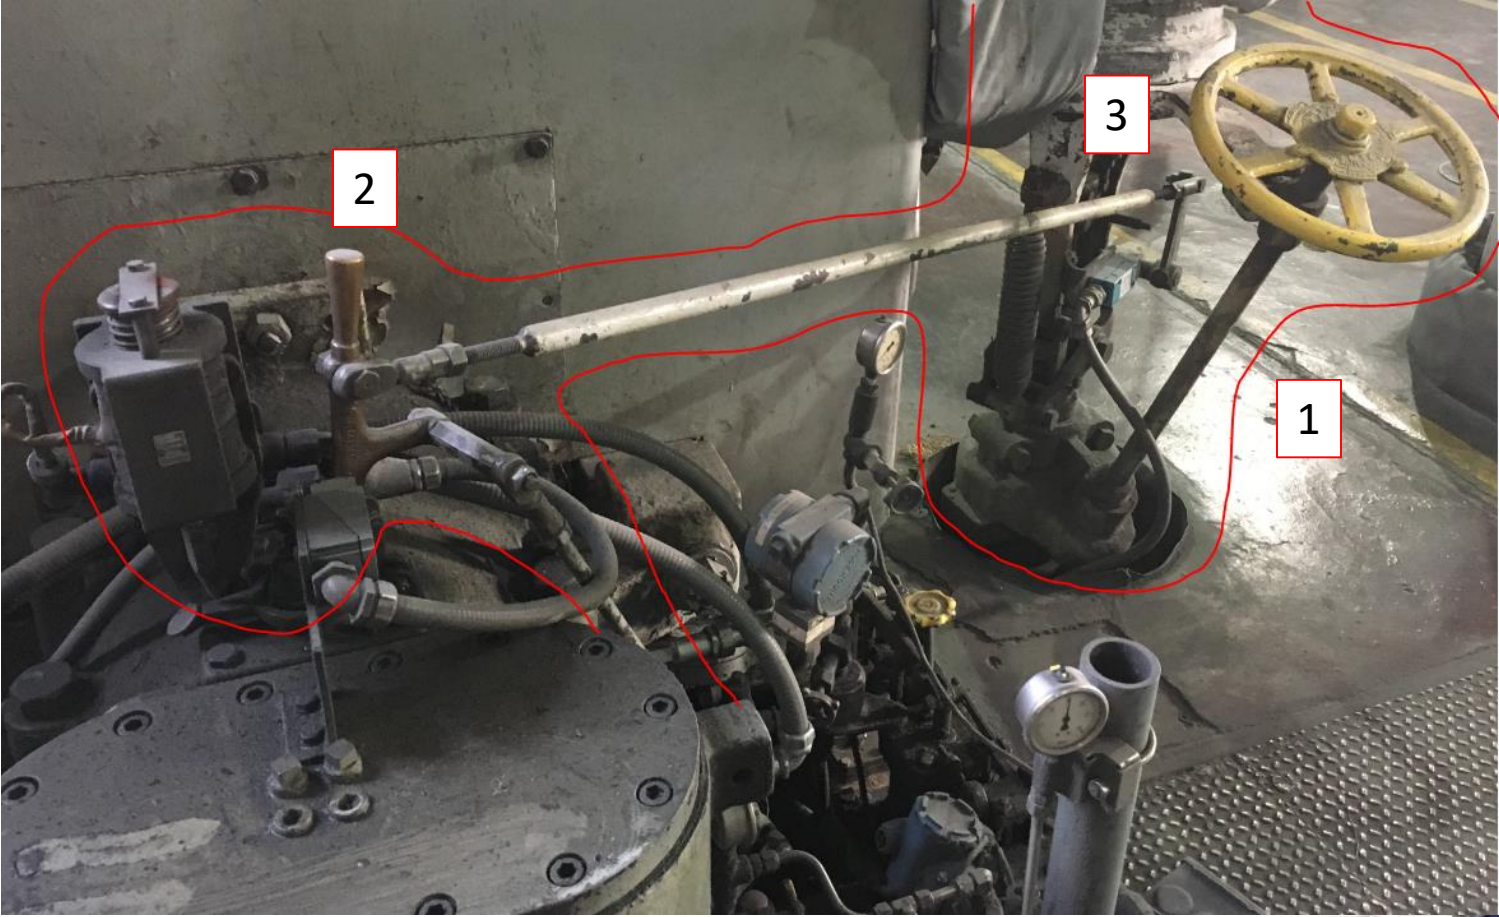
Existing Installation

- A 1944 & 1945 6MW dual extraction condensing TG's at the Celanese Narrows, VA site experienced failures of the Trip and Throttle Valve (T&TV) 6 times over a 5 year period
- When the turbine entered a tripped state, the T&TV would remain open but close unexpectedly after operators touched the handwheel.
- The problem was not repeatable after the initial incident, which limited troubleshooting efforts
- Steam conditions on site were excellent and machines of similar size and construction did not exhibit the same problems

- Previous overhauls of the valves and trip systems by the OEM field services division did not remedy the problems
- Frequency of failure of the safety system and potential consequence did not meet Celanese Risk Assessment Risk Management (RARM) criteria and required action
 - RARM utilized actual data from events to create fault trees and event trees thereby quantifying the risk
 - After review of the calculation by committee and safety, risk was determined to be unacceptable
