49TH TURBOMACHINERY & 36TH PUMP SYMPOSIA

Detection of Misalignment from Vibration Data

On a boiler feed pump driven by a motor running close to 3600 rpm, a horizontal misalignment issue was suspected by examining orbit plots besides shaft centerline plots. The follow-up inspection did uncover large parallel misalignment of 0.012 inch along the horizontal direction between the pump and the motor. The root-cause of changes in alignment indicates piping strain as evidenced by loose bolts between the pump and the foundation. The unit was then re-aligned to below 0.001 inch in parallel alignment, followed by correct re-assembly of the coupling. Shaft vibration was successfully reduced to below 2 mil pp and with a normal orbit orientation.

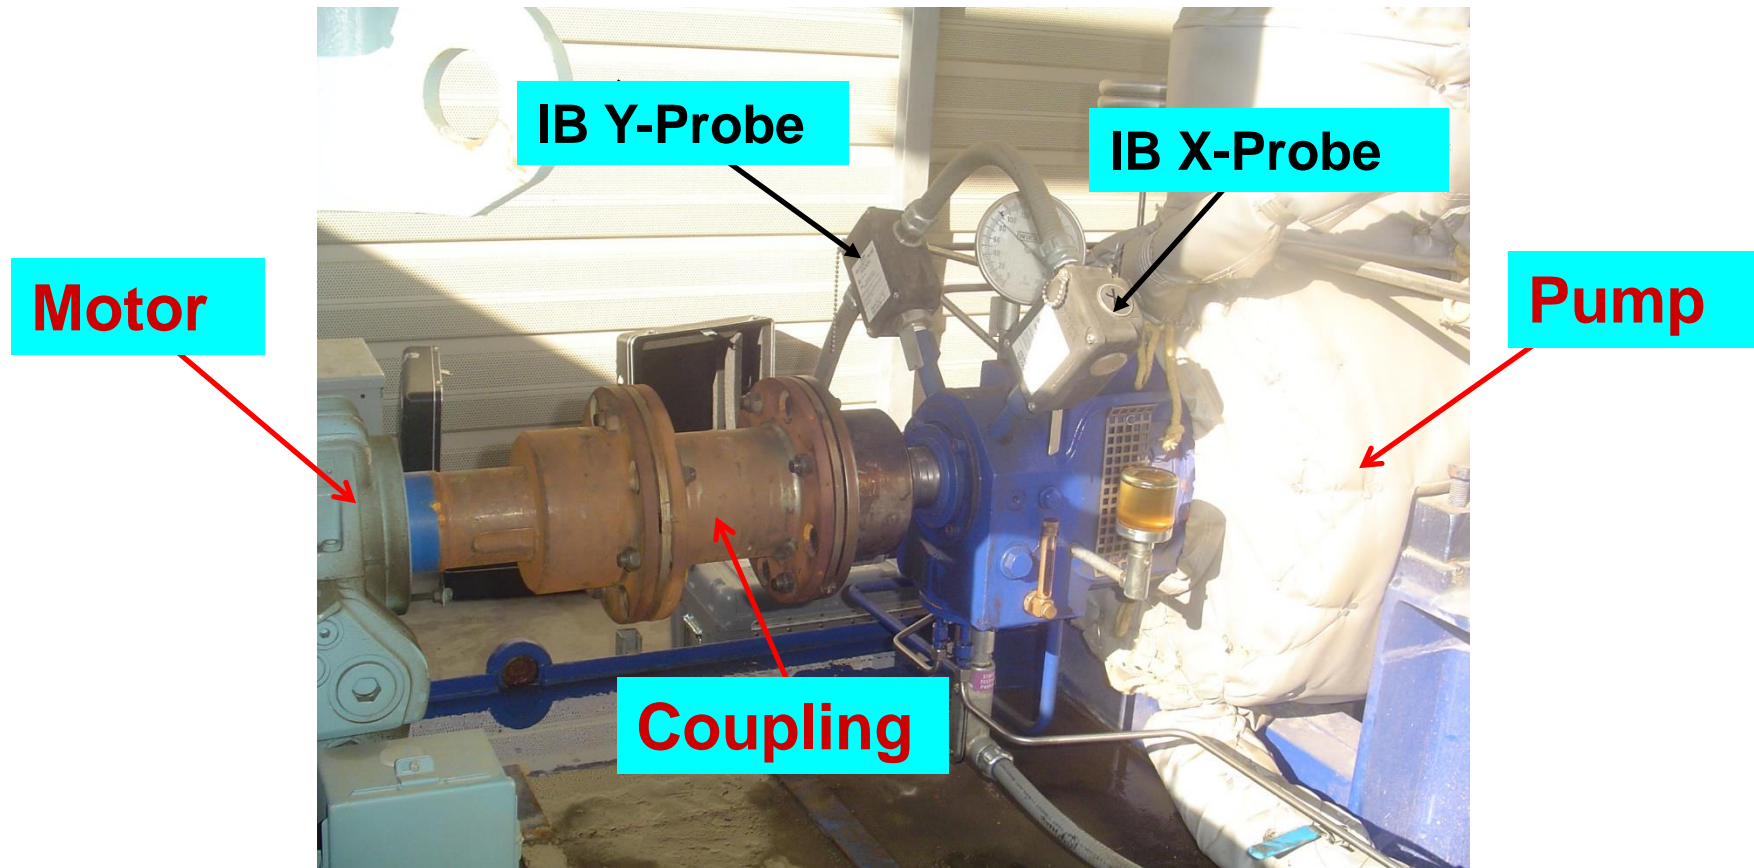
- A Boiler Feed Pump driven by an induction motor with speed close to 3600 rpm.
- Shaft monitored by proximity probes near each bearing. Data collection performed to support its startup.

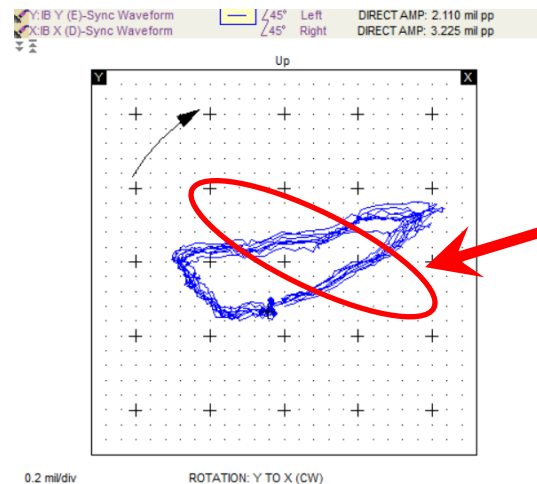
- **Misalignment?** – **Yes, likely in the horizontal direction**
 - Changes in shaft centerline position, mainly in the horizontal direction
 - Vibration level dependent on shaft centerline position
 - Abnormal orbit orientation (amplitude higher at 45 Right probe than at 45 Left probe for clockwise shaft rotation)

Normal orbit orientation
