ASIA TURBOMACHINERY & PUMP SYMPOSIUM

High Speed Coupling Failure related to Torsional Vibration

ExxonMobil

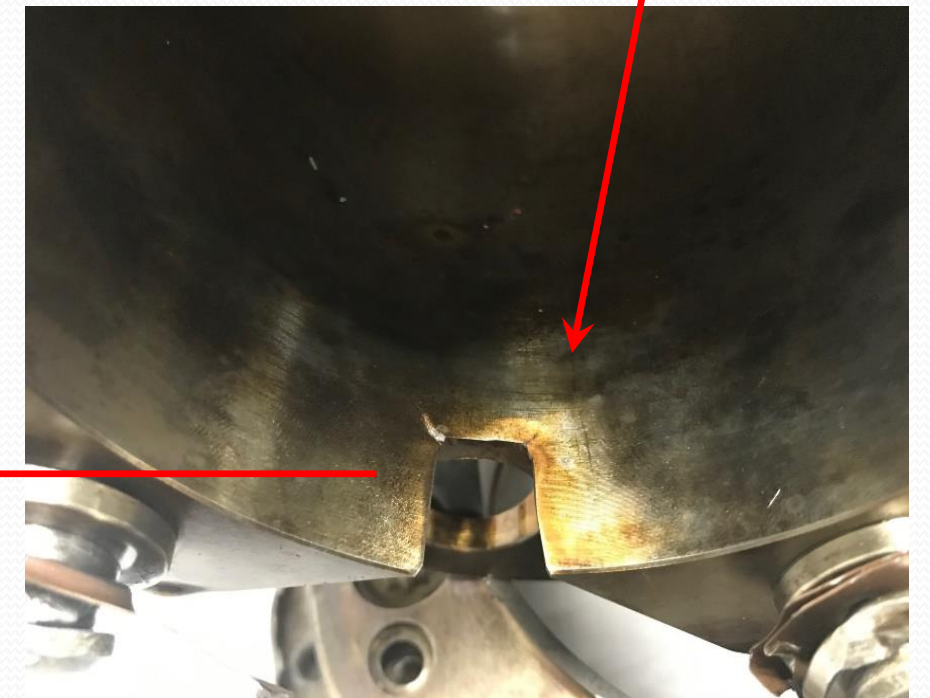
Crack propagated

Findings are similar for First failure and Second failure

- Fatigue crack initiation in two principle directions
- Gear tooth wear pattern on both sides
