Centrifugal Compressor High Sub-Synchronous Vibration (SSV) During Higher Load and Speed

Mohd Faizal Mohamed –
PETRONAS
Mohd Hafiz A Manan –
PETRONAS

Executive Summary

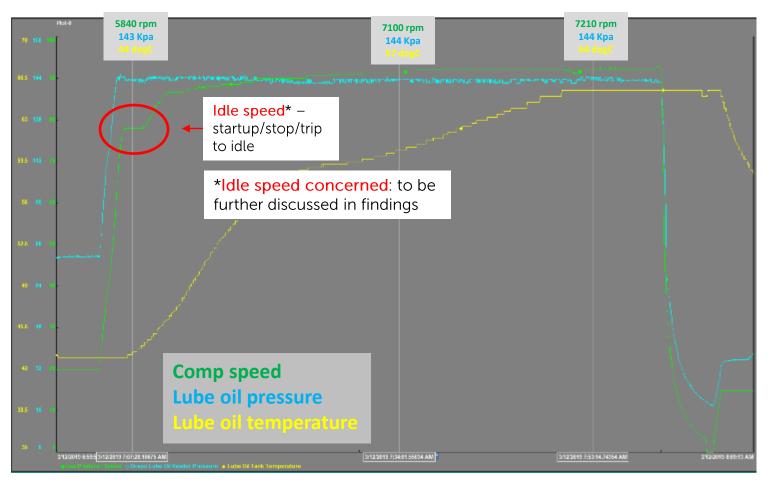
Possible Causes #1 - Instability From Hydrodynamic Fluid Film

Lubrication parameters were found satisfactory during unit in operation (within allowable range)

Lube oil analysis is acceptable

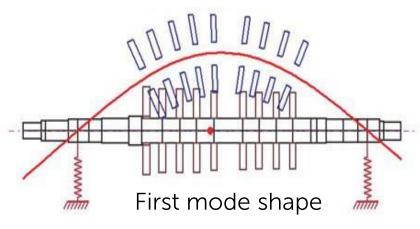
- This resulting rotor resonate whenever unit at idle speed (5840 rpm, <2% seperation margin). The rotor resonance at 1st CS with first mode shape will have largest deflection on the center leading to more exposure towards rubbing and causing severe damage to center seal

- Excessive clearance at damaged center seal behave like "third bearing" effect and causing machine experiencing stall and/or aerodynamic instability as observe from <u>sub-synchronous vibration (SSV)</u>
